Geophysical Site Survey Report

Danish Offshore Wind 2030

LOT 4, Work Package C, Area 1

Geophysical Survey – SN2023_010
North Sea, Danish Sector

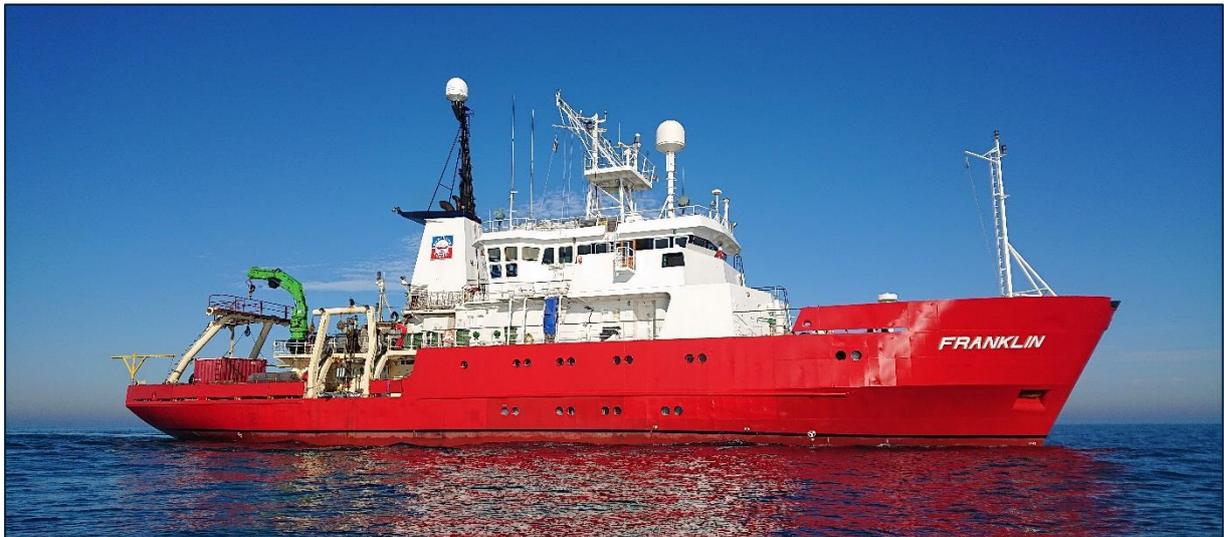
Figure 5 M/V Northern Franklin.

Part of the geophysical site survey operation was conducted by the survey vessel M/V Northern Franklin (Figure 5). The M/V Northern Franklin is fully equipped for survey activities in water depths between 10 - 250 m.

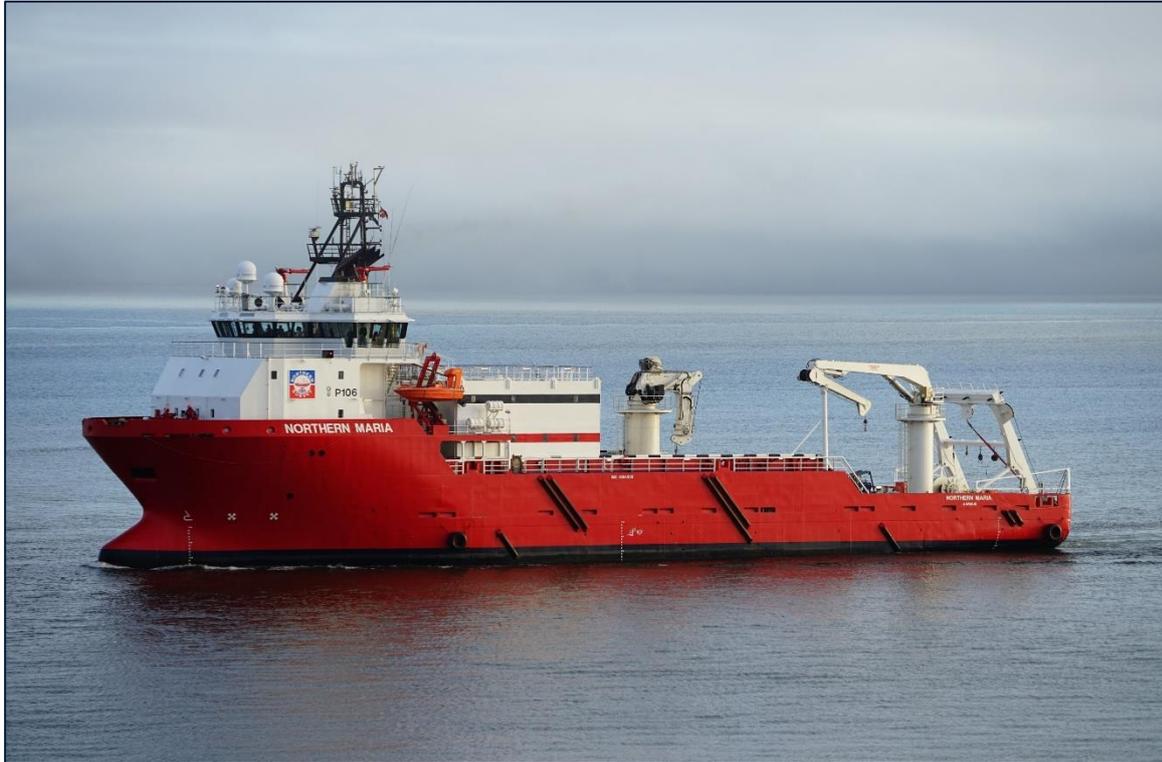
Figure 6 M/V Northern Maria.

Part of the geophysical site survey operation was conducted by the survey vessel M/V Northern Maria (Figure 6). The M/V Northern Maria is fully equipped for survey activities in water depths between 10 - 250 m.

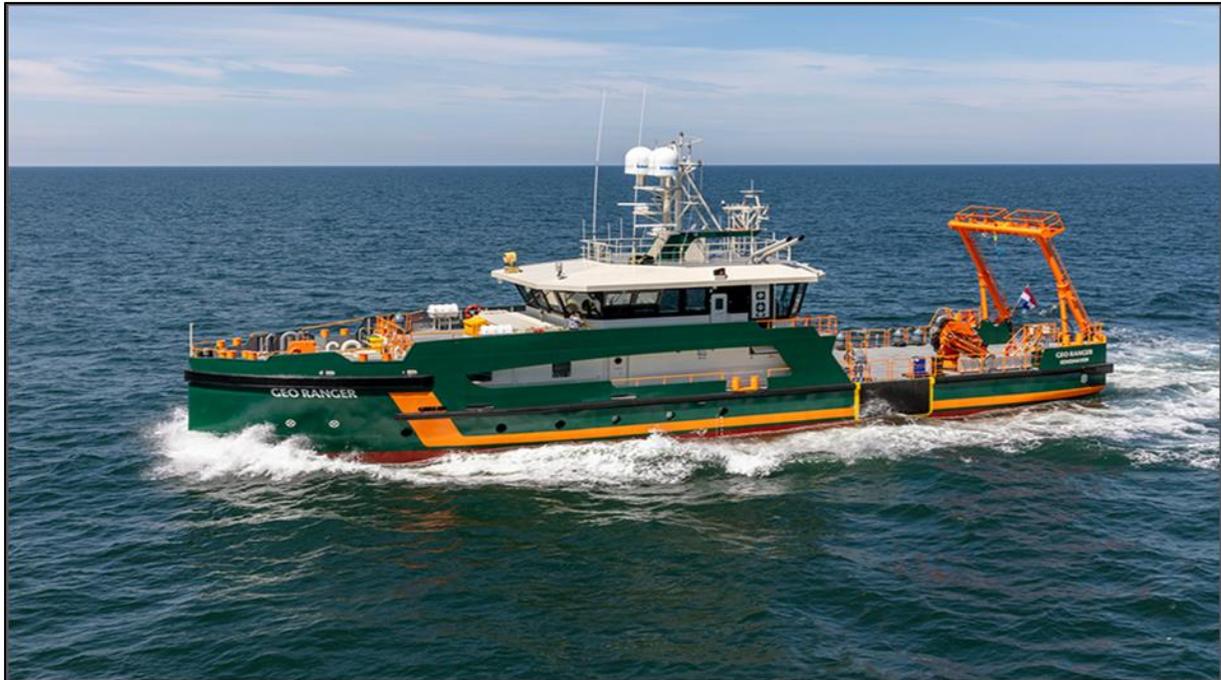
Figure 7 M/V Geo Ranger.

Part of the geophysical site survey operation was conducted by the survey vessel M/V Geo Ranger (Figure 7). The M/V Geo Ranger is fully equipped for survey activities in water depths between 10 - 250 m.

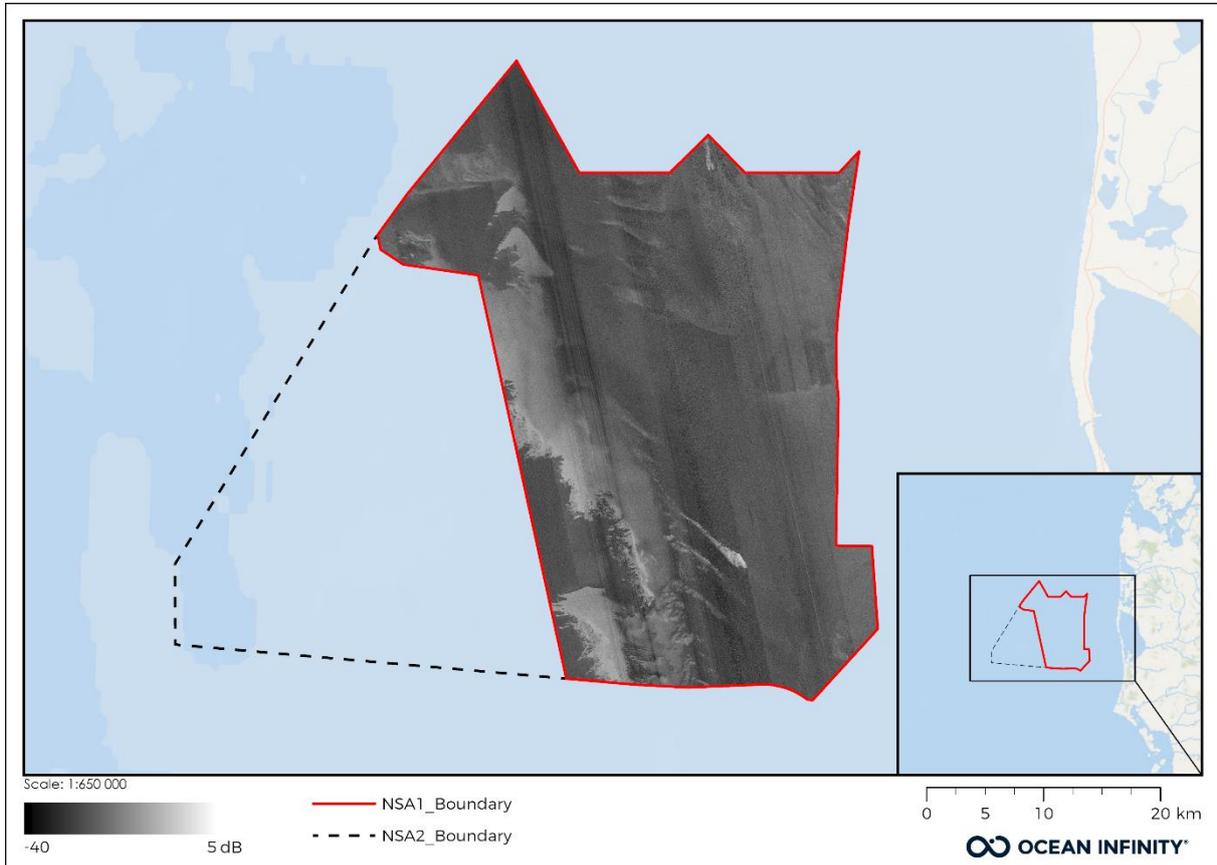
Figure 78 showing an overview of the collected backscatter for NSA1.

Our dataset, while not without challenges—specifically with the Geo Ranger data and the very large variations in sound velocity—yields satisfactory results overall. The nuanced acoustic reflectivity captured by multibeam allows for effective seafloor characterization, enabling the identification of various materials and the mapping of geomorphic features. Despite encountered challenges, the backscatter proves to be a versatile tool, contributing to the analysis of dynamic geological processes.

Following are a few examples of what can be seen in the backscatter data and what type of detail that is to be expected when conducting surveys with hull mounted multibeam echosounders at the depths 16 to 40 m meters. For a more comprehensive exploration of the surficial geology and a detailed analysis of seabed features, readers are encouraged to refer to the dedicated 8.4 Surficial Geology and Seabed Features chapter.

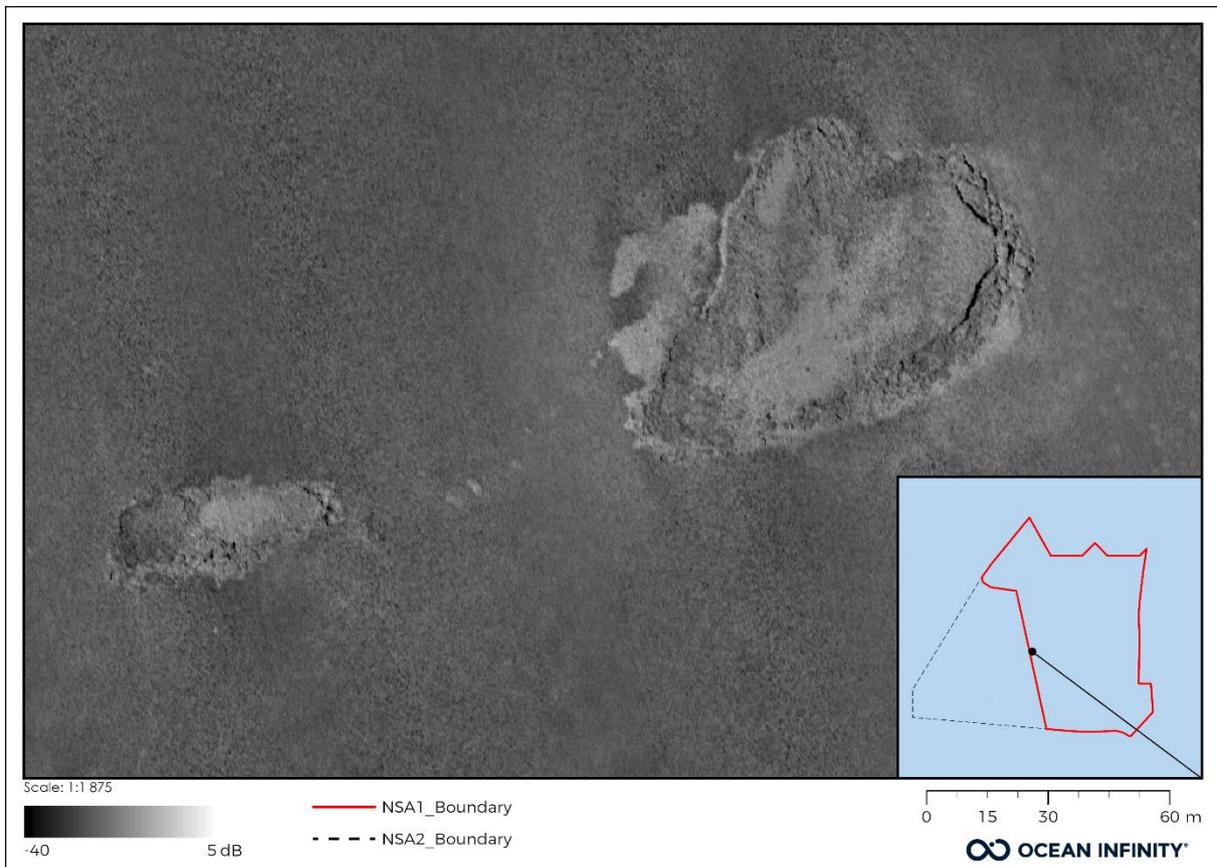
Figure 80 Outcropping till. Can also be seen in the bathy data in Figure 76 and in the SBP in Figure 143.
