HESSSELØ BATHYMETRY SURVEY 2021 – WP D SURVEY REPORT

Project name **Hesselø Cable Route Survey**
Project no. **1100044605**
Recipient **Energinet**
Document type **Survey Report**
Version **1**
Date **08/12/2021**
Prepared by **LWM/JROU/MJLF**
Checked by **RUBJ**
Approved by **RUBJ**
Description **MBES Survey**

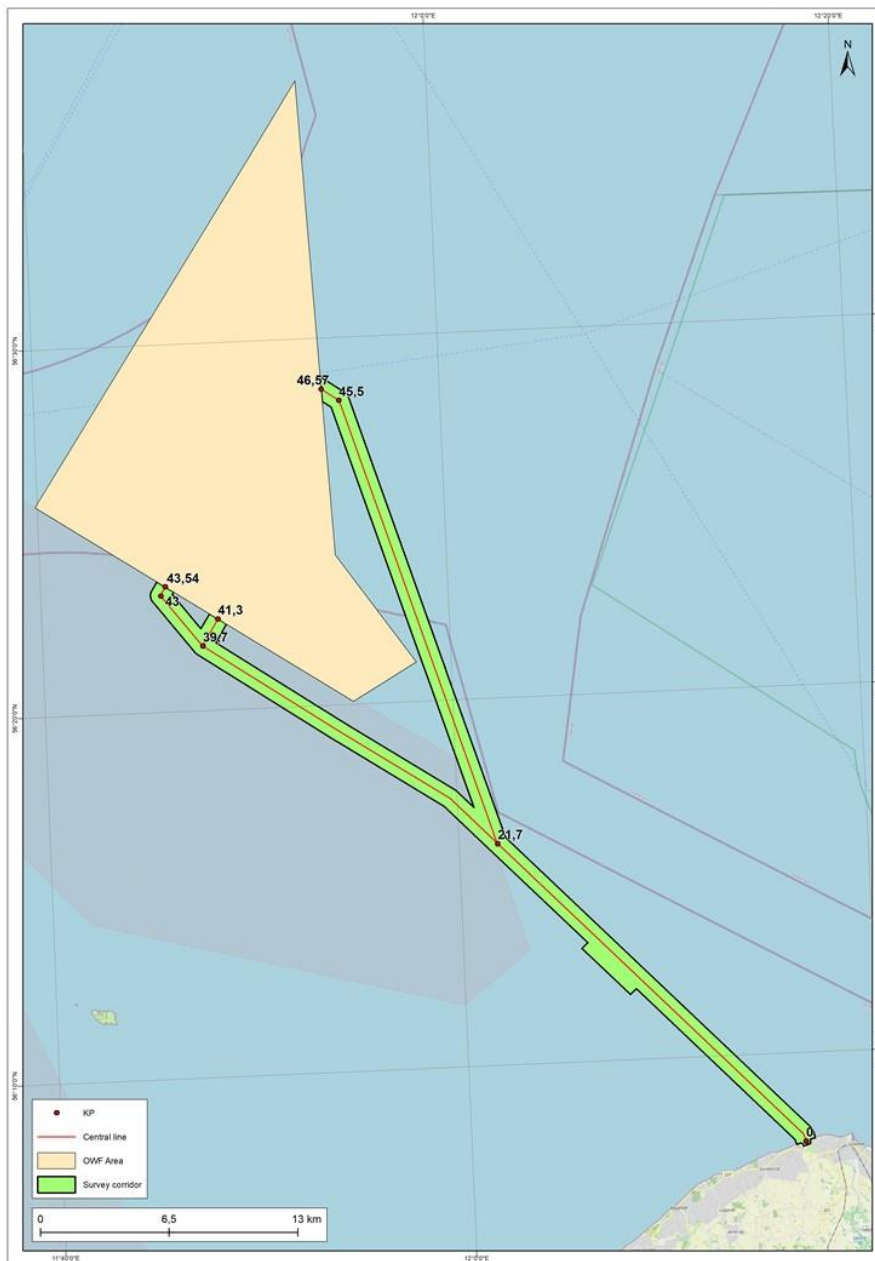
Figure 2-1 Overview map showing the survey area for the 2021 bathymetry survey.

An overview of the cable corridor is shown in Figure 2-1. The survey has been divided in a nearshore shallow part and an offshore part. The latter consist of the main corridor and an eastern arm and a western arm defined by the KP values shown in Table 2-1.

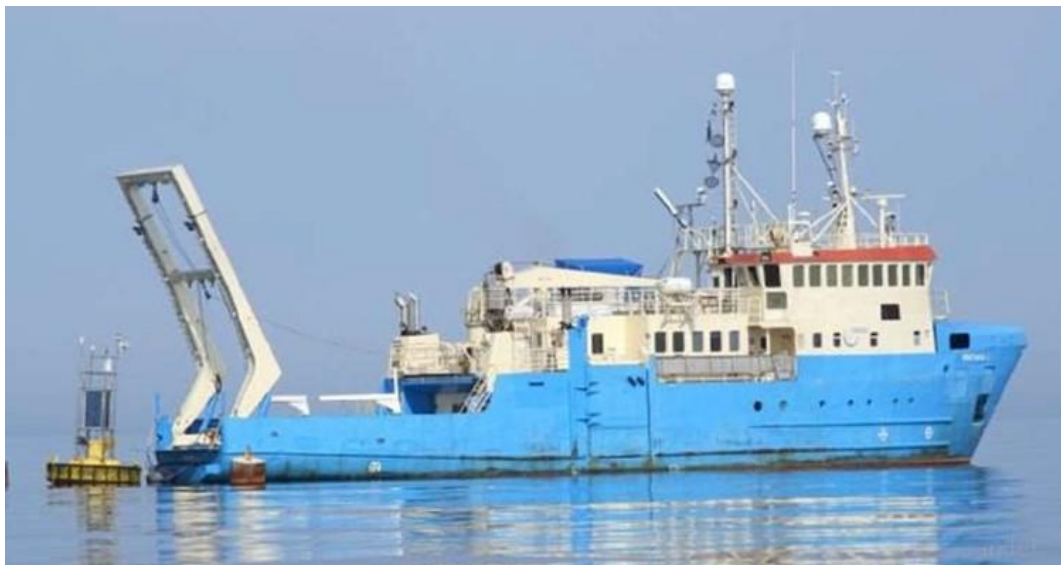
Figure 3-1 offshore survey vessel Mintaka I

The Offshore part of the geophysical survey program was conducted with the survey vessel *Mintaka I*. Figure 3-1 show the vessel used for the marine geophysical survey.

The following equipment were used for data acquisition on the Mintaka I, see Table 3-1. For the bathymetric survey a pole mounted multibeam echo sounding system was used.

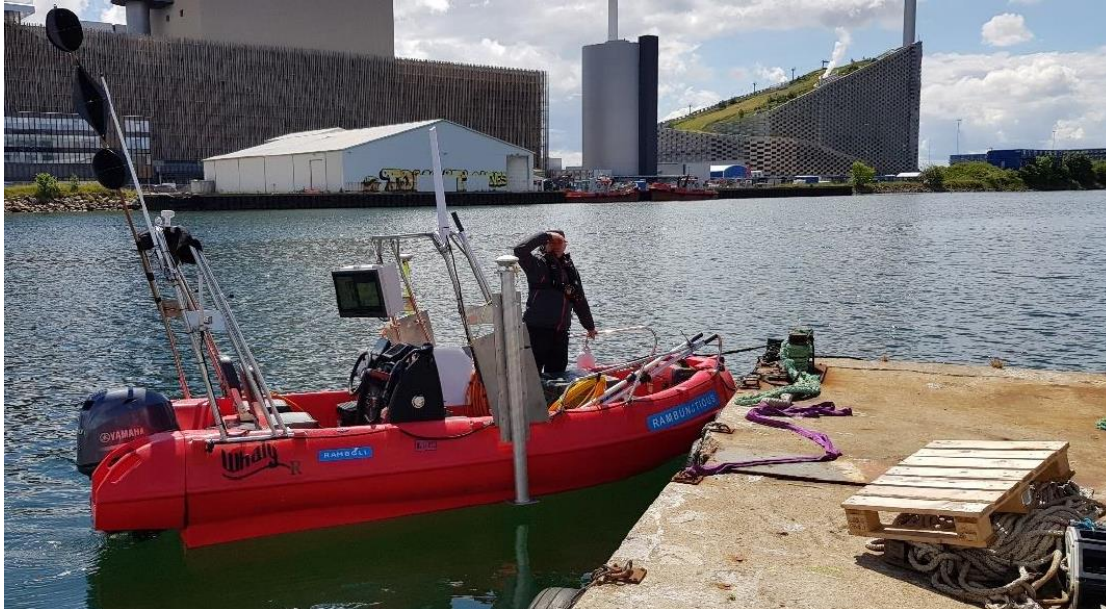
Figure 3-2 Shallow water survey vessel Rambunctious

The shallow survey was carried out using the vessel Rambunctious (see Figure 3-2).

Table 3-2 list the equipment used for data acquisition in the shallow water part onboard the Rambunctious. The MBES equipment was pole mounted on the starboard side of the vessel.

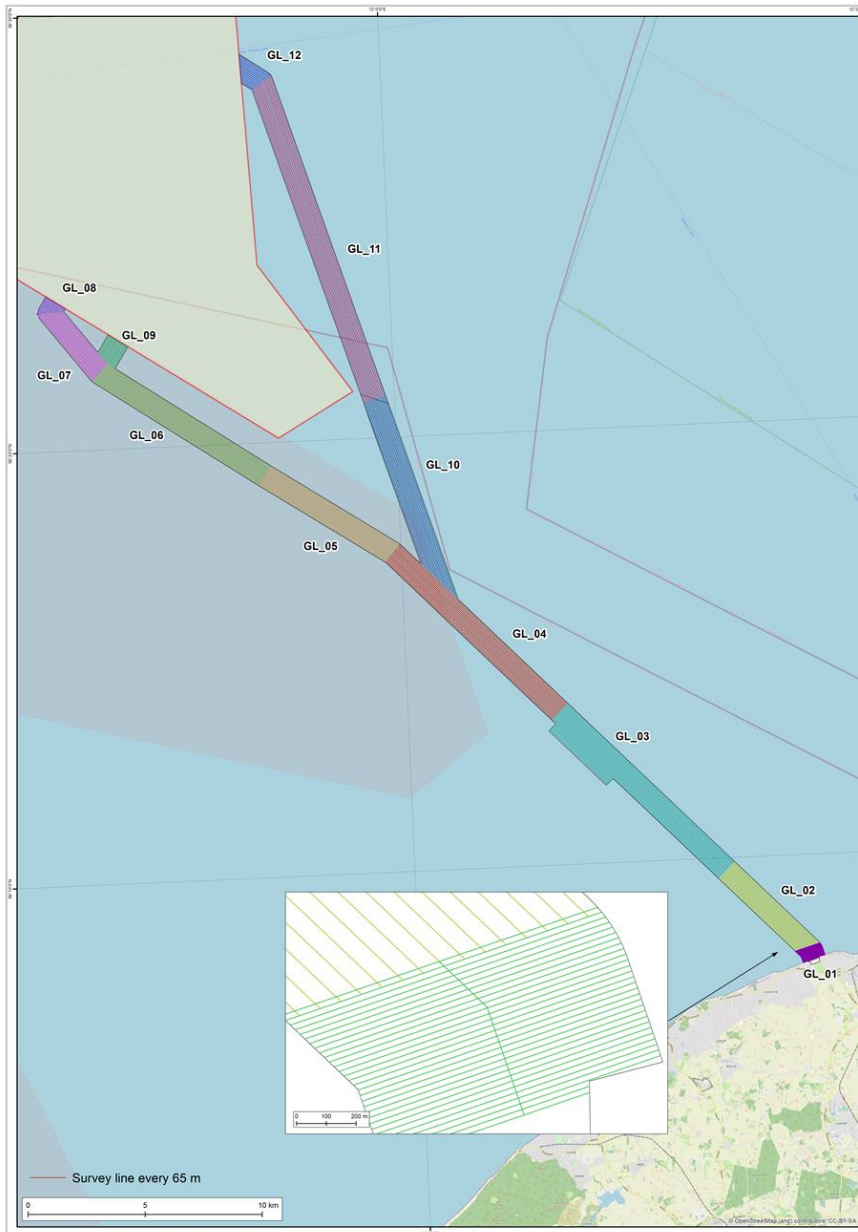
Figure 3-3 Survey area showing the sub-division into 12 sections with inserts showing planned line direction..

As for the 2020 survey, the corridor was divided into 12 sections with a line direction being parallel to the corridor in the offshore areas. For the shallow water survey the lines were planned to run parallel to the shoreline.

Lines were planned to ensure 100% MBES coverage inside the corridor. In section 2 to 12 (the offshore part) the survey lines were planned with a spacing of 65m with one centerline and 7 wing-lines to each side giving a total of 15 planned lines.

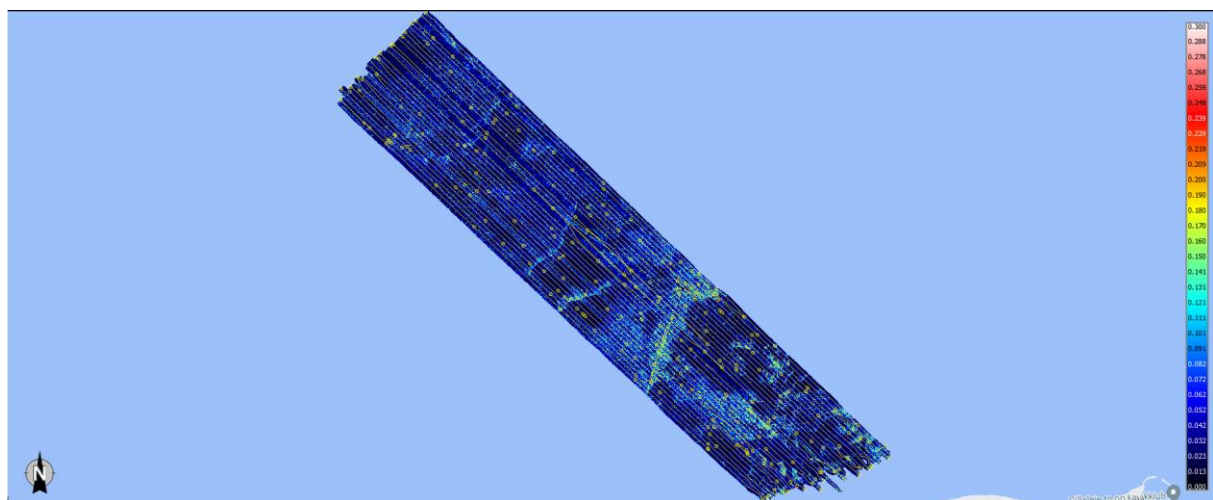
Figure 6-2 Standard deviation of the nearshore section, GL02

Figure 6-2 and Figure 6-3 shows standard deviations for the nearshore section, GL02, and for the offshore section GL06. The standard deviation (95%) grid does mainly not show values above 20-30 cm. High standard deviation are mainly caused by boulders.

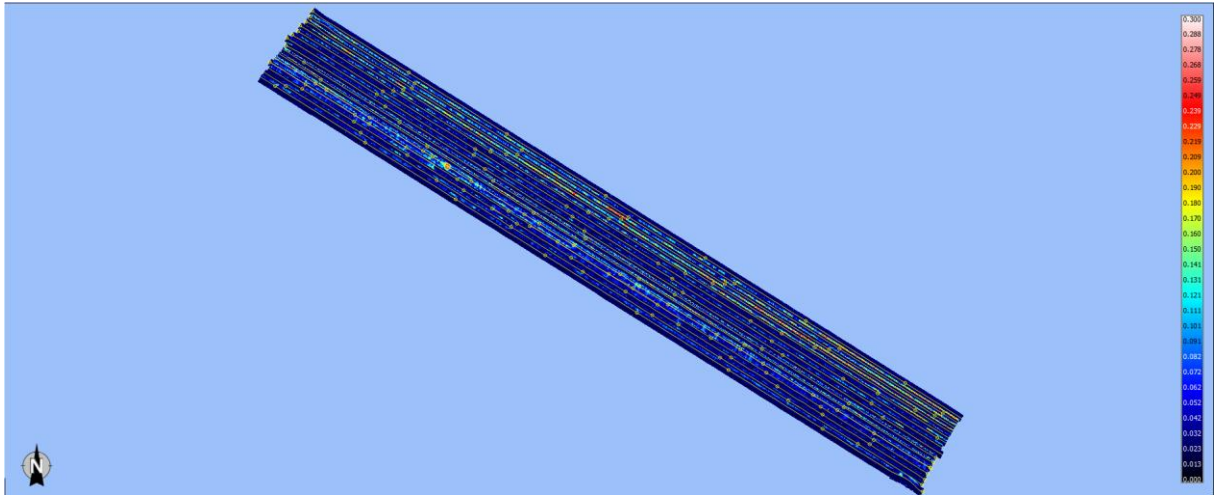
Figure 6-3 Standard deviation of the nearshore section, GL06

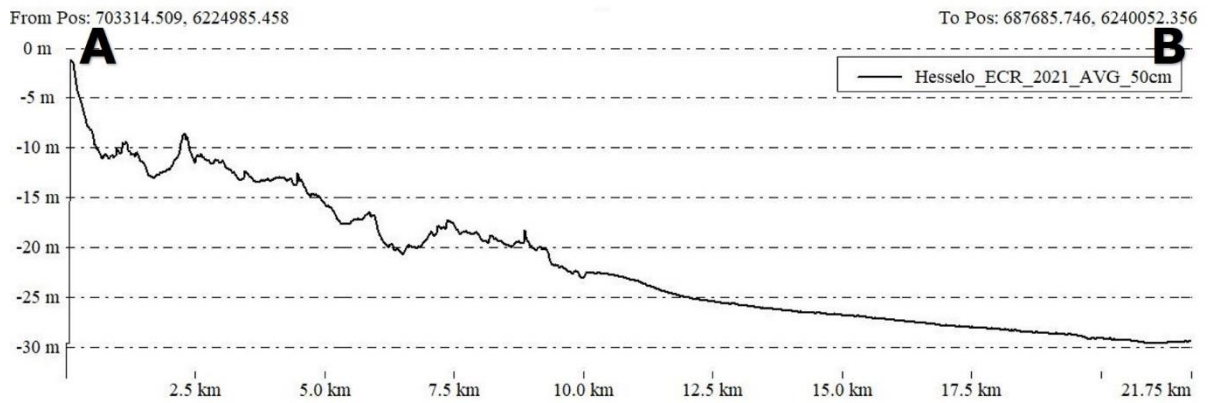
Figure 7-4 Seabed elevation profile from the coast to the intersection point between the eastern and western arm.

The following sub-section provides seabed elevation profiles along the mapped survey corridor. Figure 7-1 to Figure 7-3 show the bathymetry within the survey area with water depths ranging from -0.1m to -37.4m. Figure 7-4 to Figure 7-6 displays the elevation profiles along the centerline.

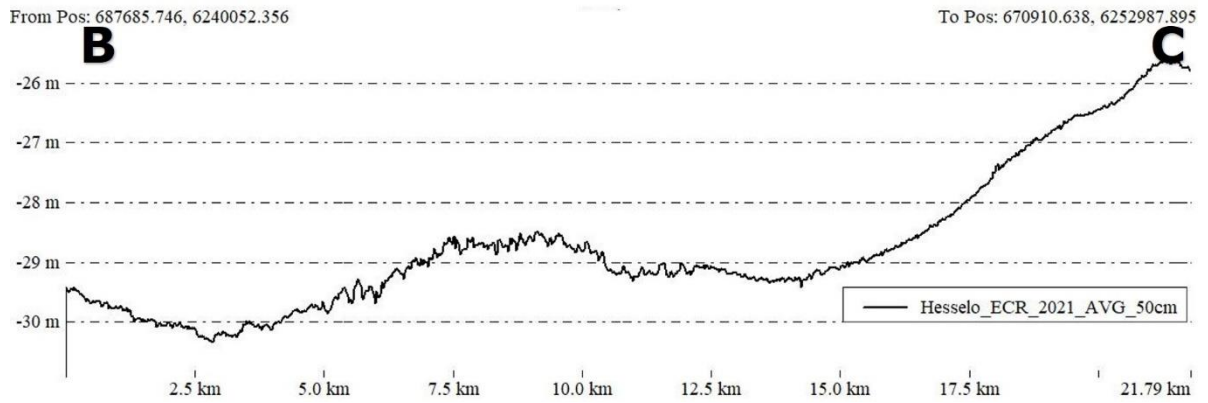
Figure 7-5 Seabed elevation profile along the western arm, from the intersection B-point.

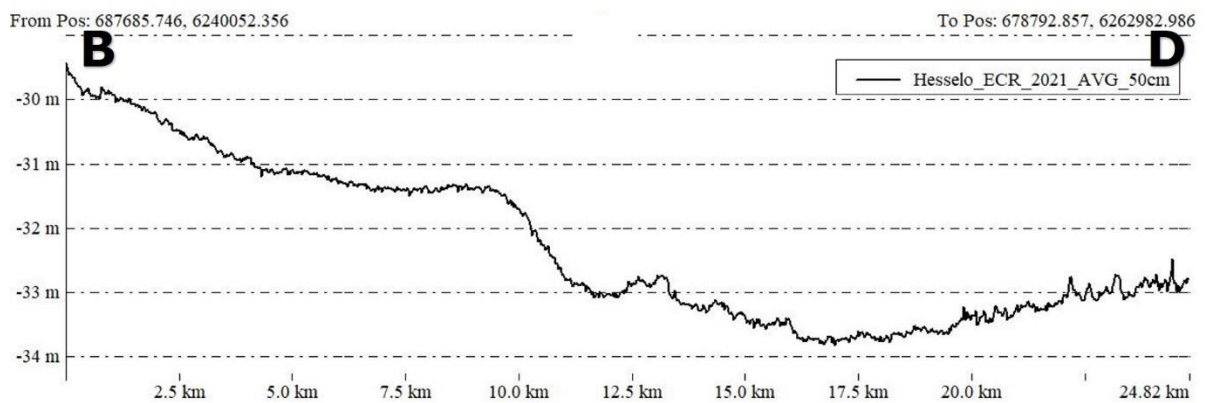
Figure 7-6 Seabed elevation profile along the eastern arm, from the intersection B-point.

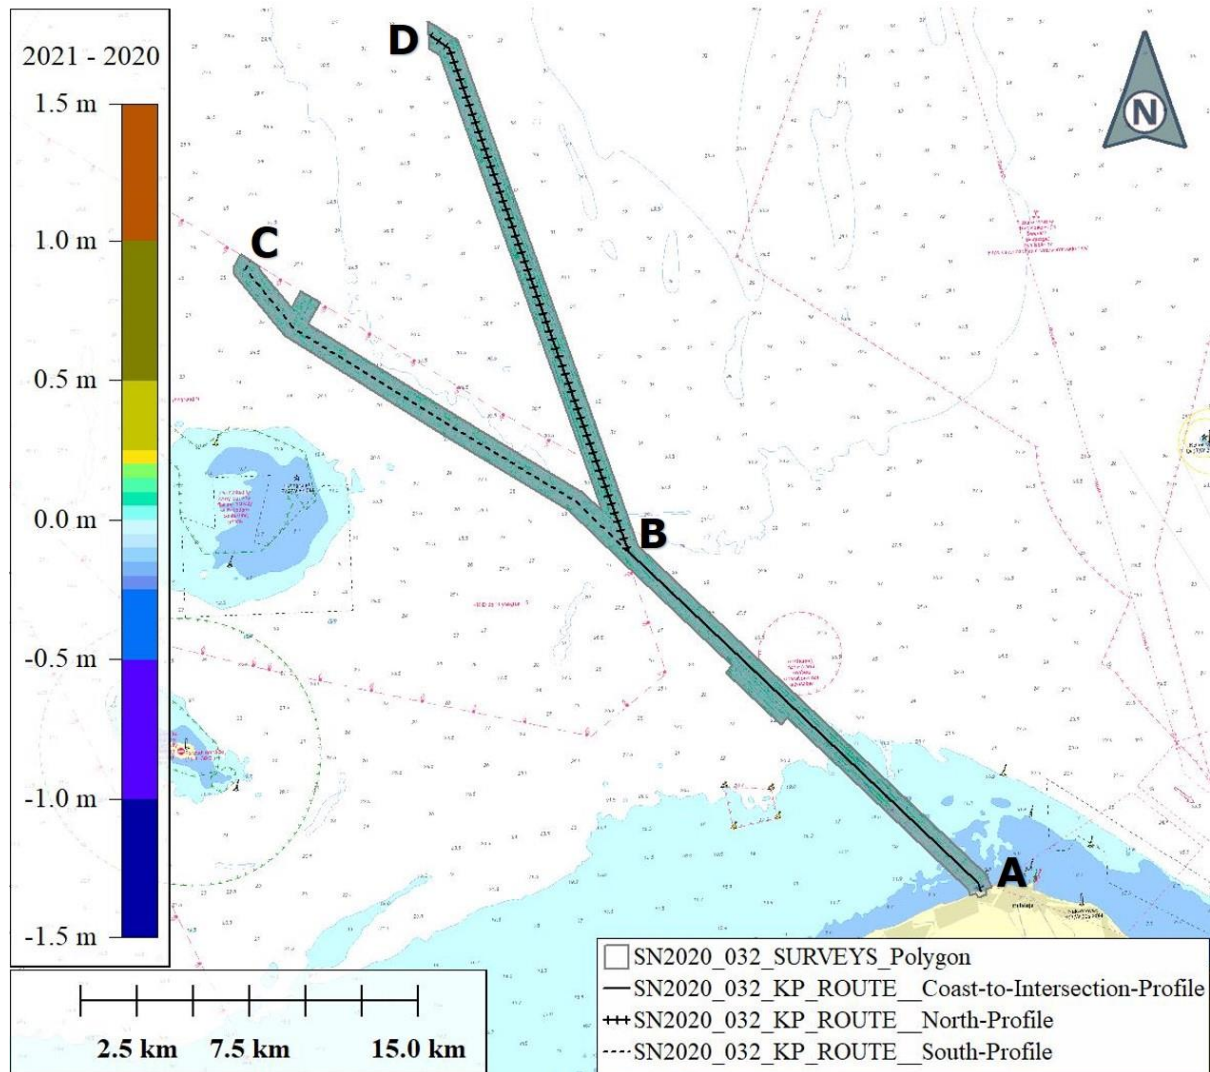
Figure 7-7 Difference 2021 – 2020 datasets with an overview of the three profiles areas along the cable routes.

Figure 7-7 shows an overview of the bathymetric differences. The differences fluctuate between -1.5m to 1.5m. A detailed evaluation of the data variation is shown in Figure 7-8 histograms. Profiles were also created along the centerline; see Figure 7-9 to Figure 7-11.

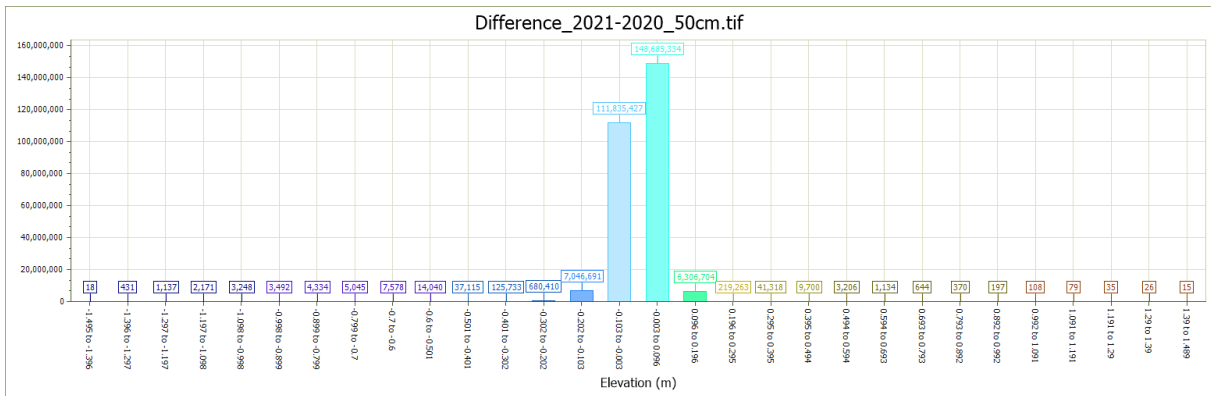
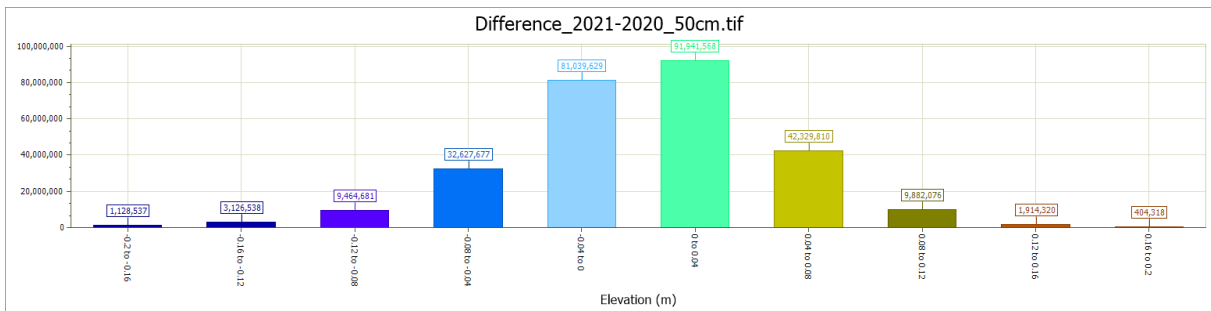
Figure 7-8 2021-2020 difference-histograms. Above, along the entire grid, and below; for between -0.2 to +0.2 m. Negative values indicate erosion whereas positive are related to accretion of sediment.

By comparing the 2021 survey with 2020 data a slight accretion of sedimentation is observed. Figure 7-8 shows how the difference in data is mainly located between -0.2m to 0.2m. However, within this range, 52.6% is among 0m to 0.12m whereas 45.0% is between 0m to -0.12m.

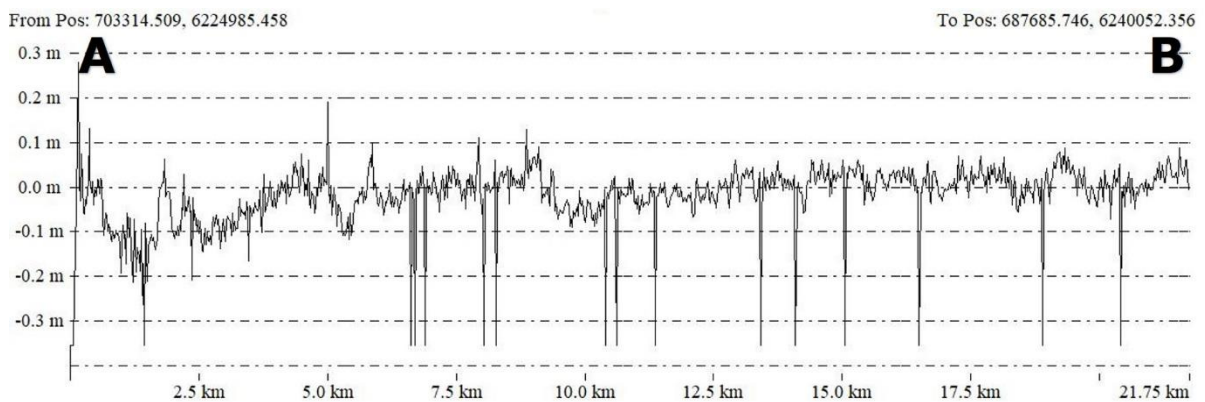
Figure 7-9 Difference 2021 – 2020 from the coast to the intersection point between the eastern and western arm. Negative values indicate erosion whereas positive are related to accretion of sediment.

Figure 7-9 shows mainly erosion values up to 0.2m around the coast area and further to the coast, an average accretion of 0.03m with a maximum accretion of 0.1m until the intersection point between the eastern and western arm. From this point, toward the south, Figure 7-10 shows an average accretion of 0.03m with local maximum accretion areas of 0.1m. However, from the intersection towards the eastern arm, Figure 7-11 shows an average erosion of 0.05m with a maximum erosion of 0.15m.

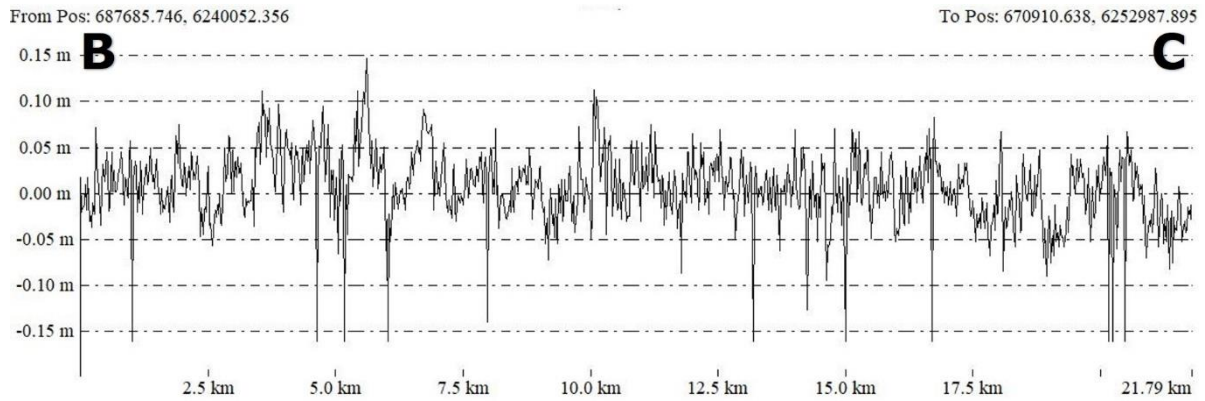
Figure 7-10 Difference 2021 – 2020 along the intersection and the south line. Negative values indicate erosion whereas positive are related to accretion of sediment.

The below profiles show the differences in 3 sections along the center line. Variations of 0.03m to 0.1m are mainly seen in the figures, with some outliers along the lines. Erosion areas close to the coast and at the end of the south and north routes are visible, with few centimeters of accretion along most of the surveyed area.

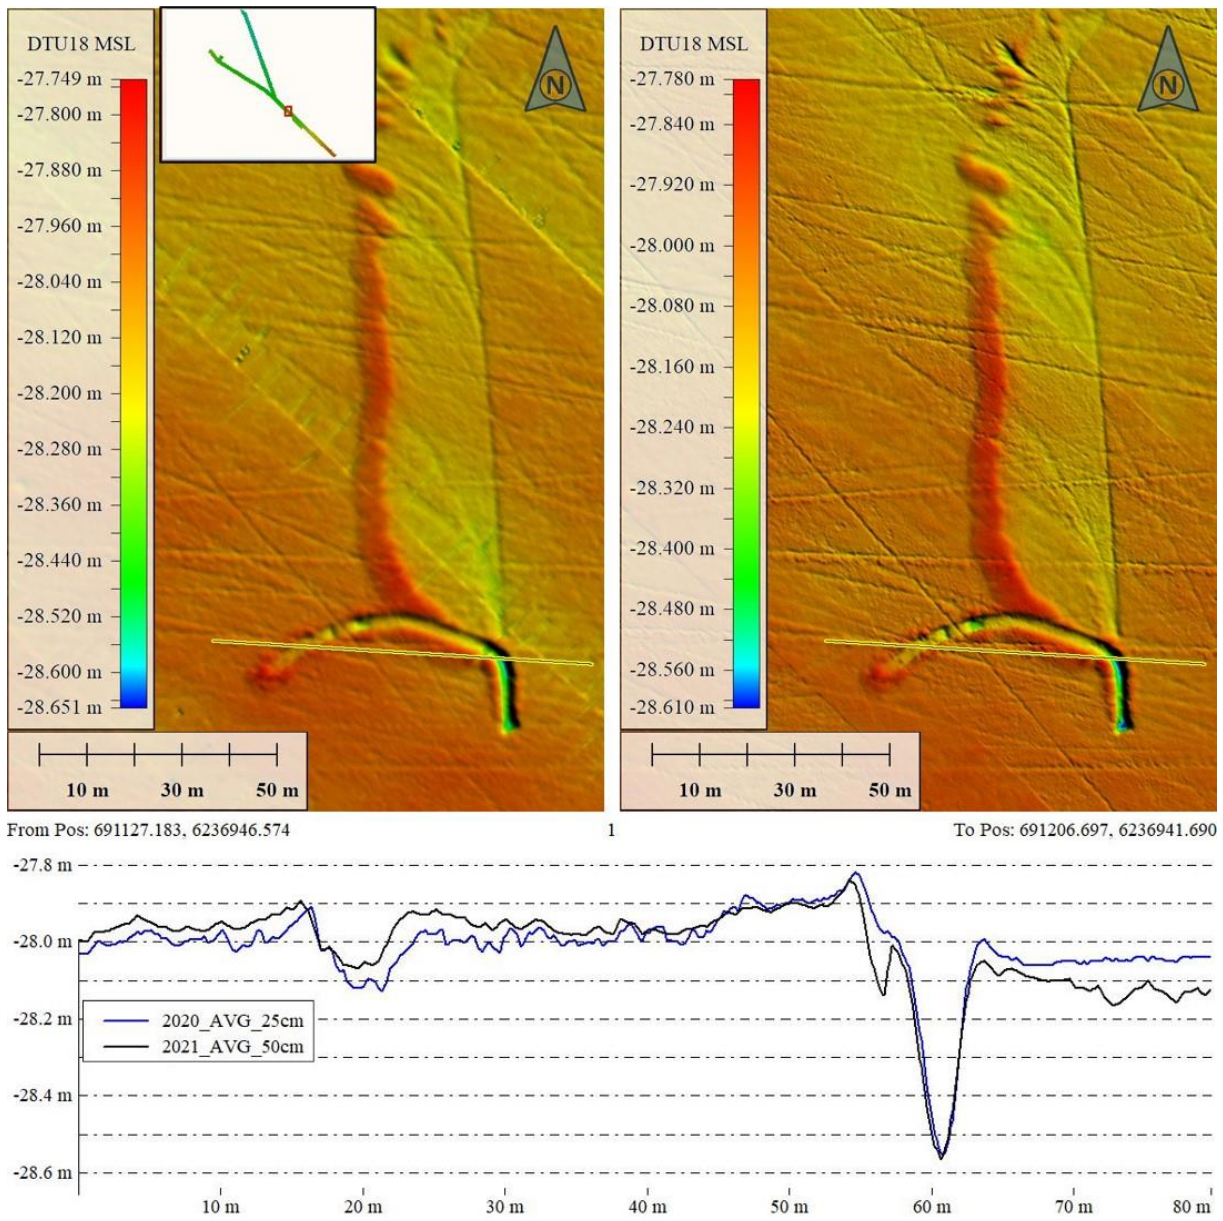
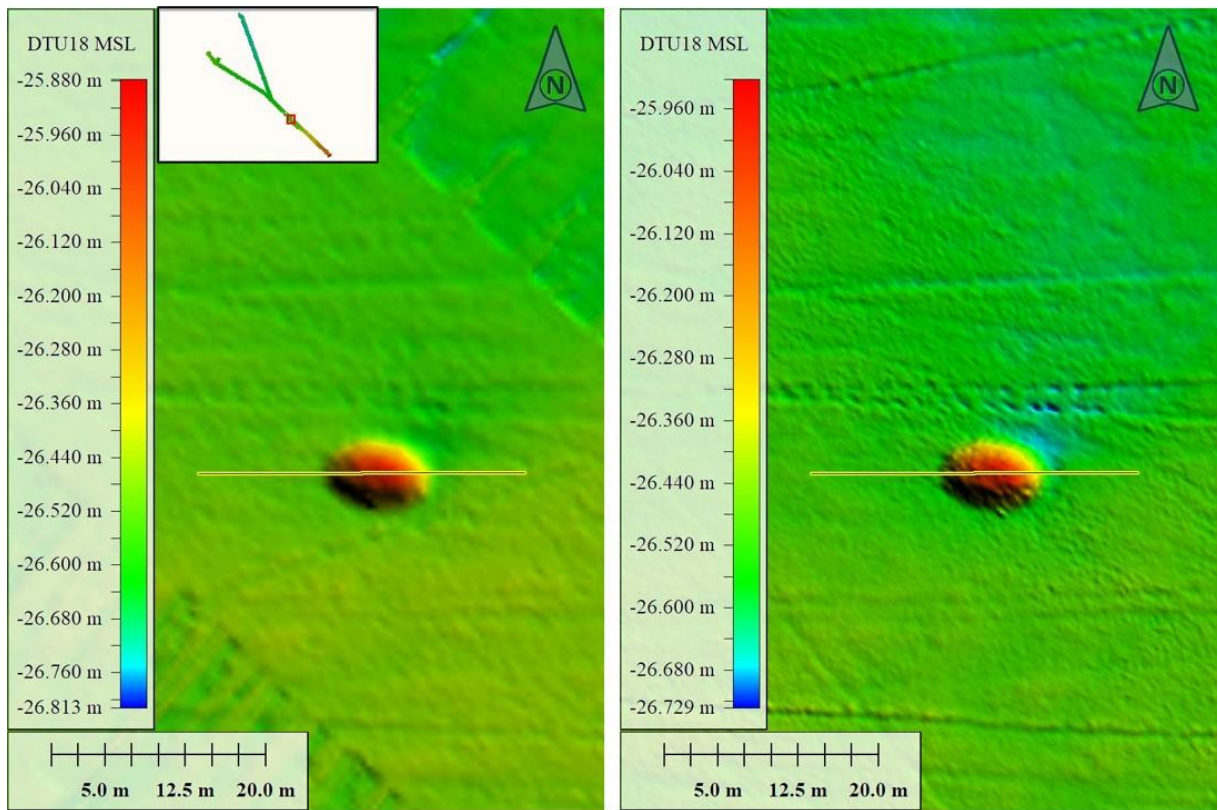
Figure 7-13 Survey comparison of a seabed feature example with depth profiles; 2021 (left) and 2020 (right). Minor data variations are seen between datasets and up to 0.18m in some local areas.

As expected from the above sub-section, minor variations are seen between datasets around seabed features and up to 0.18m in some local areas; see Figure 7-13 to Figure 7-15.

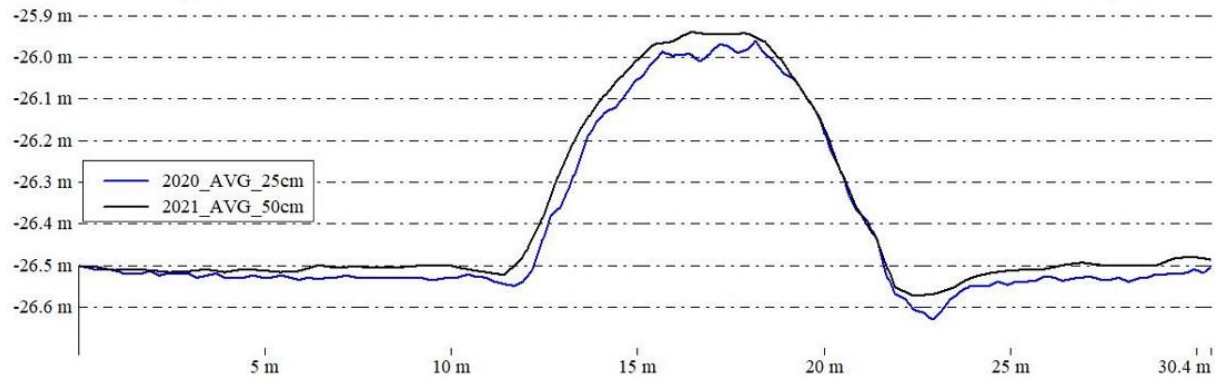
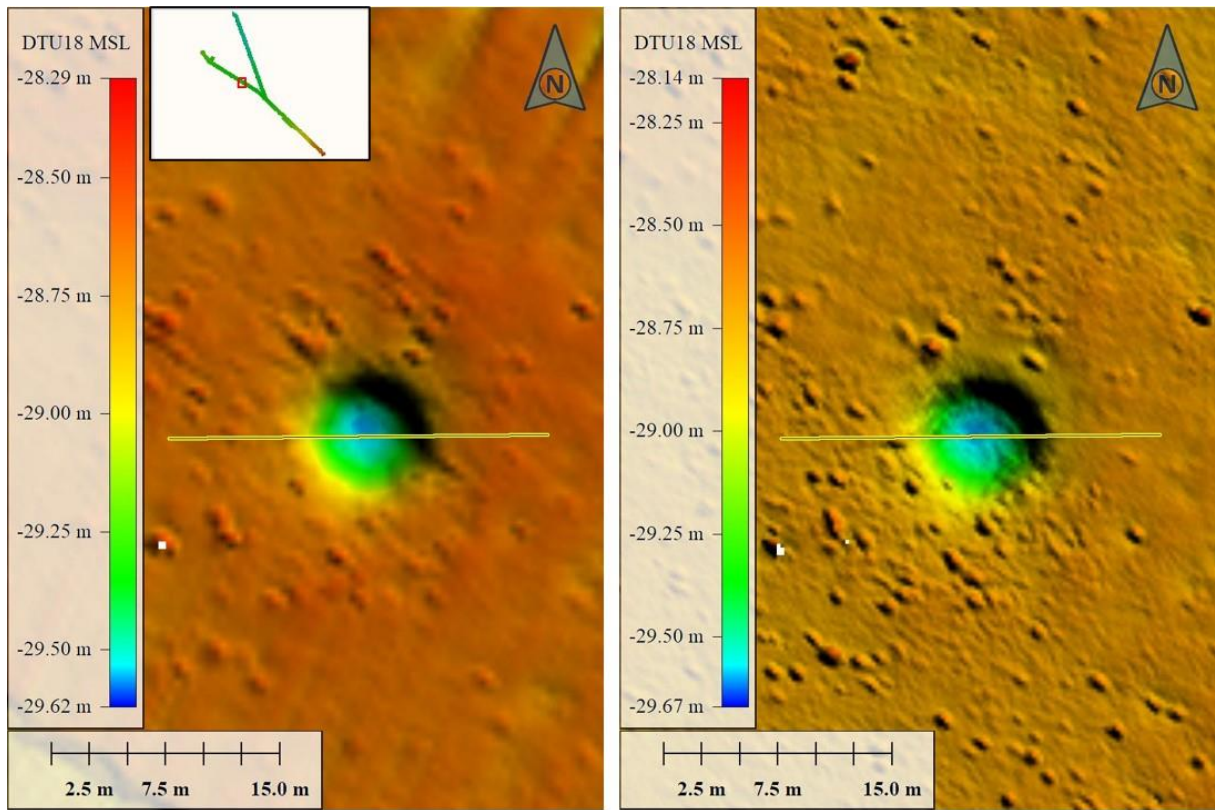
Figure 7-14 Survey comparison of a seabed feature example with depth profiles; 2021 (left) and 2020 (right). Minor data variations are seen between datasets and up to 0.06m in some local areas.

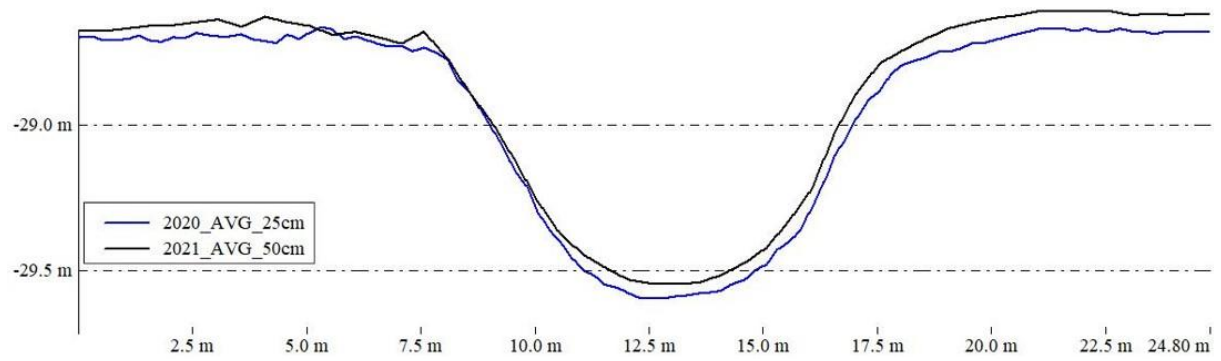
Figure 7-15 Survey comparison of a seabed feature example with depth profiles; 2021 (left) and 2020 (right). Minor data variations are seen between datasets and up to 0.07m in some local areas.

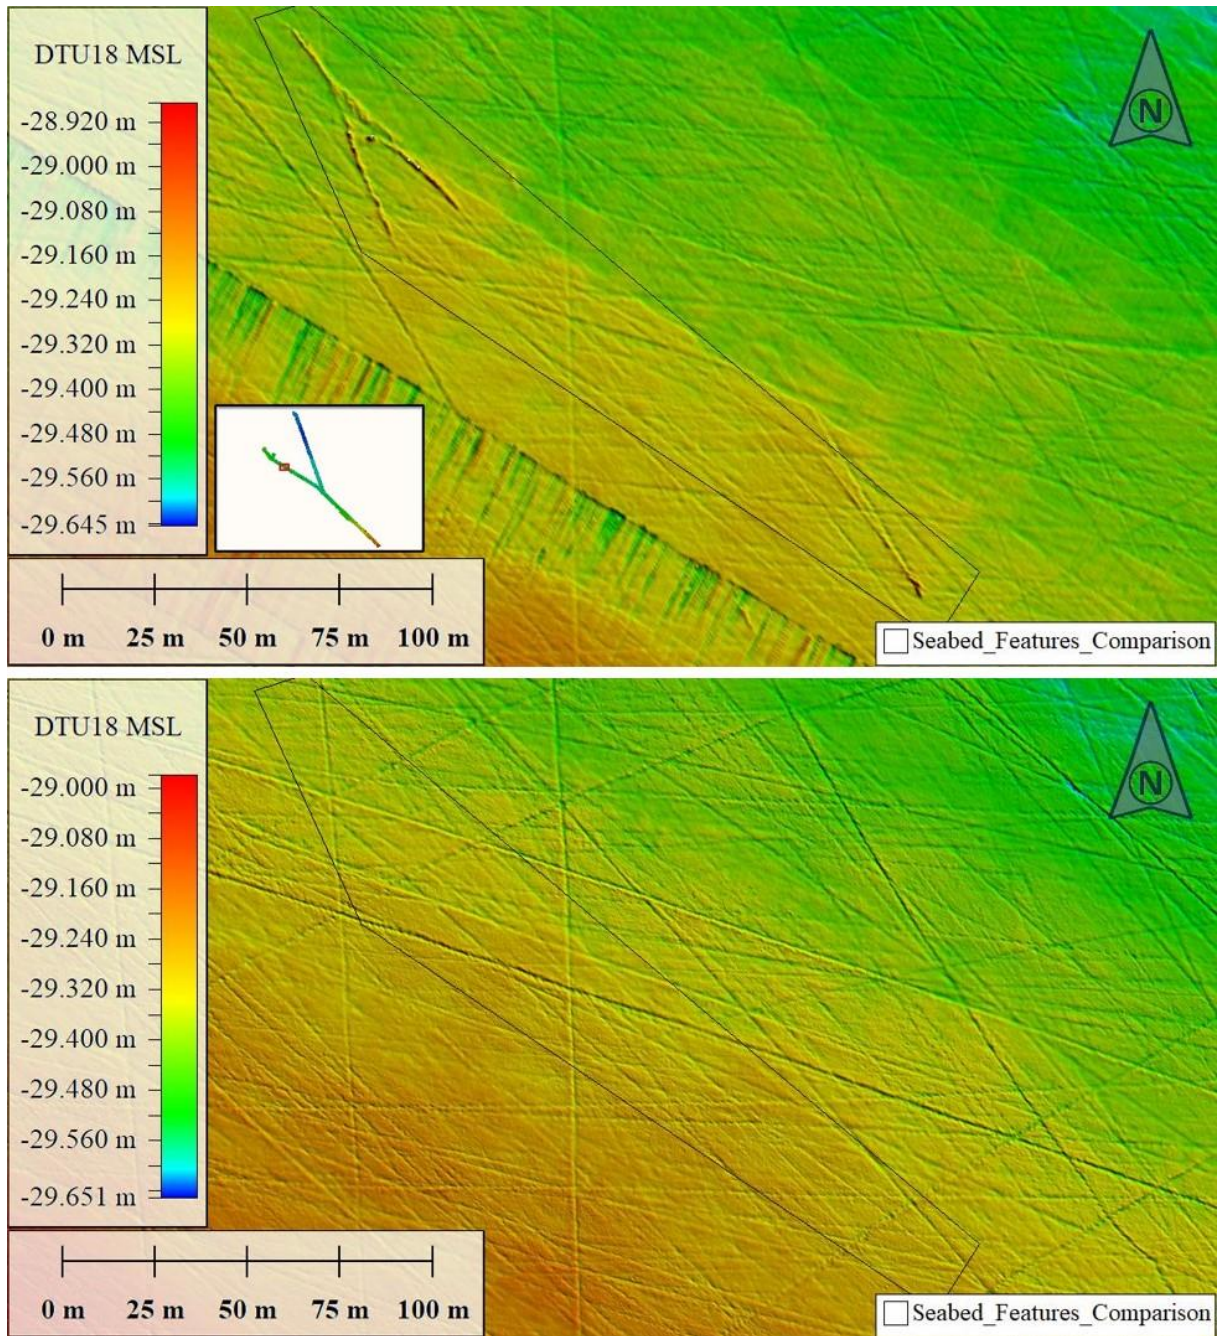
Figure 7-18 Survey comparison with new anthropological features appearing in latest survey (UTM 32N position: 676515.190 E, 6247715.486 N); 2021 (above) and 2020 (below).

Even though most anthropological seabed features remain unchanged in the 2021 survey, few new elements are visible across the new dataset, as seen from Figure 7-16 to Figure 7-19.
