# Energy Island Cable Route Survey Baltic Sea

Danish Baltic Sea  
April - August 2022

**DOC NO.**  
103971-ENN-OI-SUR-REP-SURVLOT1-VO

### Baltic Sea OWF and Energy Islands LOT1 Cable Route Survey Overview

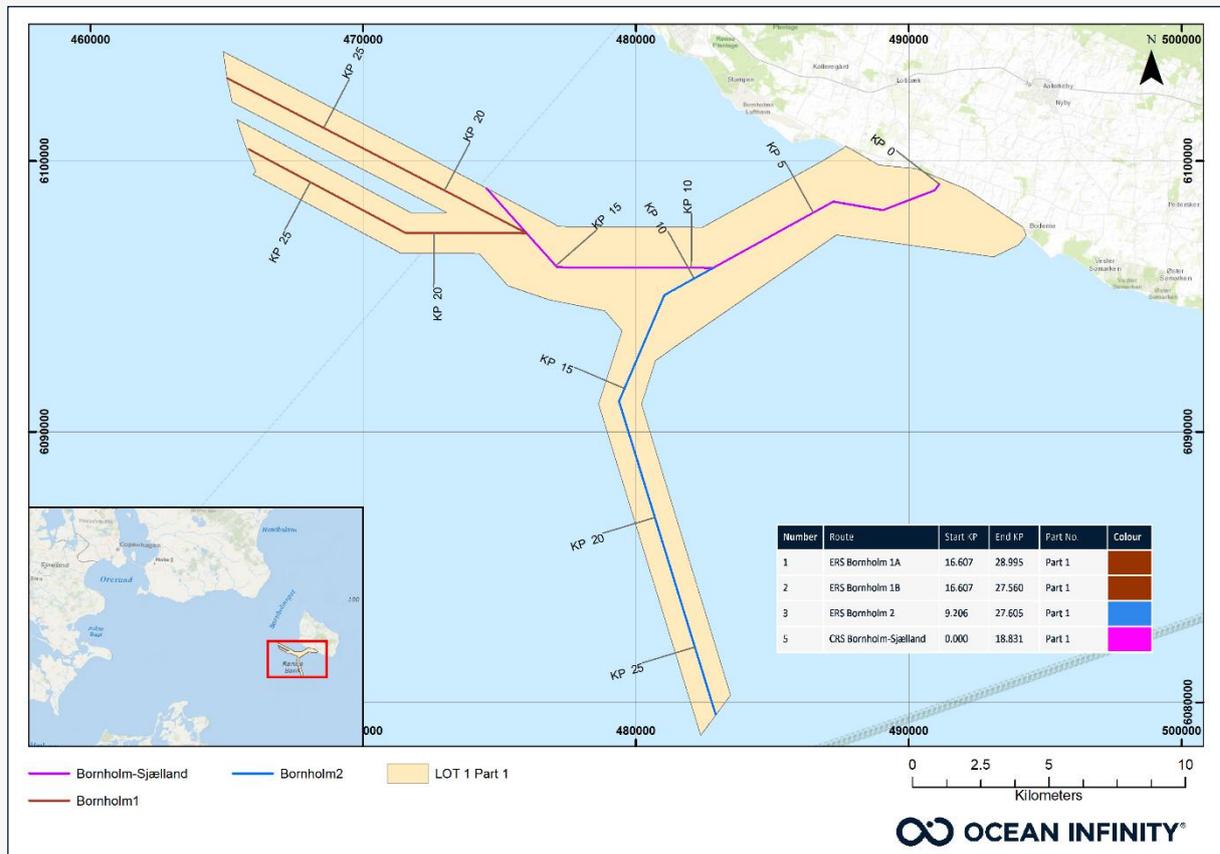
Figure 1 Overview of defined section of Part 1, Bornholm.

An overview image of the defined section of Part 1 is presented in Figure 1.

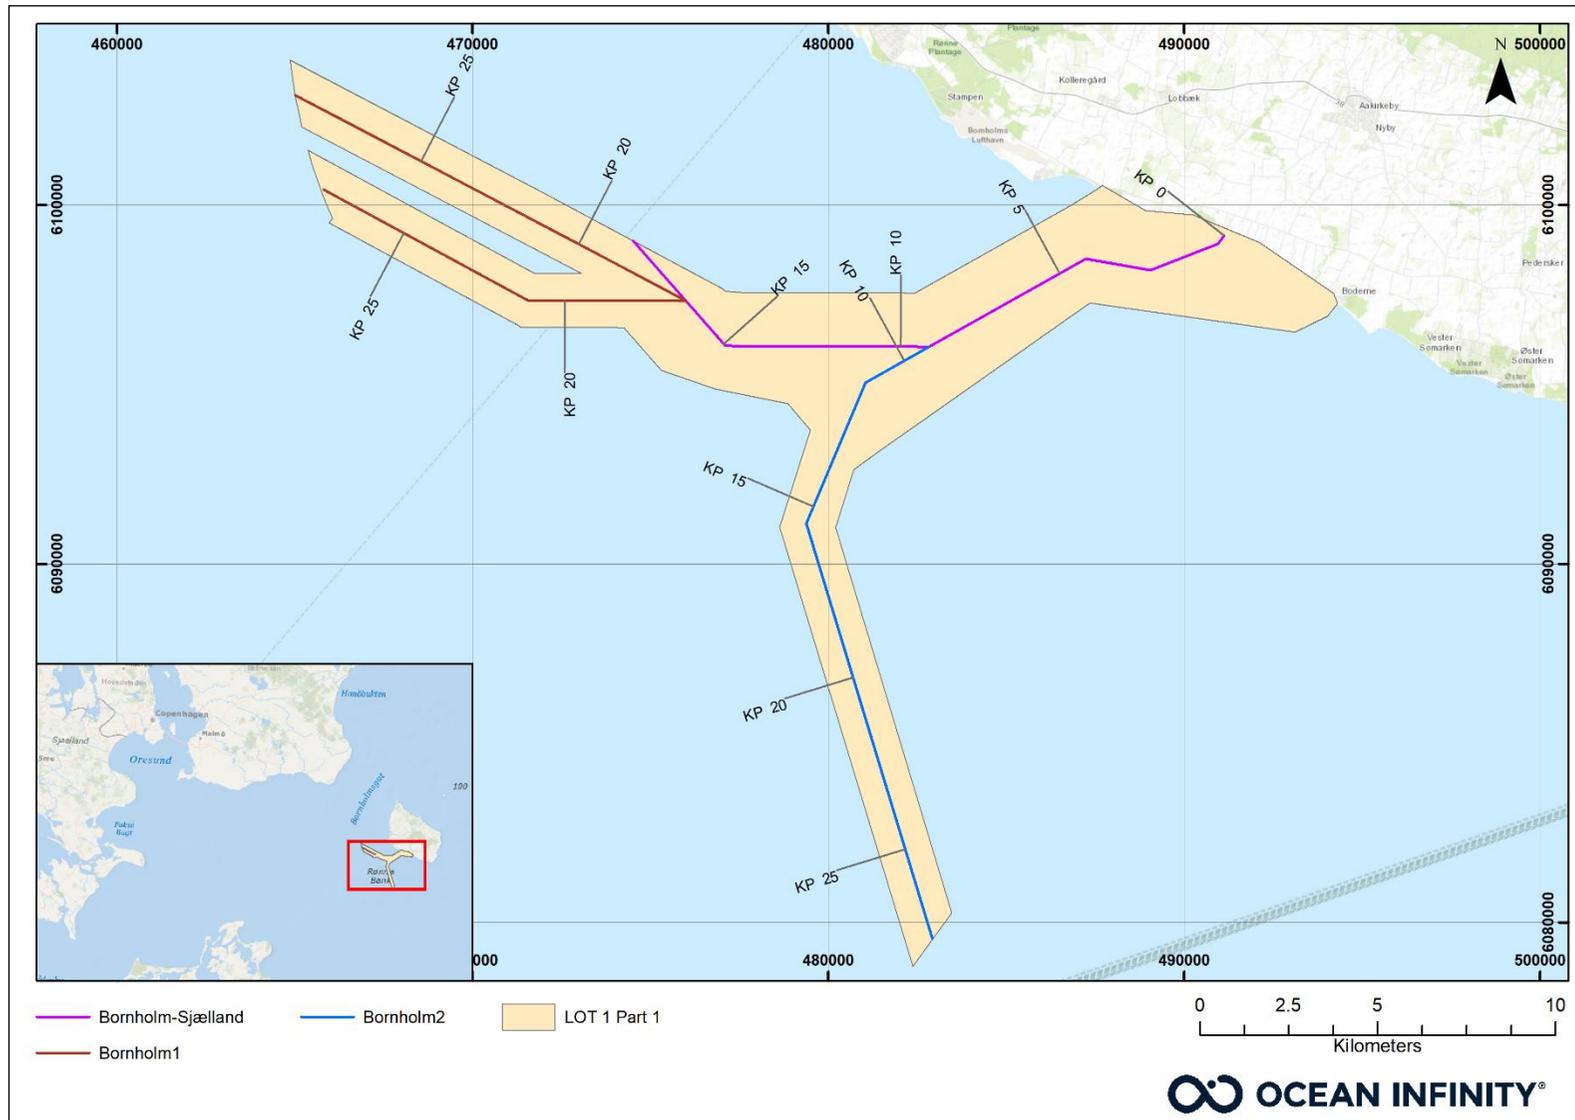
Figure 4 Overview of the defined section of Part 1 export cable routes and Denmark nearshore, Bornholm.

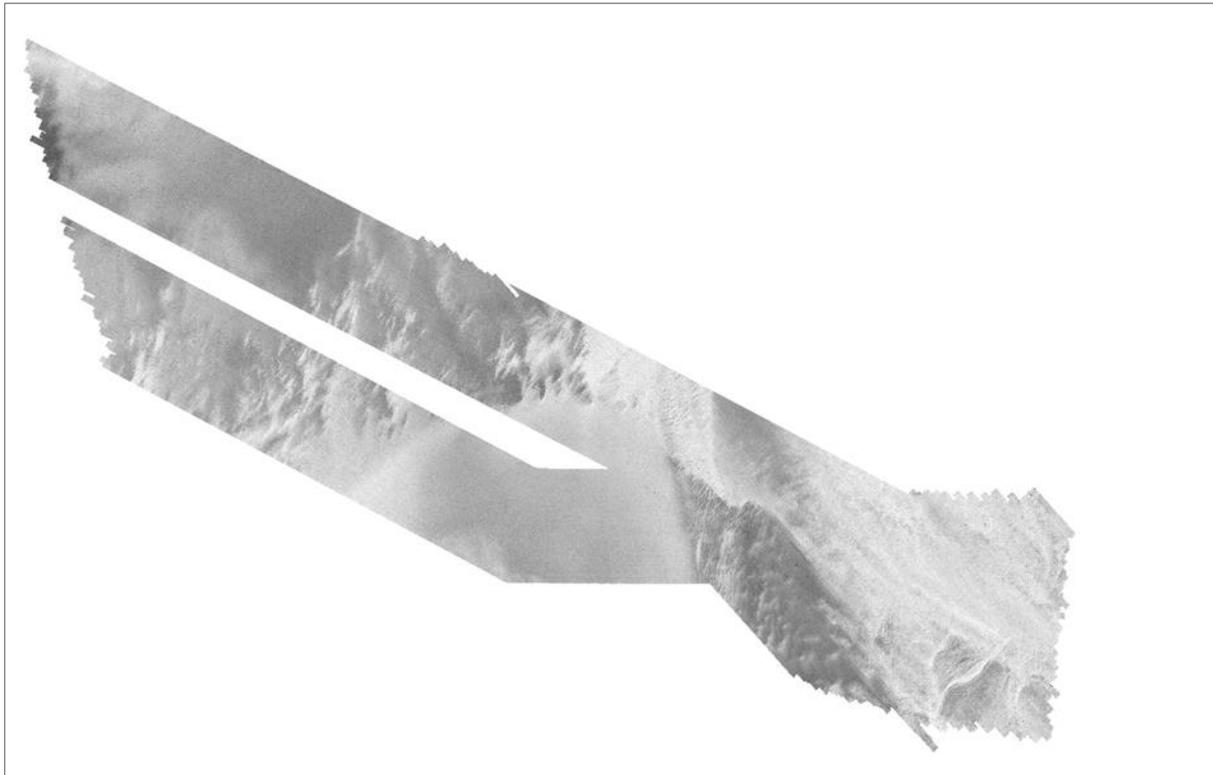
Figure 17 showing the result of processed backscatter data. WPA, Block B1D.

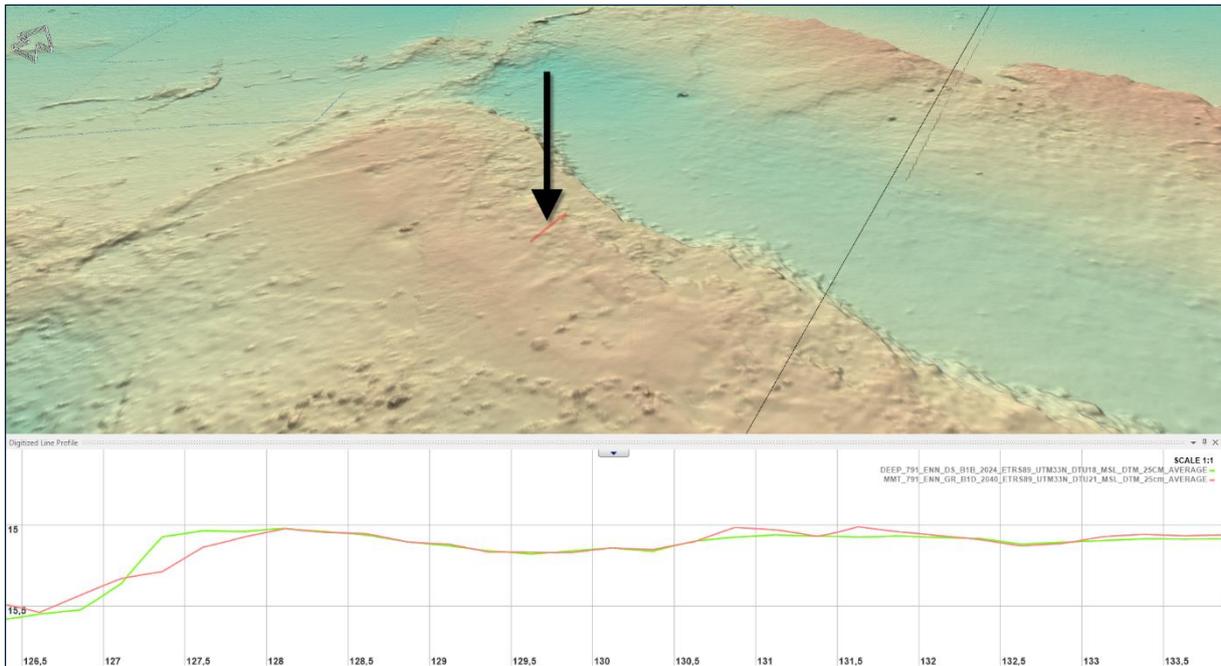
Figure 27 showing fluctuating data between B1B and B1D.

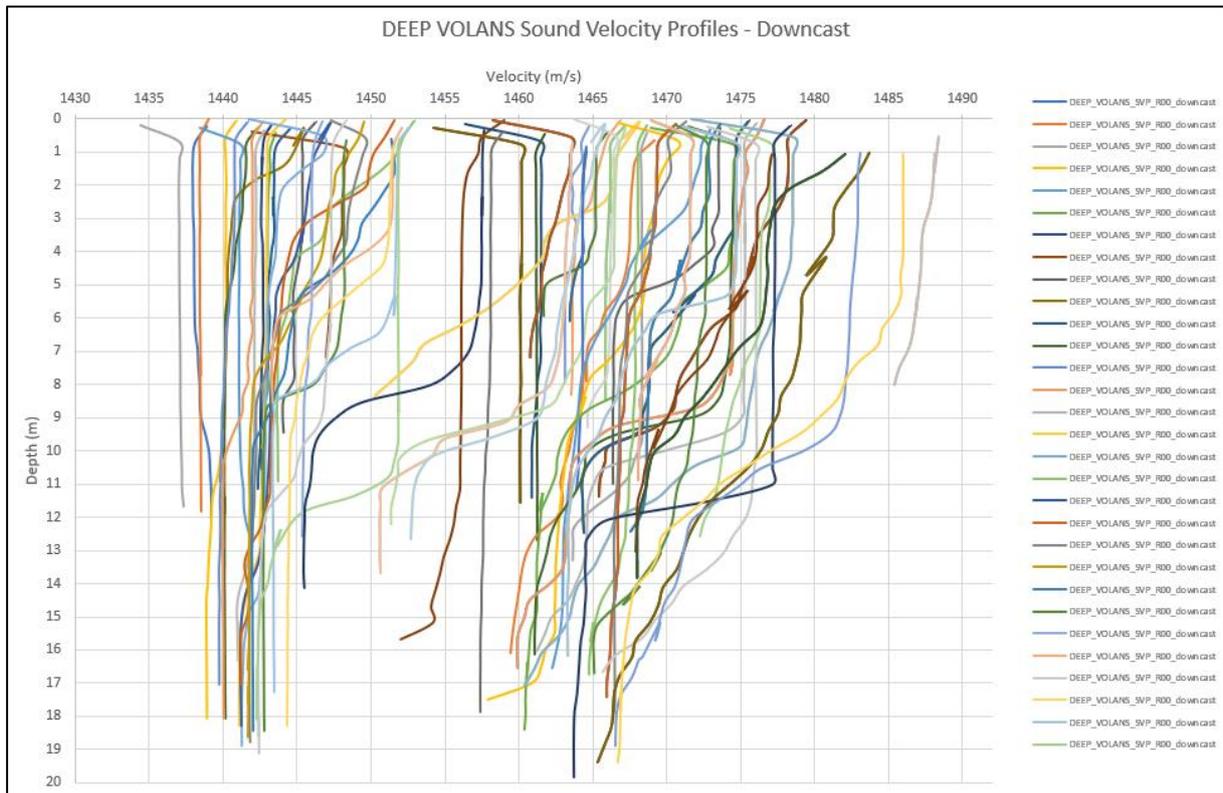
Figure 28 Sound velocity comparisons from Deep Volans. Charts are showing rapid changes and fluctuation through the water column.

The major source of misalignment in depth between run lines in the survey has been issues with sound velocity related errors due to the pycnocline effect and rapidly changing sound velocity. Even though the data remains within specifications, sound velocity errors create unwanted fluctuation in the outer beams and slight “bending” of the seafloor which causes visual errors and, in worst cases, can affect the data and make it harder to interpret. Even though efforts were made during processing of the data, rapid and great changes in sound velocity creates errors that are basically impossible to remedy completely. So, in spite the fact that extensive amount of SVPs taken there will still be slight misalignments in some problem areas. Results of sound velocity profiles can be seen in Figure 28, Figure 29 and Figure 30.

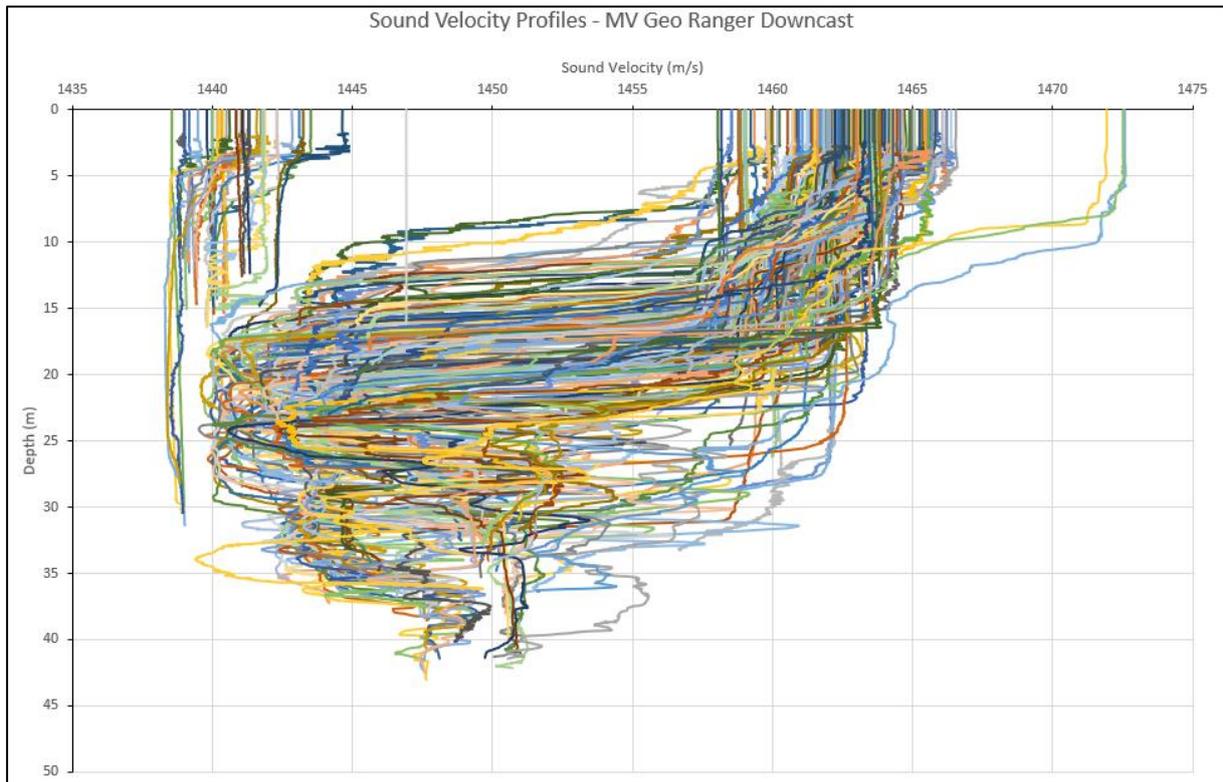
Figure 30 Sound velocity comparisons from Geo Ranger. Charts are showing rapid changes and fluctuation through the water column

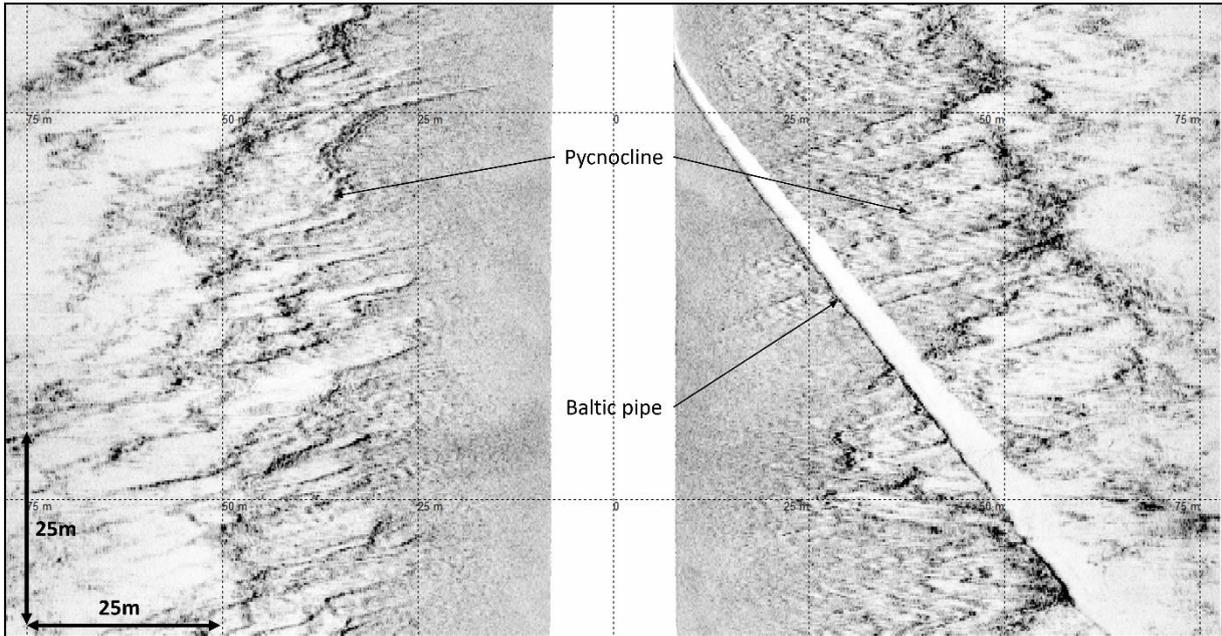
Figure 36 Pycnocline as observed on B1D; route ID Bornholm 1.

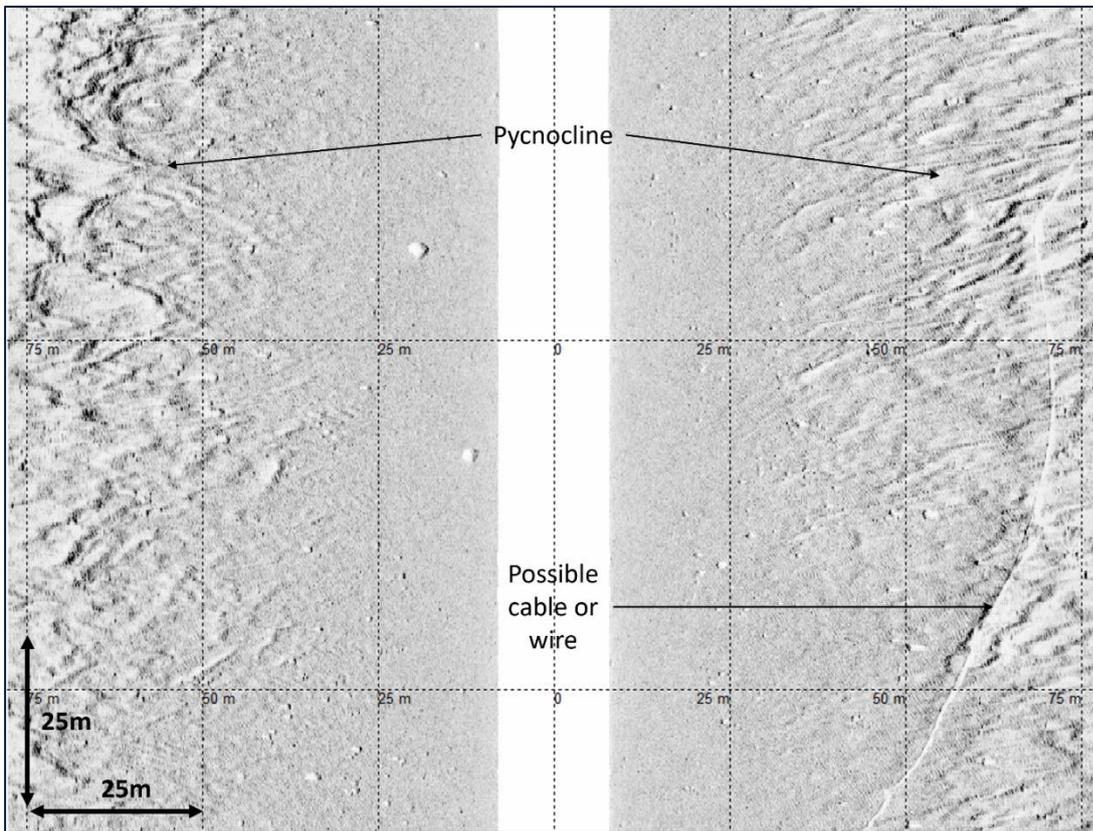
Figure 37: Pycnocline as observed on B1D; Route ID Bornholm-Sjælland.

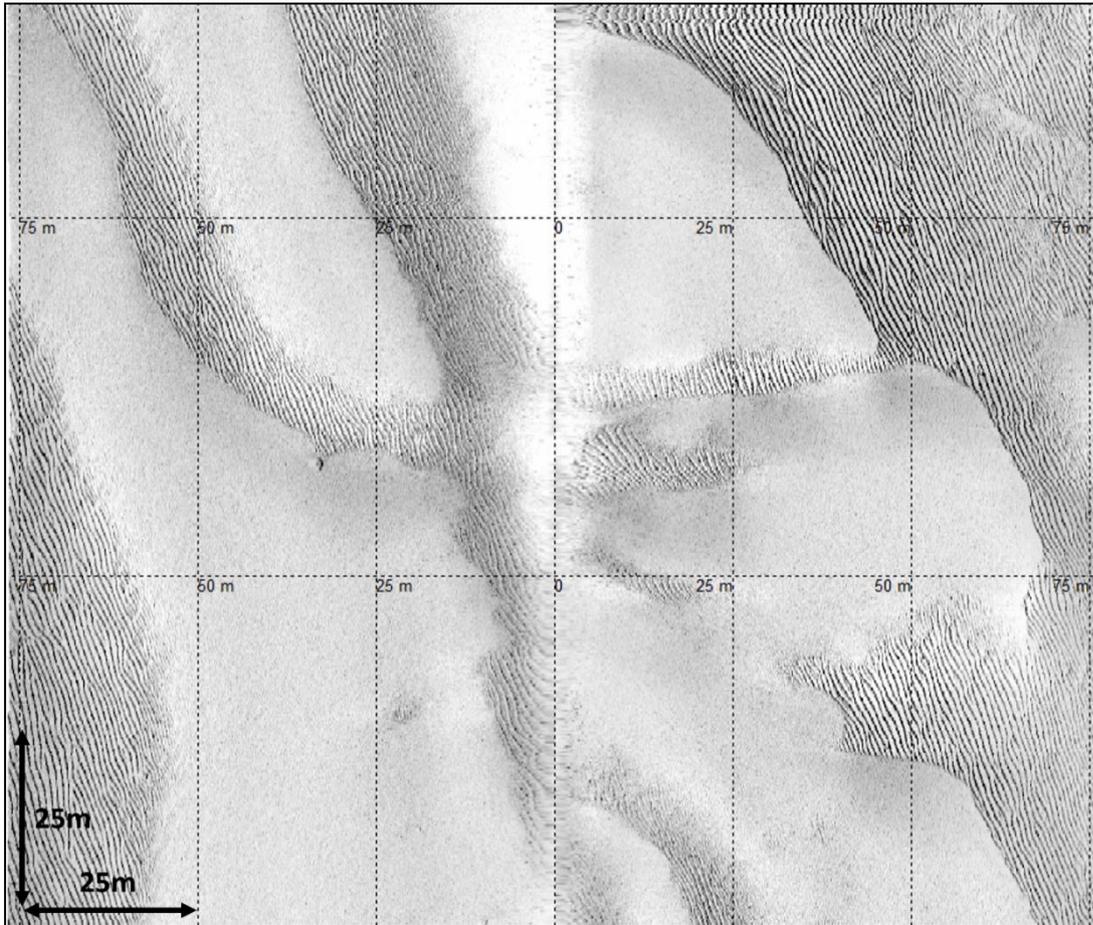
Figure 38 Example of good HF data from B1C.

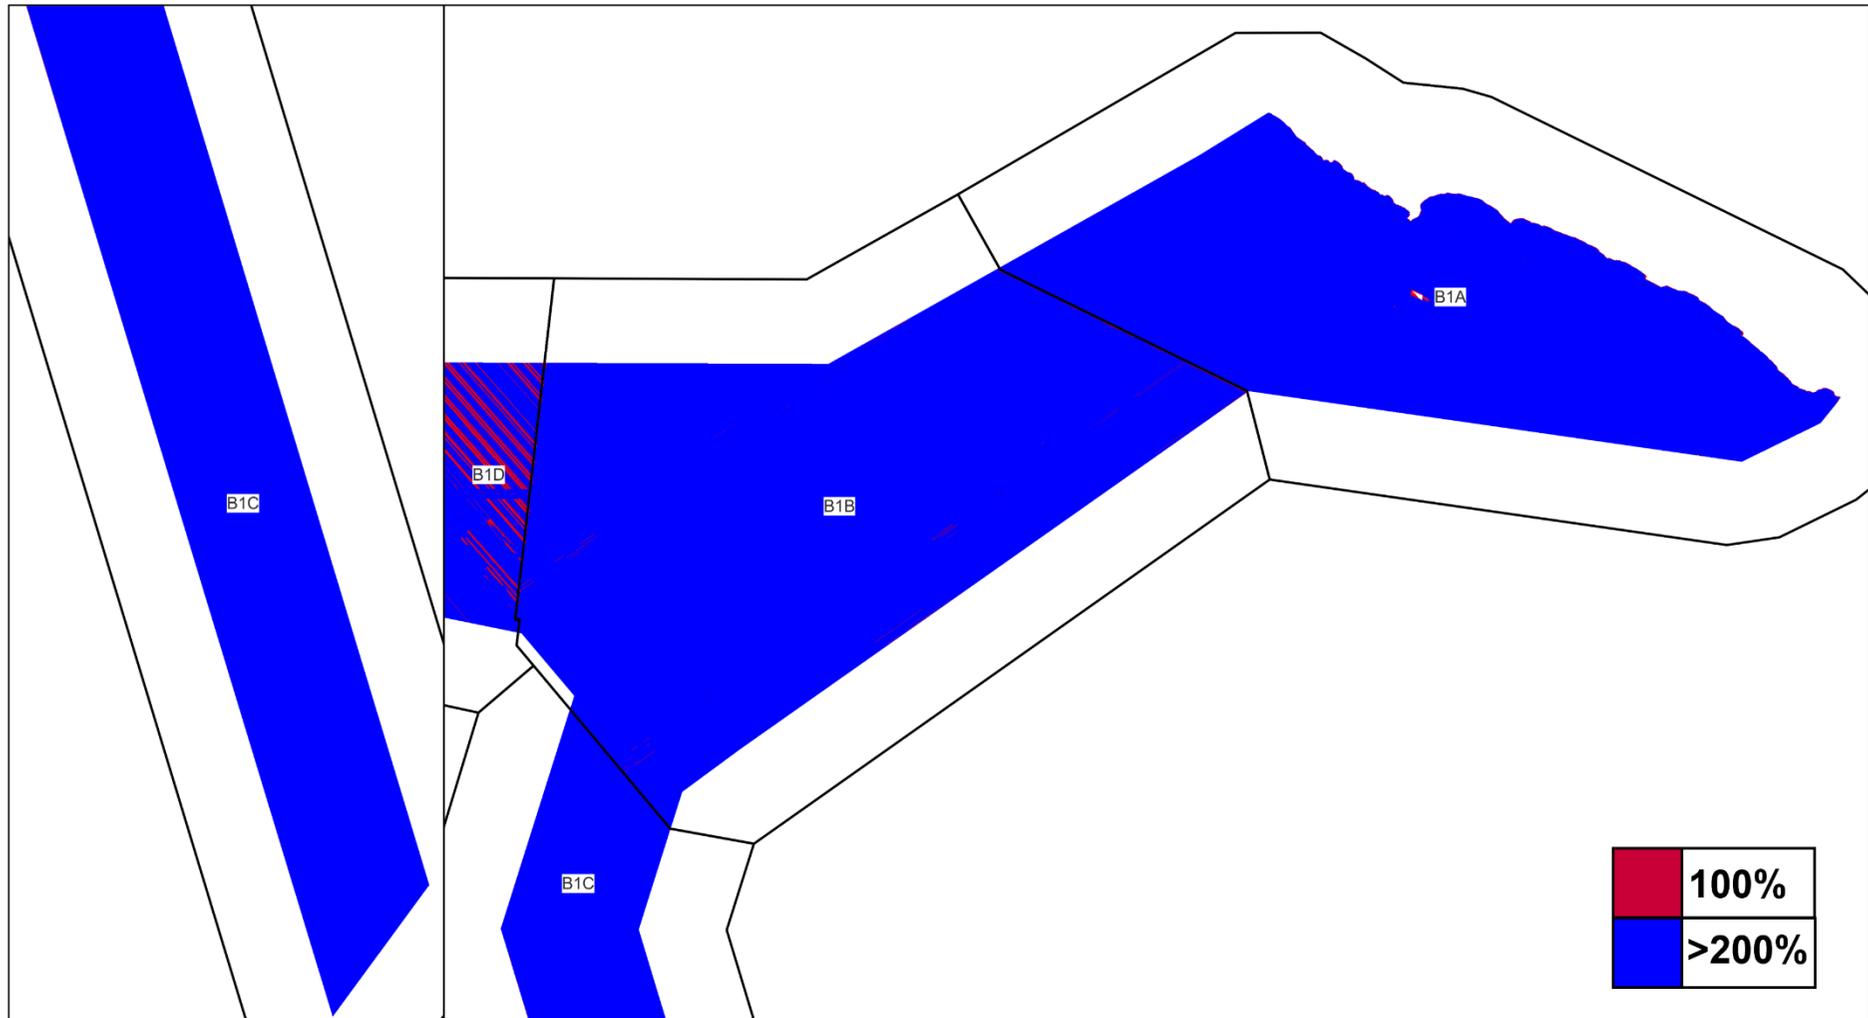
Figure 39 SSS coverage plots in Block 1A, 1B and 1C.

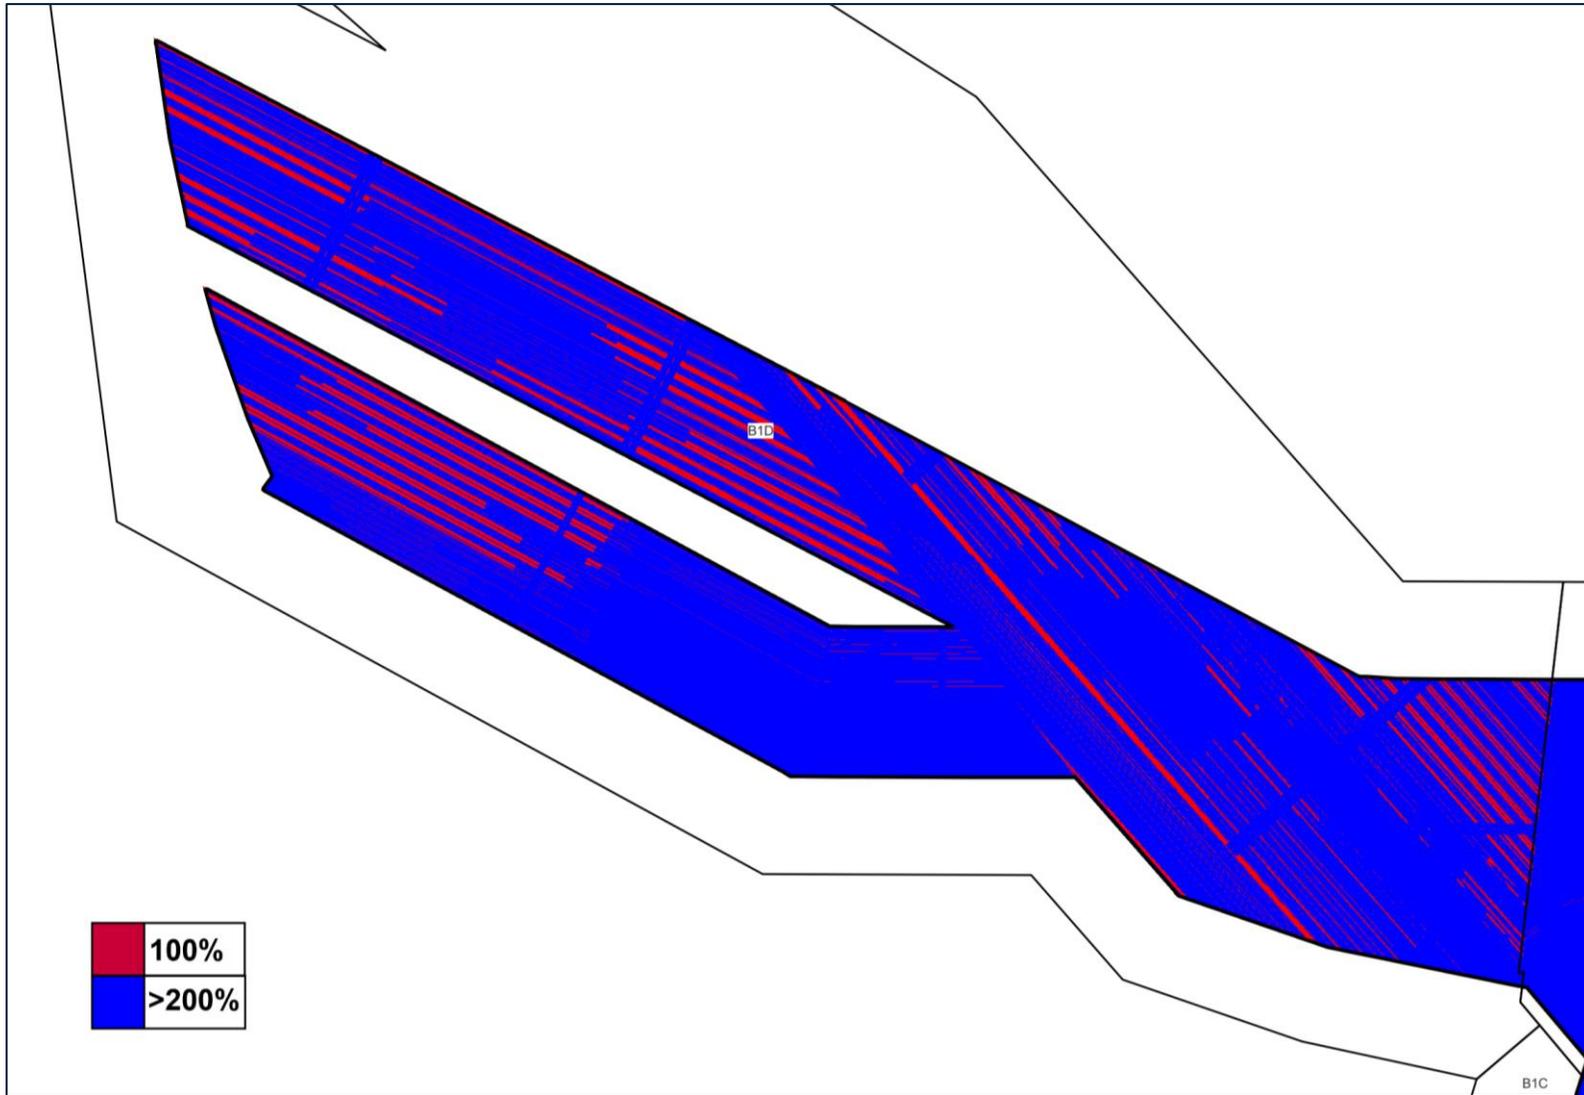
Figure 40 SSS coverage plots within defined boundary in Block 1D.

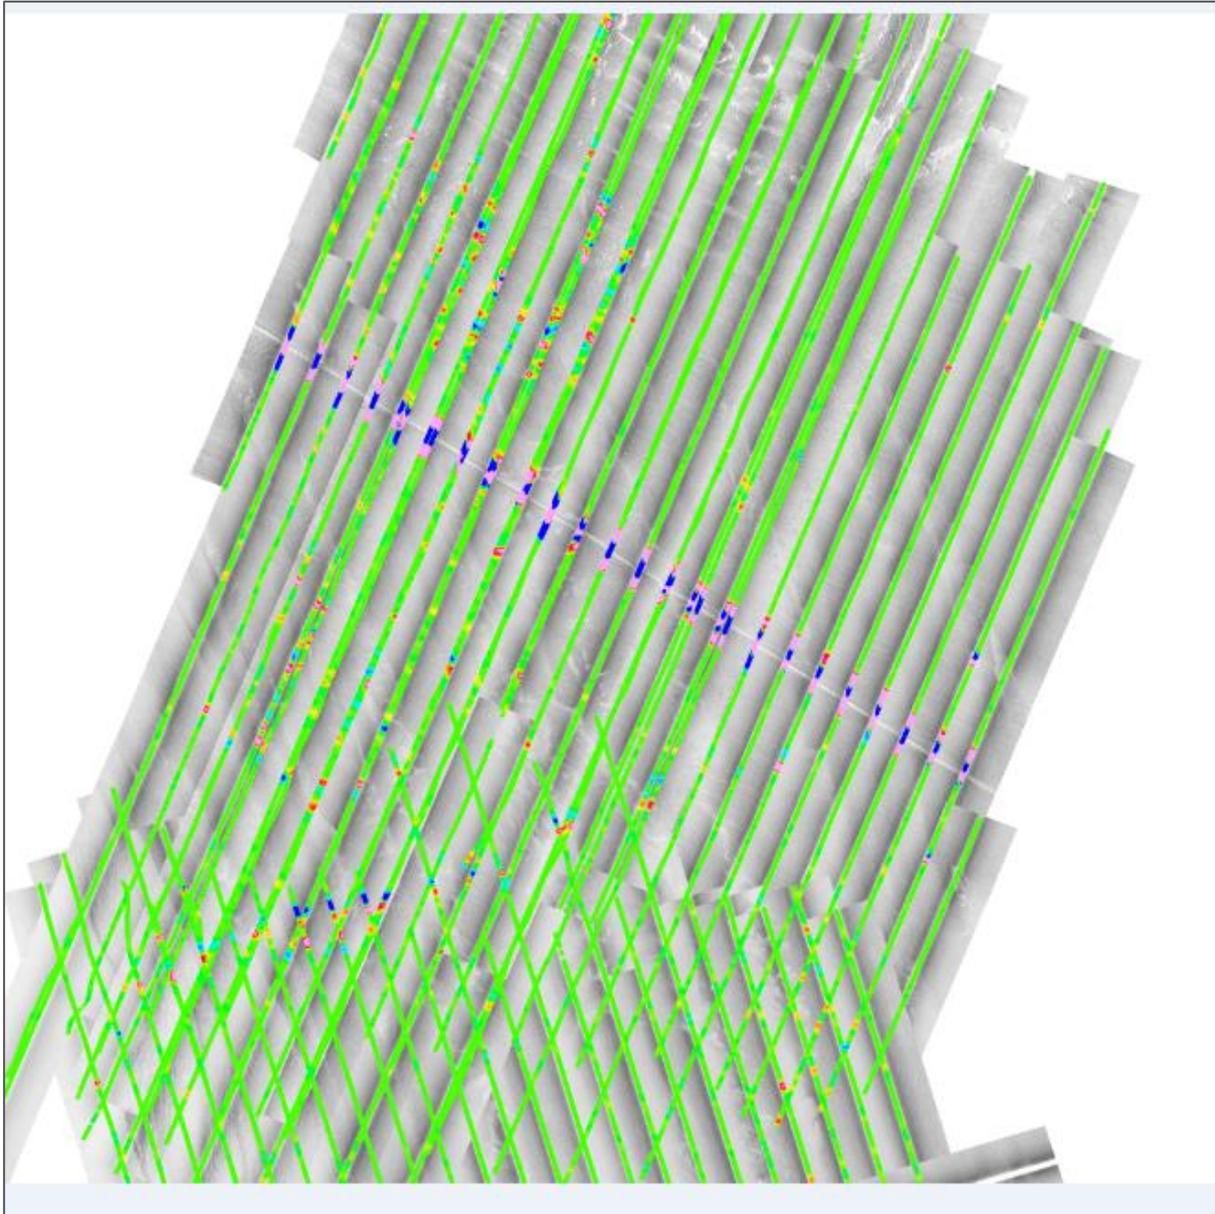
Figure 44 Magnetic residual grid over pipeline crossing showing feature continuity with opposite survey heading.

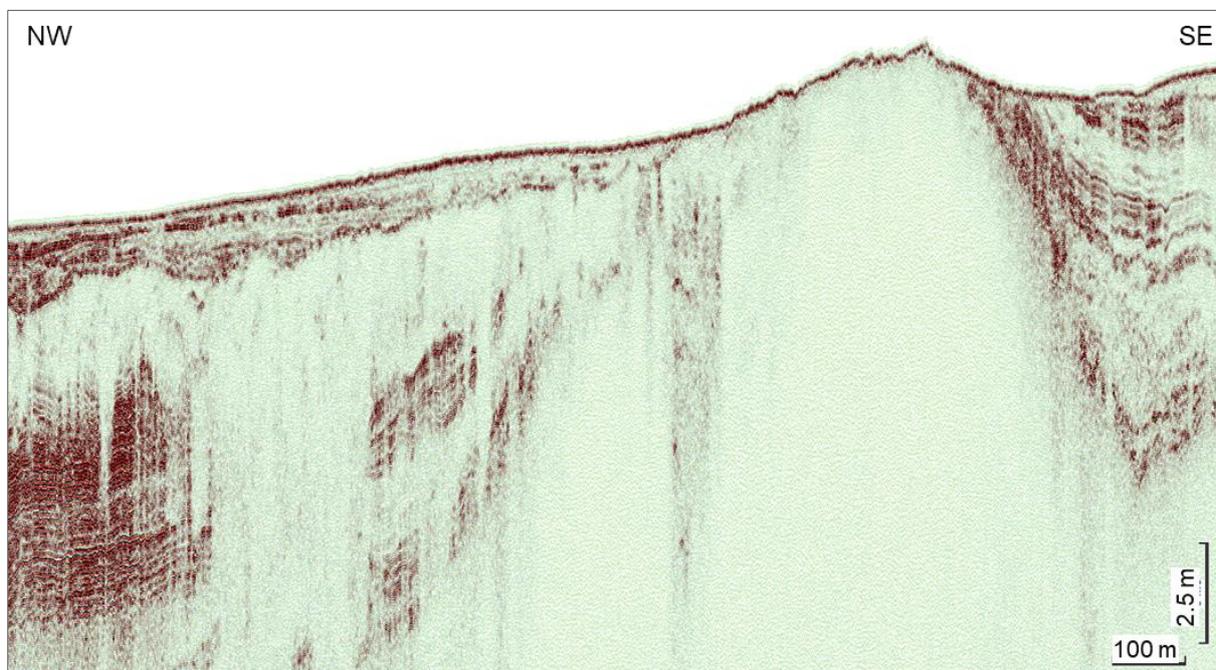
Figure 45 Example of good data, displaying penetration >10m and multiple laminations within geological units, from line P140, block B1D from KP 26.078 to KP 24.378 on CRS BH-DK2

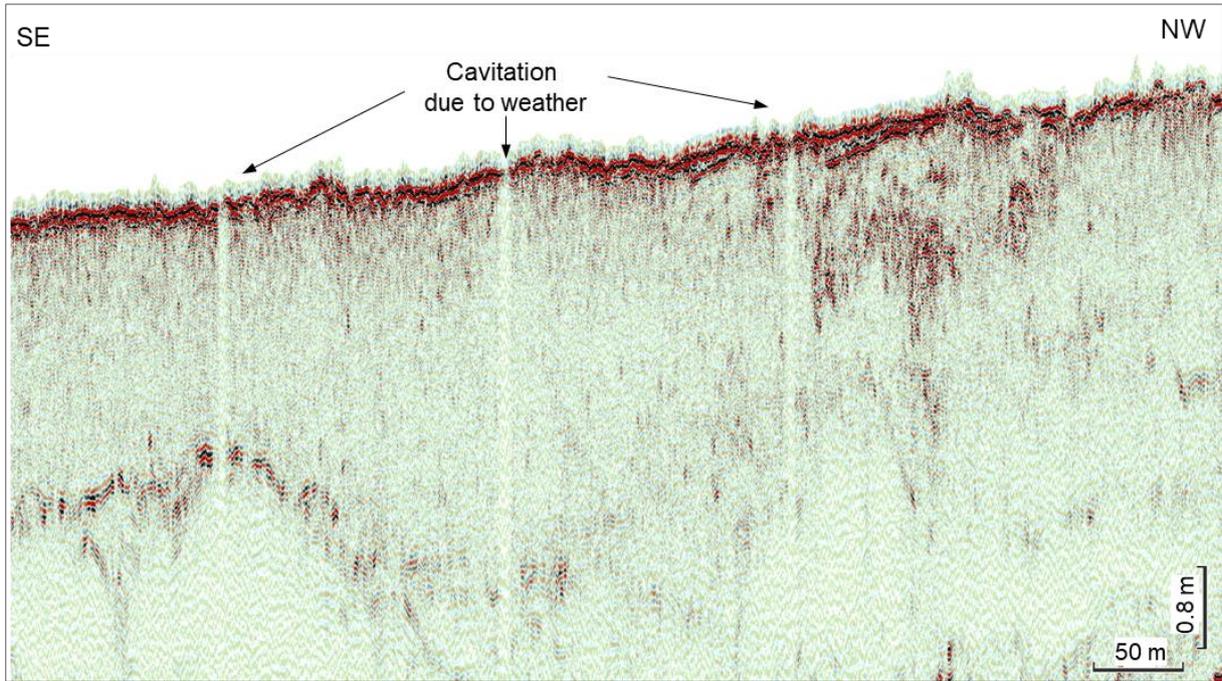
Figure 46 Cavitation caused by weather. Line 47, Block B3D from 204.126 to KP 204.803 on CRS KS

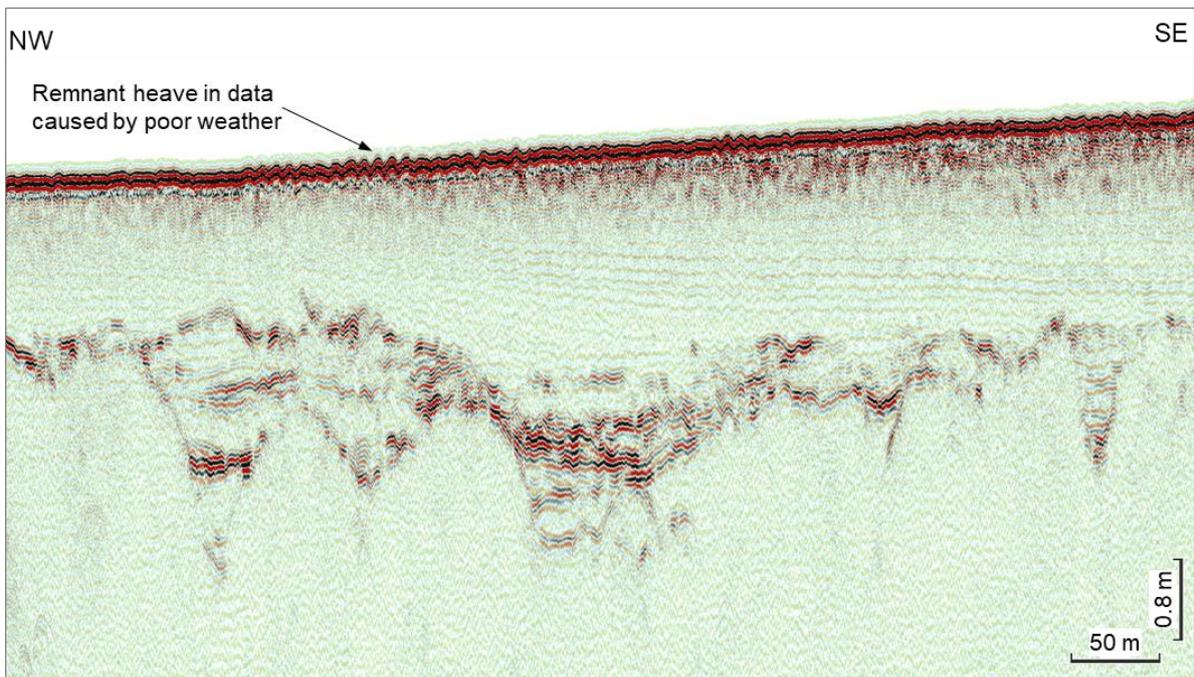
Figure 47 Remnant heave in data caused by poor weather. Line 560, Block B1D from KP 23.597 to KP 22.914 on CRS BH-DK2

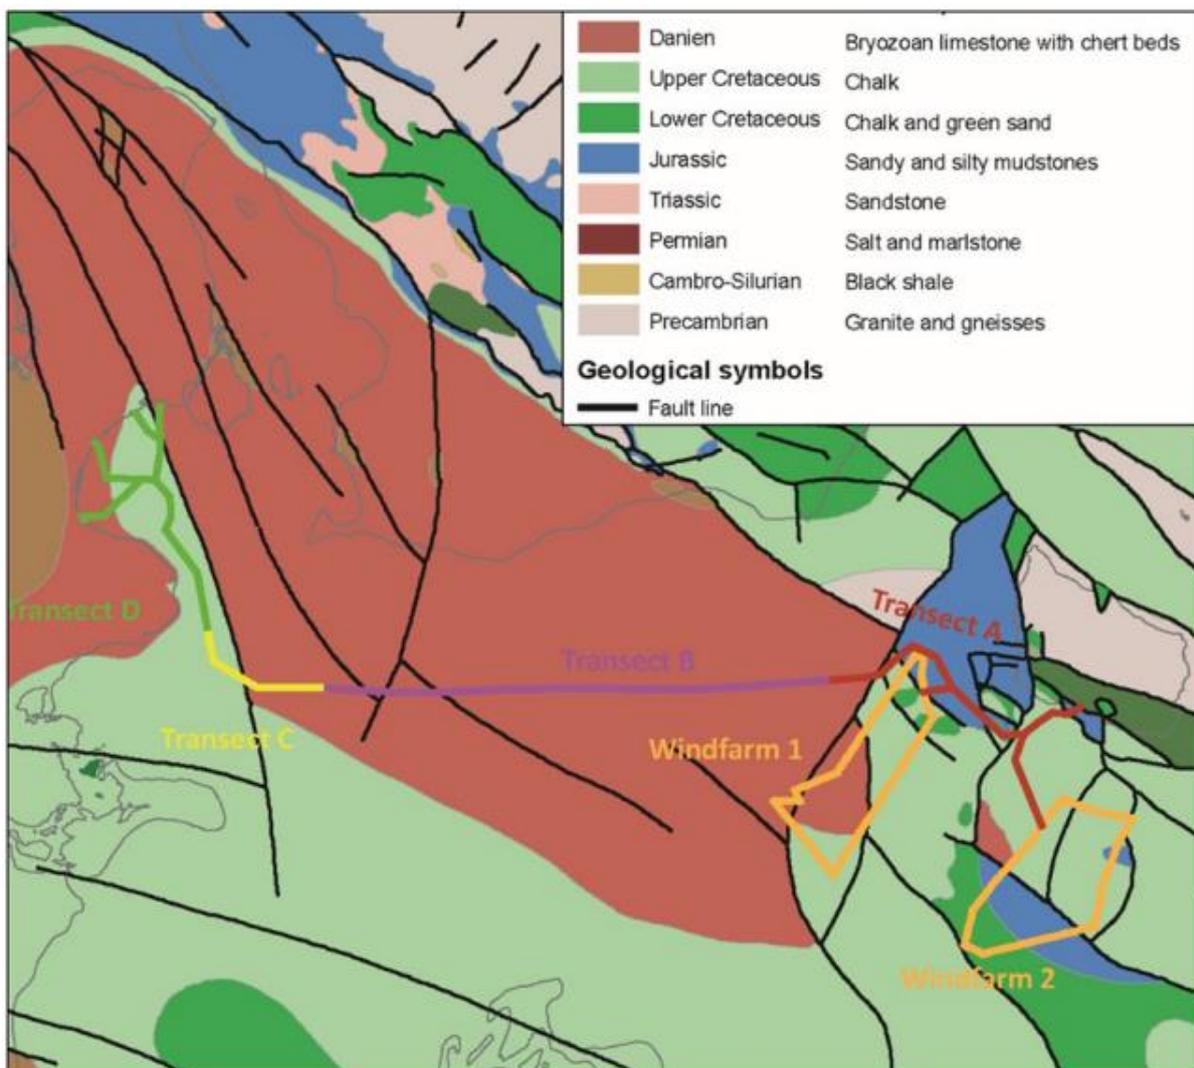
Figure 48 Bedrock geology in the survey area from Koge to Bornholm. From Varv (1992).

The Pre-Quaternary geology near Bornholm comprises of bedrock consisting of Jurassic to Danien sediments, while the Arkona Basin (Transect B) consists of Danien limestone, and Fakse to Køge Bugt (Transects C and D) consists of Upper Cretaceous Chalk, with Danien limestone present primarily outside the survey area (Figure 48). Complex faulting is known to be present in the Pre-Quaternary sediments due to the presence of the 30-50 km wide WNW-ESE-trending Sorgenfrei–Tornquist Zone that transects this region of the Baltic Sea.

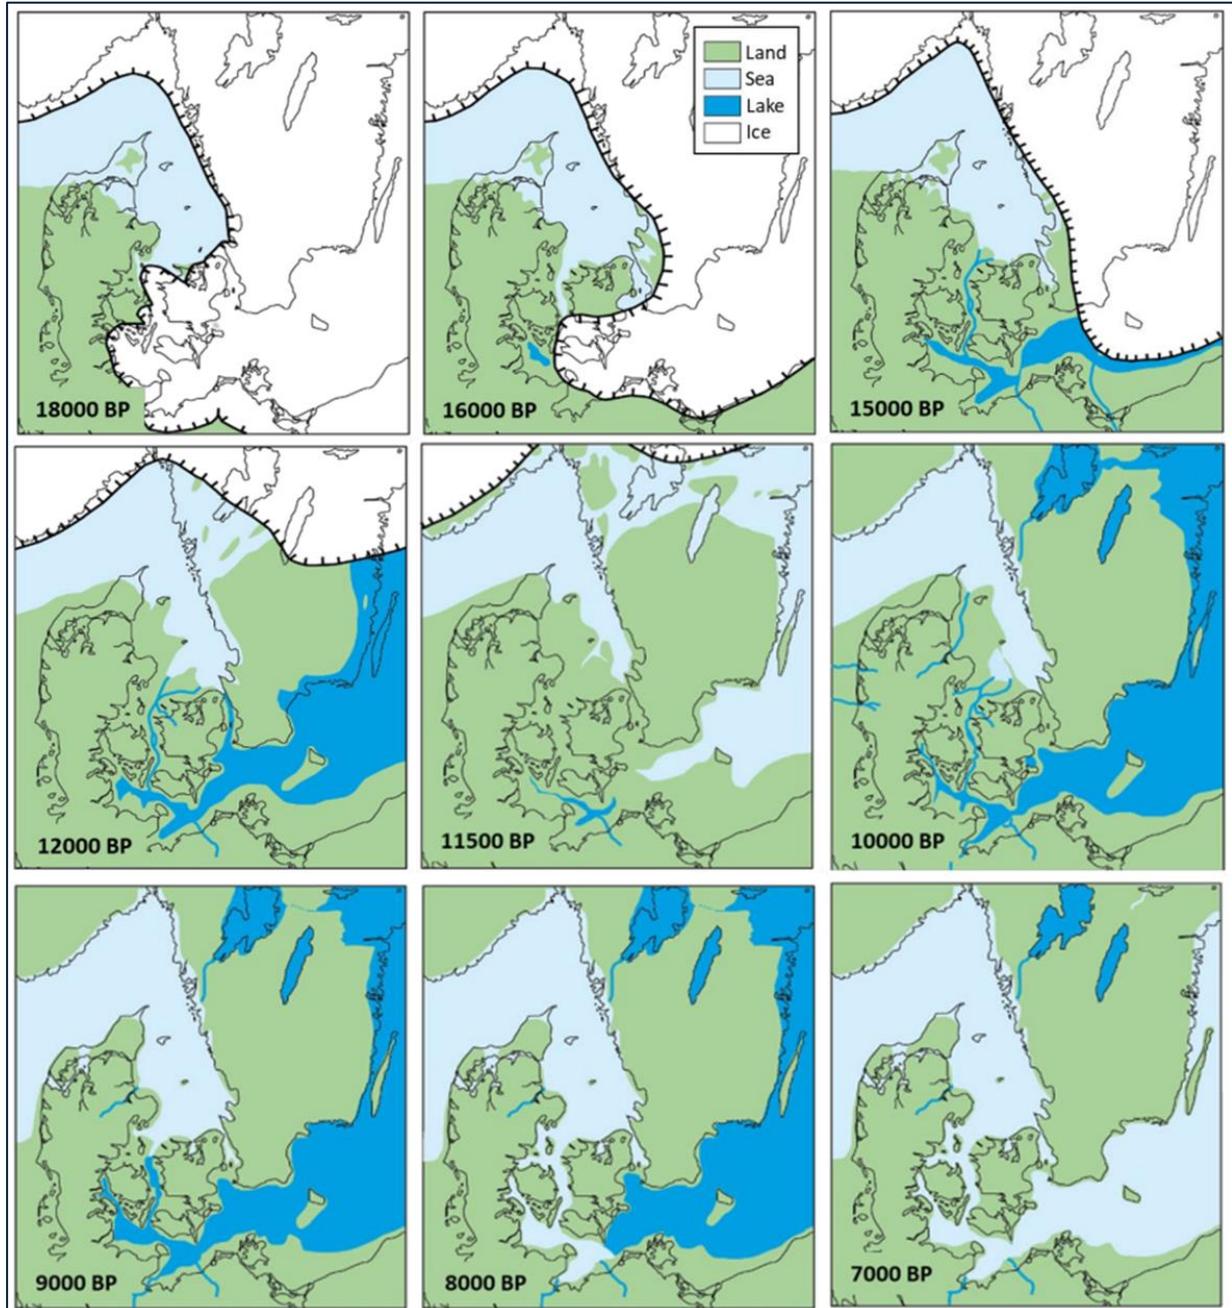
Figure 49 Paleogeographical maps showing the development of the Danish area from ca. 18000 to ca. 7000 years BP. Modified from Jensen et al. (2003)

The Scandinavian Ice Sheet reached its maximum extent in Denmark about 22000 years Before Present (BP), followed by stepwise retreat. The general deglaciation and postglacial history of the south-western Kattegat and the western Baltic is presented in the following palaeogeographical maps (Figure 49).

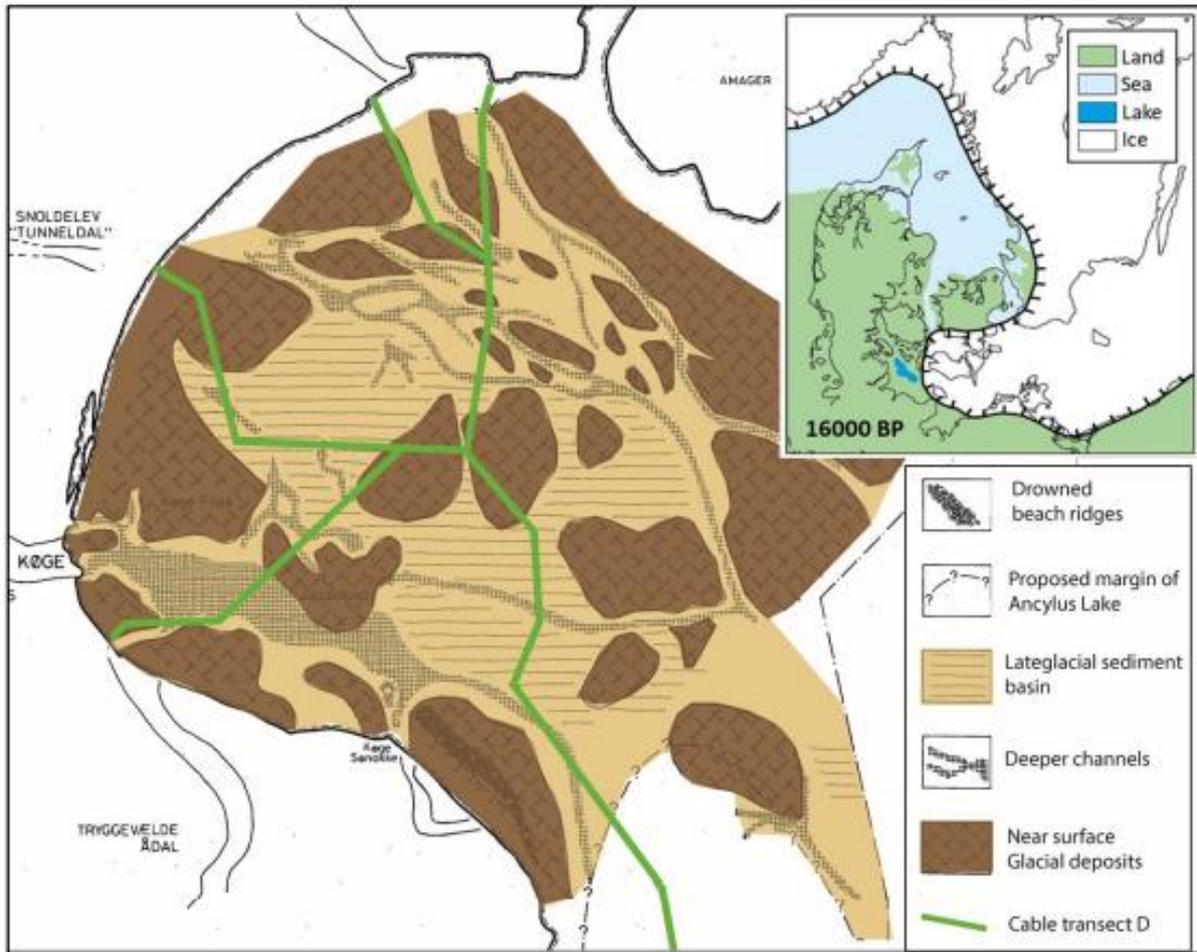
Figure 50 General distribution of near surface glacial deposits (till) and Late-Glacial sediment basins (from Skov og Naturstyrelsen 1987).

part, fining up to silts and clays in the uppermost meters. The distribution of near surface glacial deposits and late glacial sediment basins as a result of this glacial retreating 16000 years ago can be seen in Figure 50.

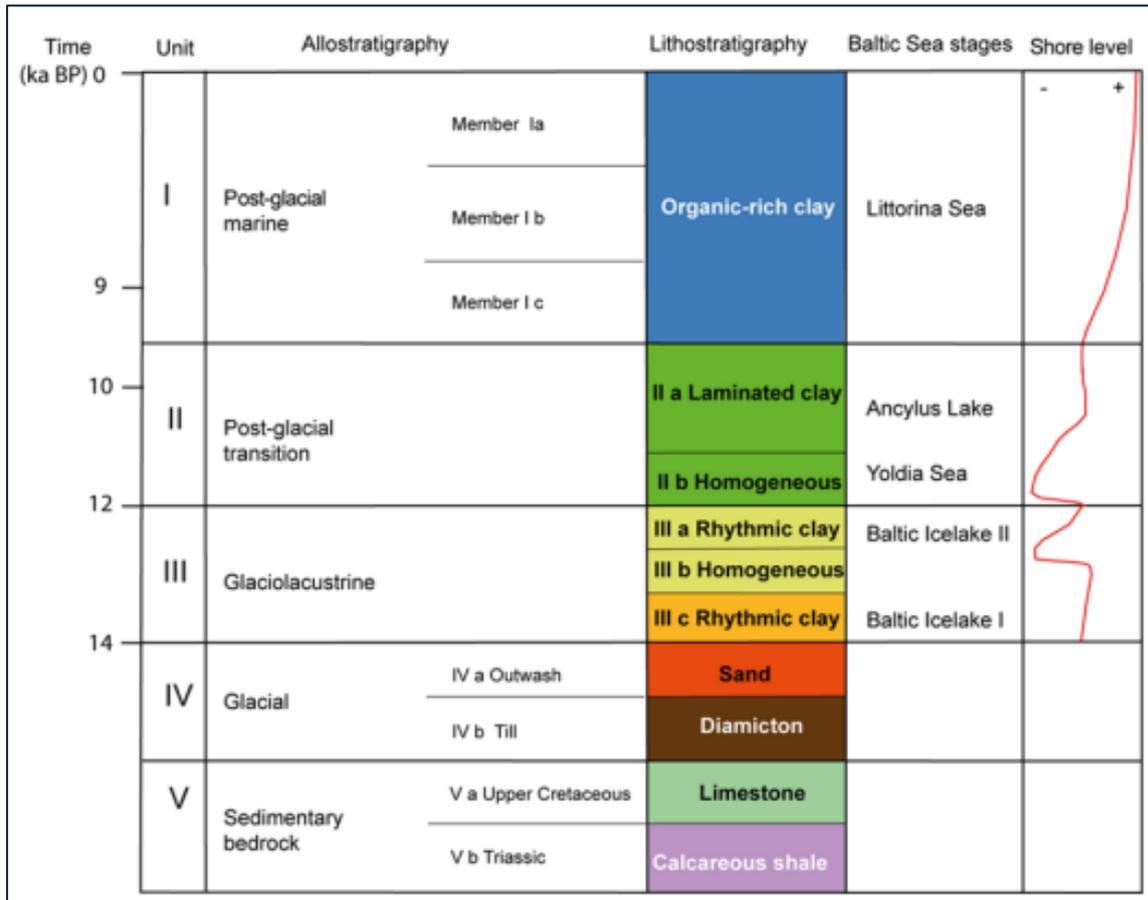
Figure 53 General stratigraphic model of Parts 1 and 3, within the Bornholm Basin (Jensen et al. 2017).
