# Energy Island Cable Route Survey Baltic Sea

Danish Baltic Sea  
April - August 2022

**DOC NO.**  
103971-ENN-OI-SUR-REP-SURVLOT1-VO

### Baltic Sea OWF and Energy Islands LOT1 Cable Route Survey Overview

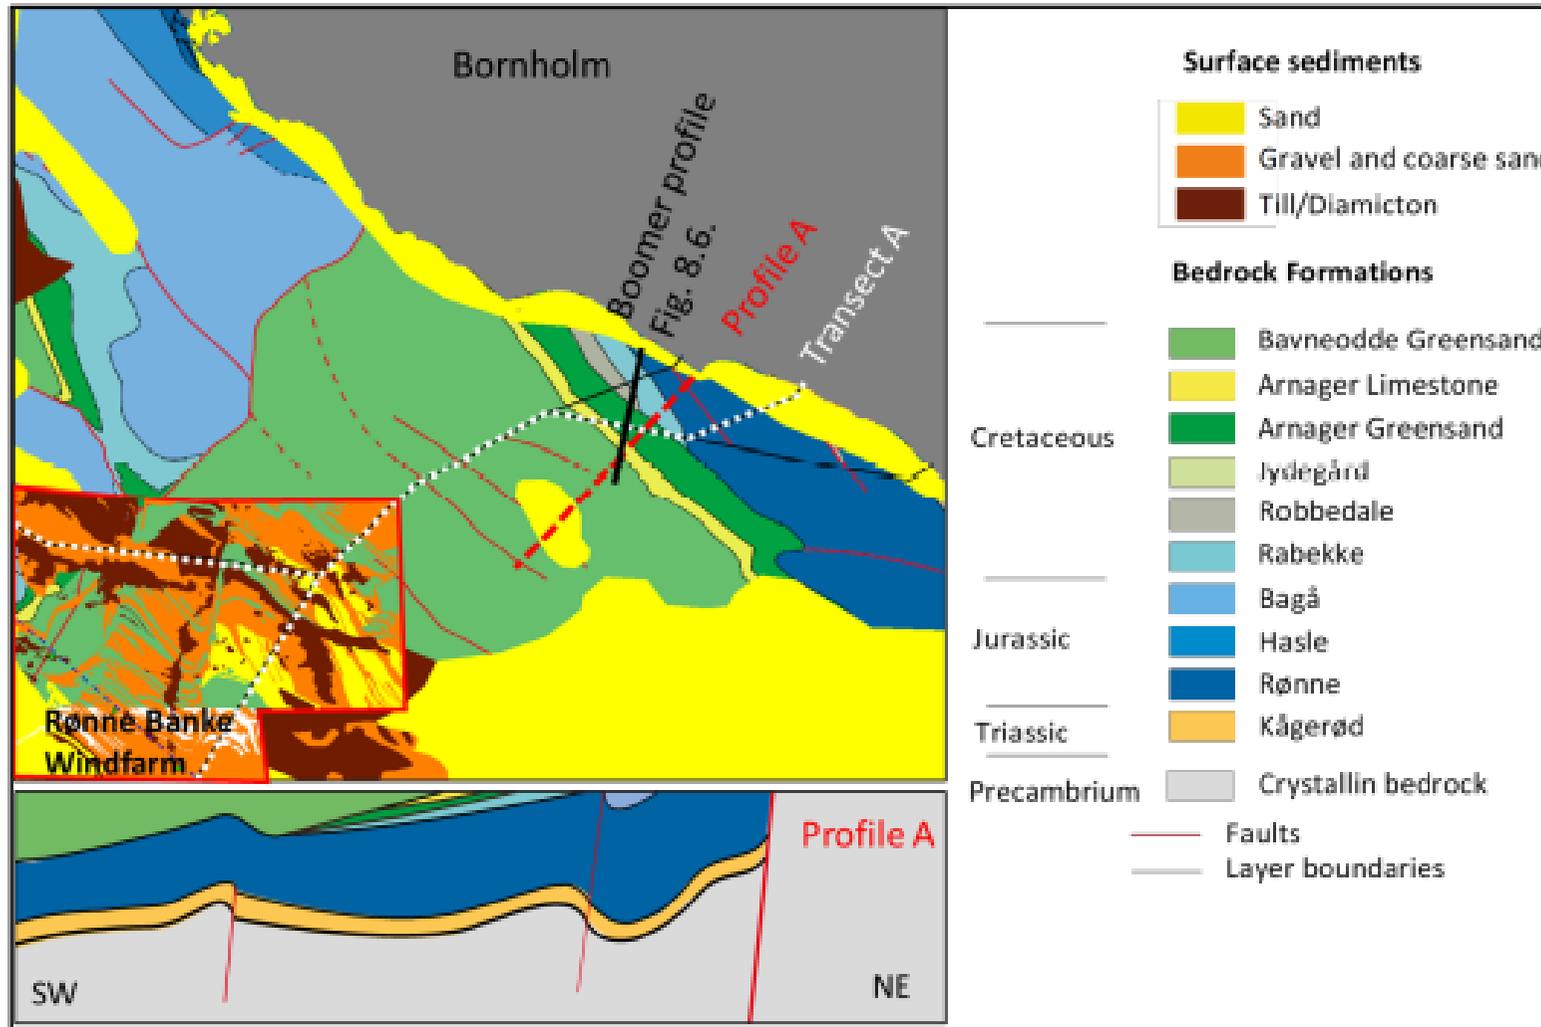
Figure 54 Shallow sediments in nearshore area of Part 1(Bornholm) from south-west Rønne Banke Windfarm, to north-east Sose Bugt landfall.

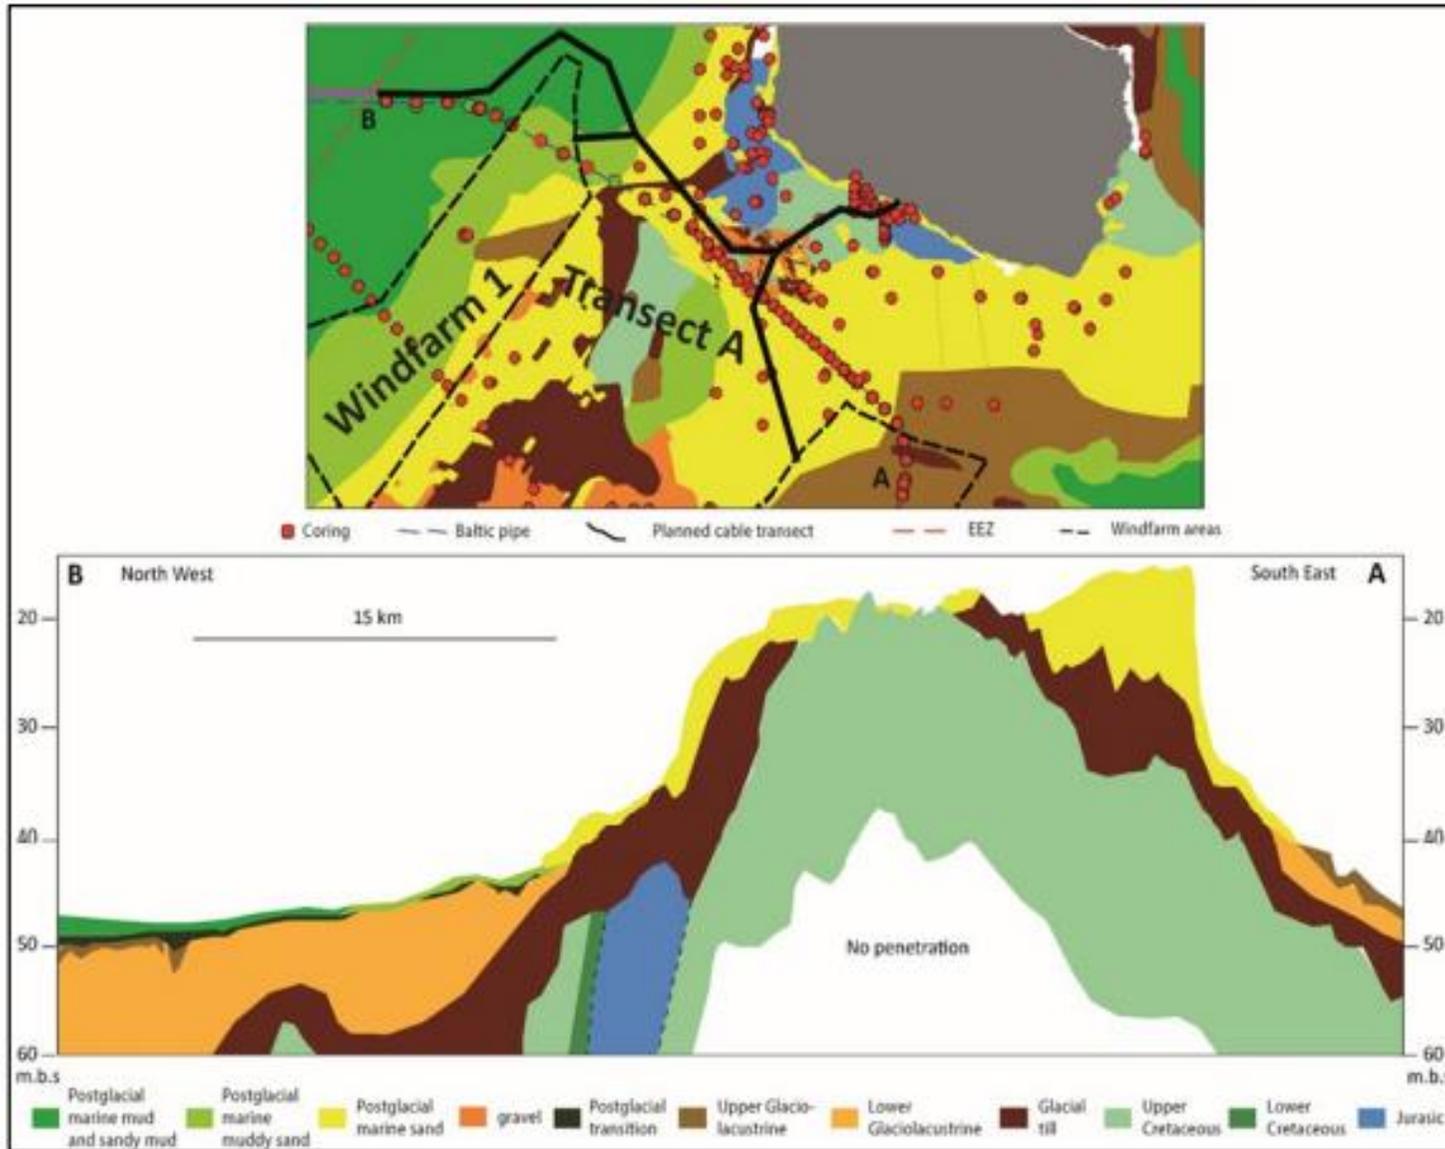
Figure 55 Shallow sediments in offshore area of Part 1 (Bornholm) between Windfarm areas 1 and 2.

An overview of the expected offshore geology in Part 1 (Bornholm) can be seen in Figure 55, as extracted from the desktop study (GEUS 2021). The distribution of shallow sediments reflects to some degree the bathymetry of the region. Fine-grained mud has accumulated in the central parts of the basins, with thickening of glaciolacustrine clayey/silty sediments and deepening of the Quaternary glacial till towards the Arkona Basin. Till and bedrock are often located at or near the surface in the shallow parts, indicative of non-deposition or erosion. In the absence of confirmative ground truthing the bedrock units were detected along the route proximal to Bornholm Island is group termed as “SEDIMENTARY ROCK”. From approximately KP 0.000 to KP 15.000 (i.e., B1A, B1B and north end of B1C) the top of the SEDIMENTARY ROCK was difficult to detect. This was due to the coarseness of the overlying seabed sediments, weathered interface of the rock and very irregular rock bedding.

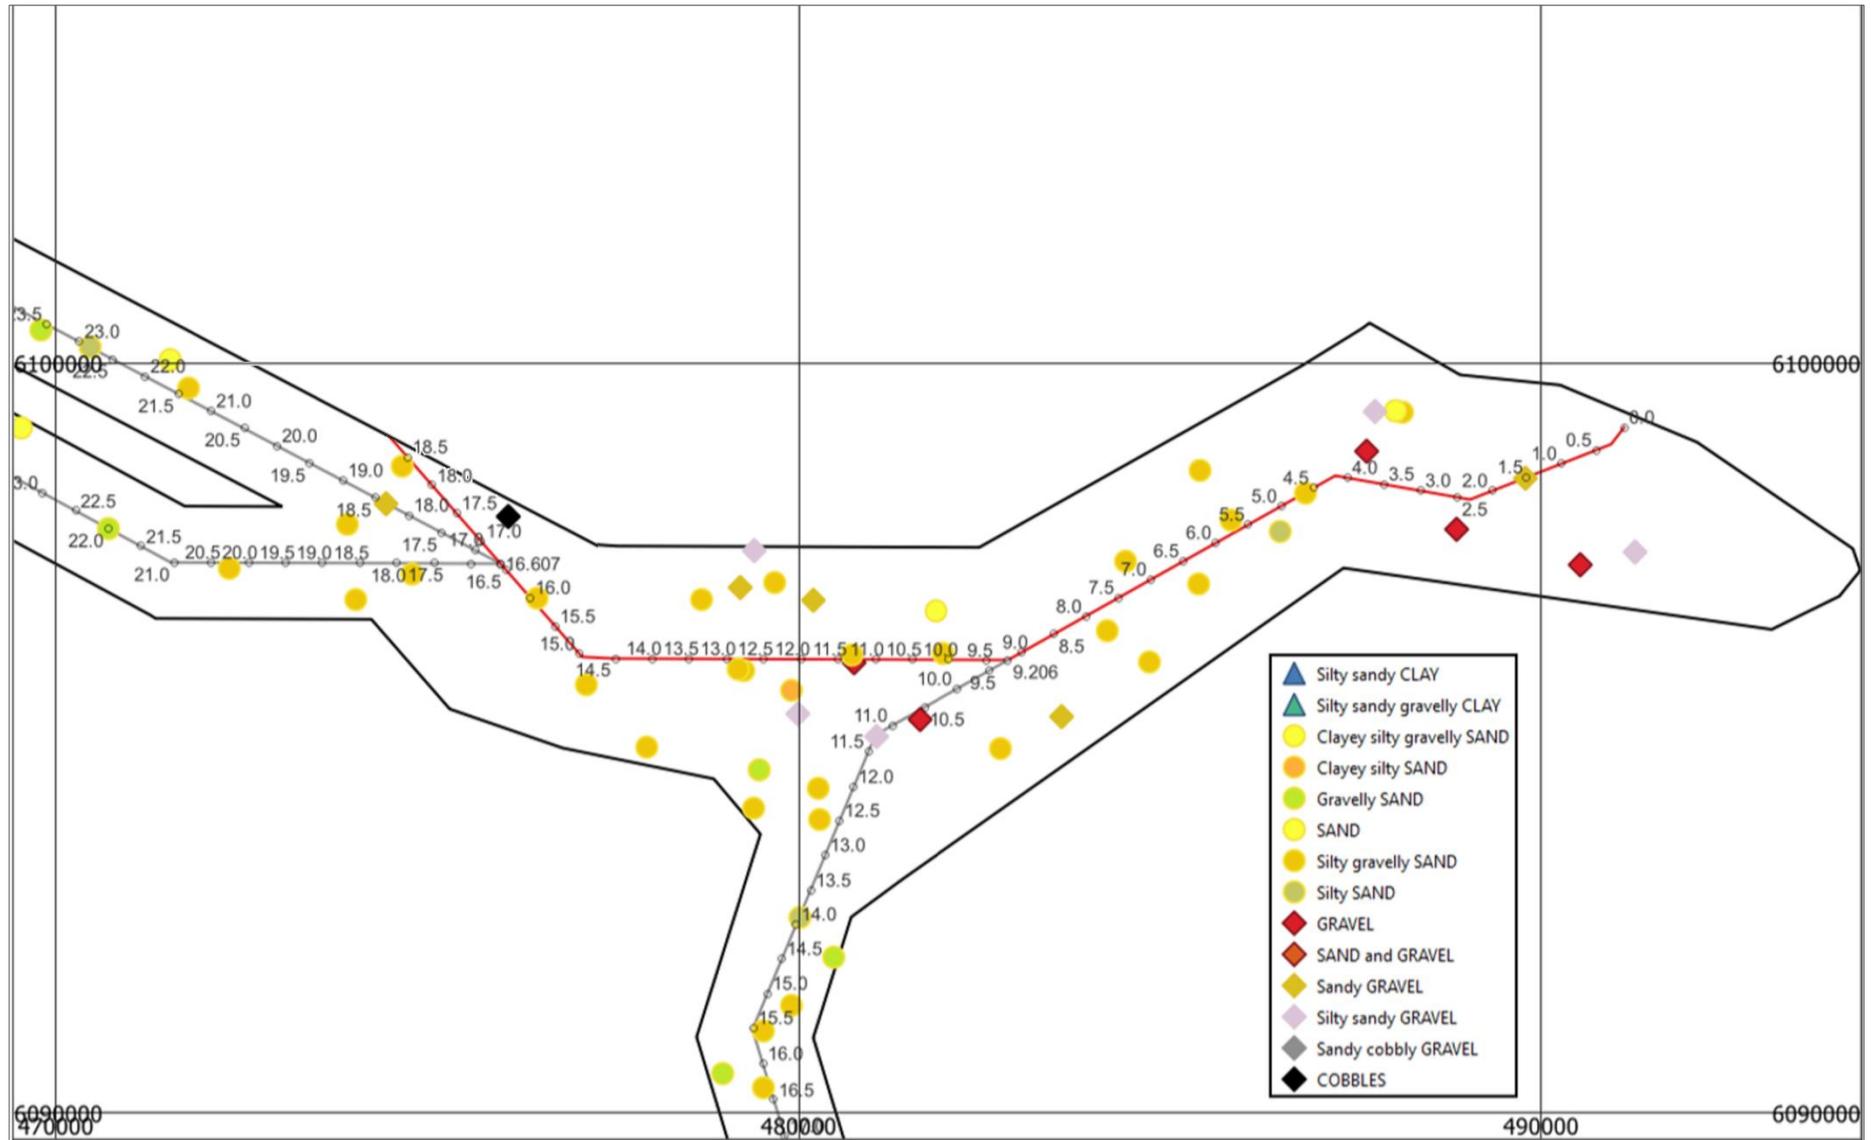
Figure 59 CRS Bornholm-Sjælland grab Sampling overview KP 0.000 to KP 18.831.

The following grab samples were acquired, Figure 59 and Table 30. Full description of the grab sample results is contained in Table 30.

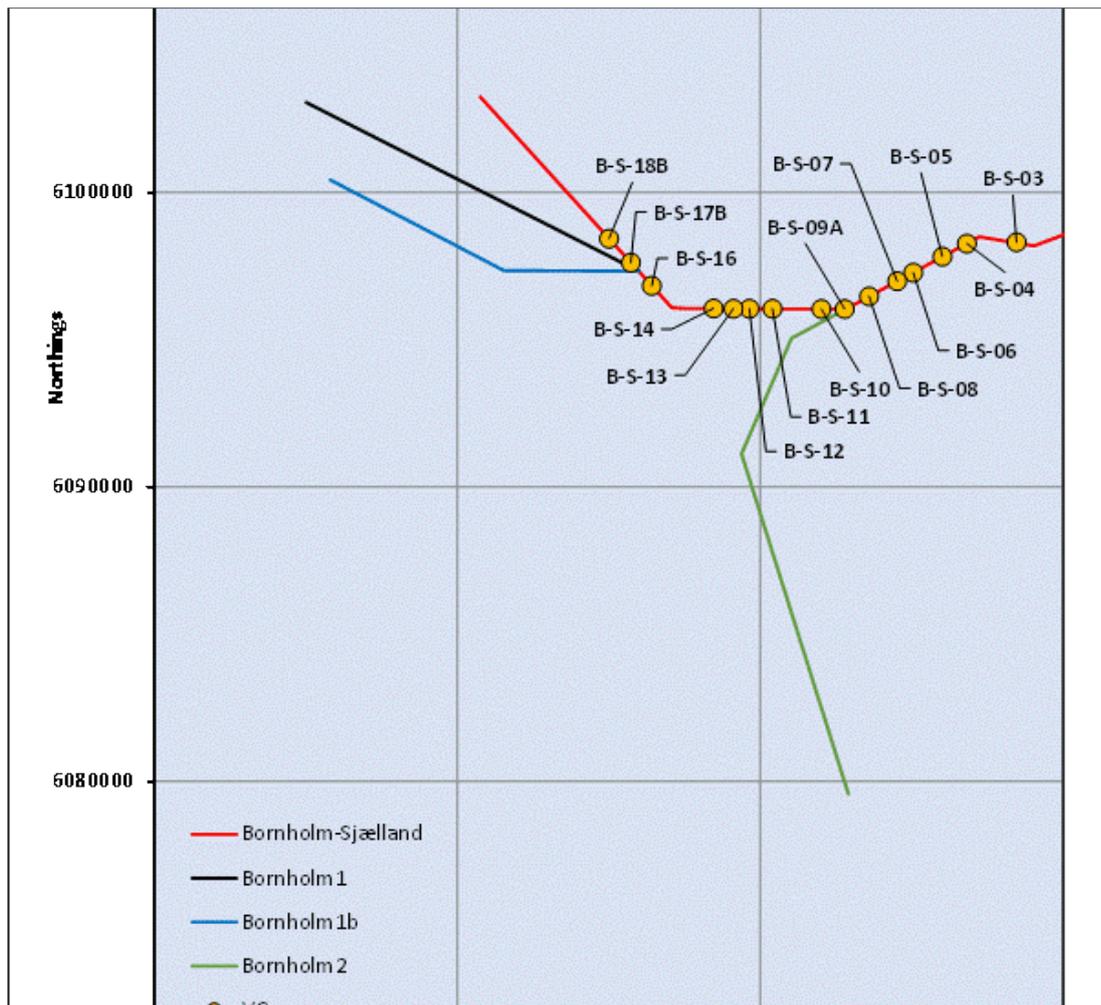
Figure 60 Geotechnical locations on the B-S route.

The geotechnical VC locations on the Bornholm - Sjælland (B-S) route are shown below (Figure 60). Fifteen VC were carried out with co-located CPT at every location, with the exception of location B-S-04. The investigated locations cover approximately 15.2 km, from KP 2.911 through to KP 18.088.

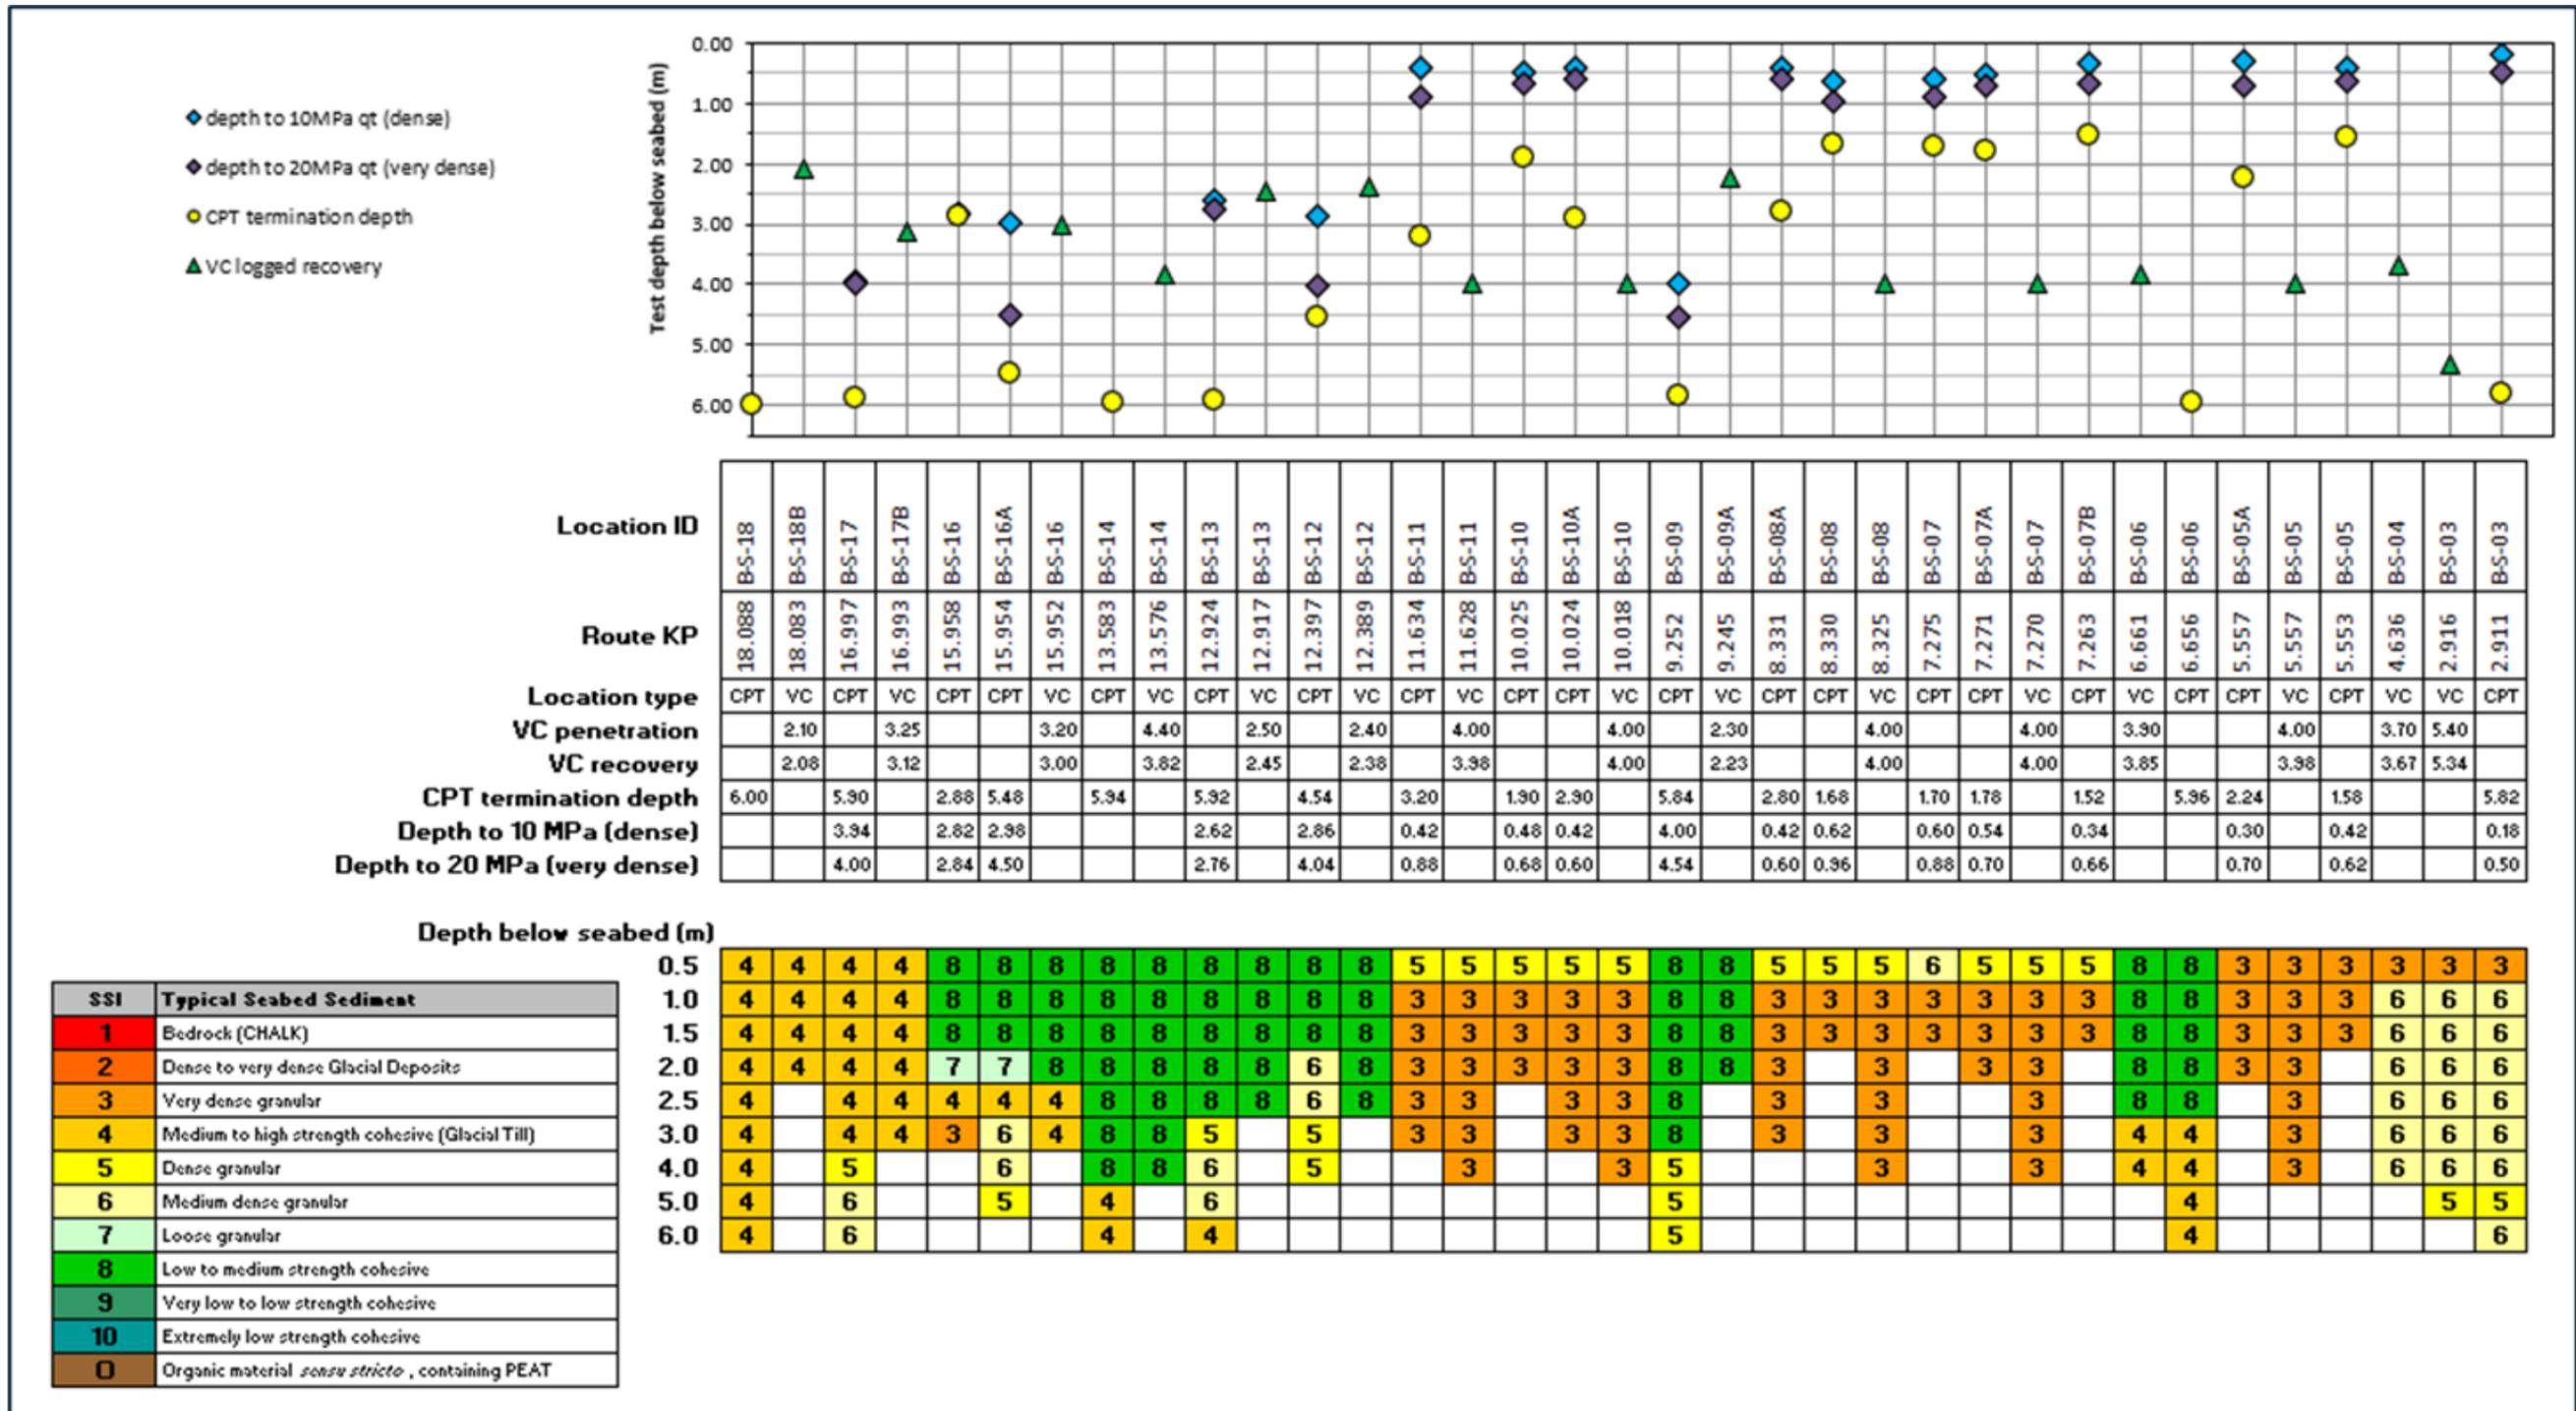
Figure 61 Seabed Sediment Index for B-S route (KP 18.088 to KP 2.911), Part 1.

The assigned Seabed Sediment Index for the B-S route is shown below (Figure 61).

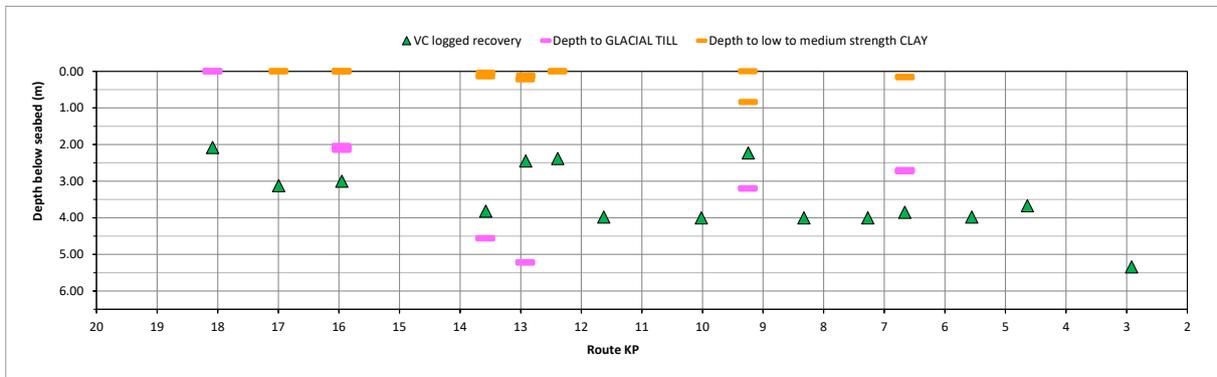
Figure 62 Plot of VC recovery and interpreted strata depths for route B-S, Part 1.

From KP 12.389 (location B-S-12) through to KP 18.088 (location B-S-18) CLAY becomes more prevalent (Figure 62). Glacial Till is present in this section, from 5.22 m depth at KP 12.924, becoming present at seabed level towards the end of this section at KP 18.083 (location B-S-18). The Glacial Till is typically low to intermediate plasticity, medium to high strength firm very silty very sandy slightly gravelly CLAY. The CLAY is calcareous. At most locations, the Glacial Till is overlain by a low to medium strength, intermediate to high plasticity, very silty sandy CLAY, locally slightly gravelly. Thin to thick silt laminae are often present. This CLAY can be up to 6.00 m thick (location CPT-B-S-18).

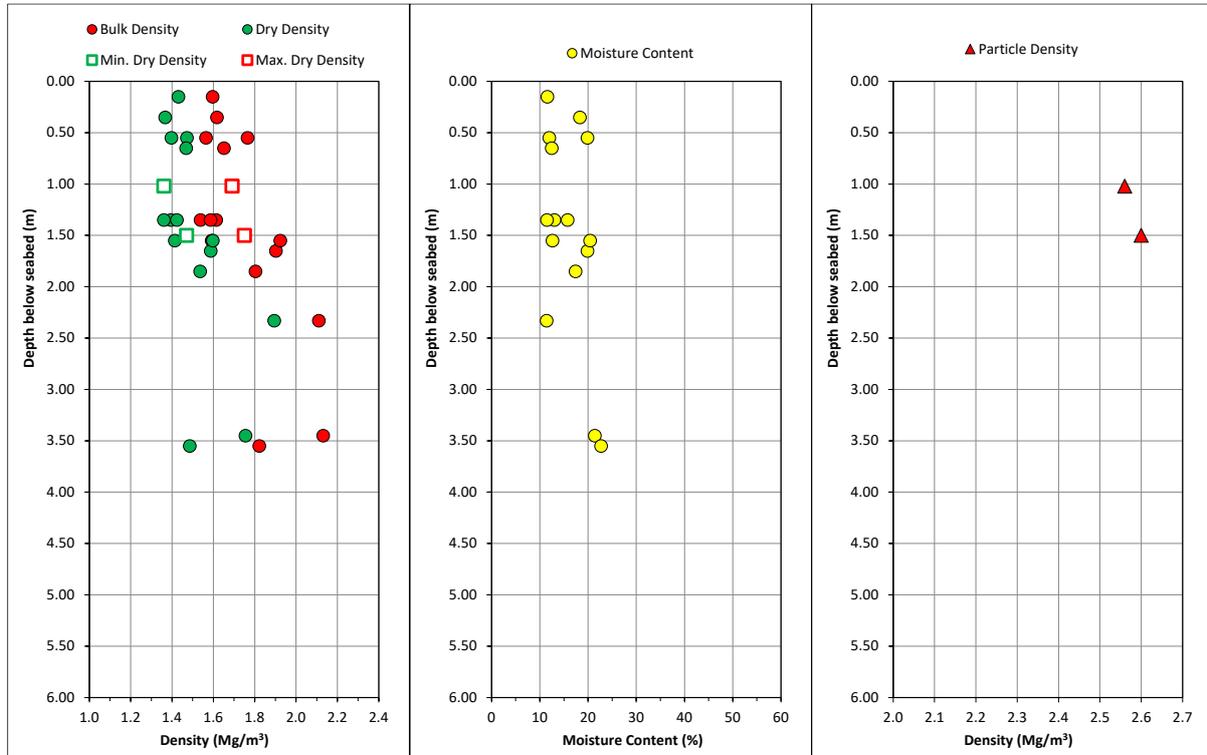
Figure 65 Laboratory test data for granular material, route B-S, Part 1.

Laboratory test data are summarised below for granular material (Figure 65). The tested material has bulk and dry densities in the ranges from 1.54 to 2.13 Mg/m<sup>3</sup>, and 1.36 to 1.89 Mg/m<sup>3</sup>, respectively. There is a general increase in density with depth. Min and max dry density results are in the ranges 1.36 to 1.47 Mg/m<sup>3</sup>, and 1.69 to 1.75 Mg/m<sup>3</sup>, respectively. Particle densities are 2.56 to 2.60 Mg/m<sup>3</sup>. Moisture contents in granular material are in the range 11 to 23 %.

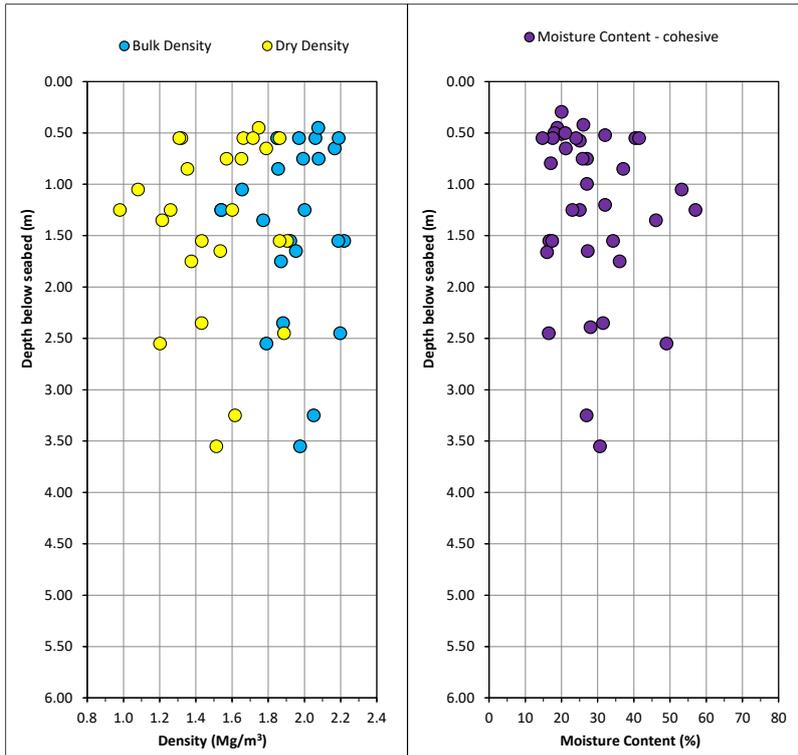
Figure 66 Laboratory test data for cohesive material, route B-S, Part 1.

Laboratory density test data are summarised below for cohesive material (Figure 66). Bulk and dry densities for Glacial Till are in the ranges from 1.97 to 2.22 Mg/m<sup>3</sup>, and 1.57 to 1.90 Mg/m<sup>3</sup>, respectively. In lower strength CLAY bulk and dry densities are in the large ranges 1.54 to 1.95 Mg/m<sup>3</sup>, and 0.98 to 1.53 Mg/m<sup>3</sup>, respectively. Determined moisture contents are also shown below for cohesive material. Glacial Till typically has moisture contents in the range 16 to 27 %, whilst lower strength CLAYs are much more variable, from 15 to 57 %.

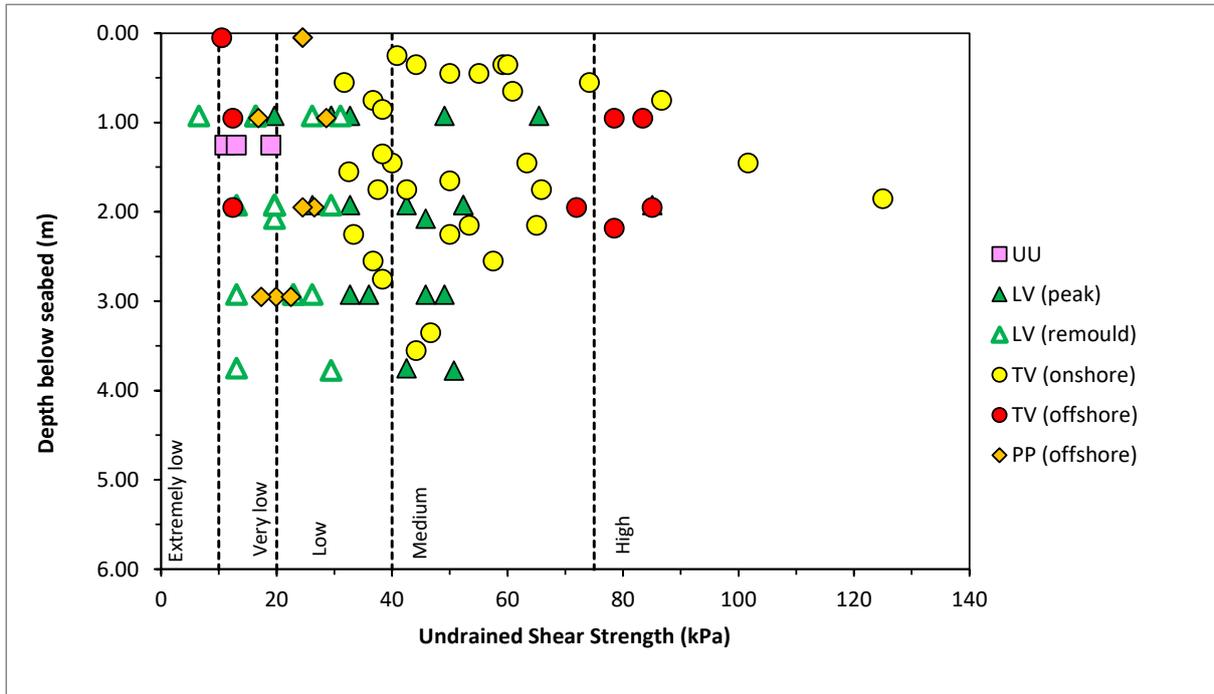
Figure 68 Laboratory shear strength data for route B-S, Part 1.

Laboratory shear strength data for cohesive material are shown below Figure 68). The data indicates two groups. Stiff to very stiff CLAY, considered to be Glacial Till are typically in the medium to high strength ranges, whilst non-glacial CLAY is generally very low to low strength. In most cores, there is a general increase in undrained shear strength with increasing depth.

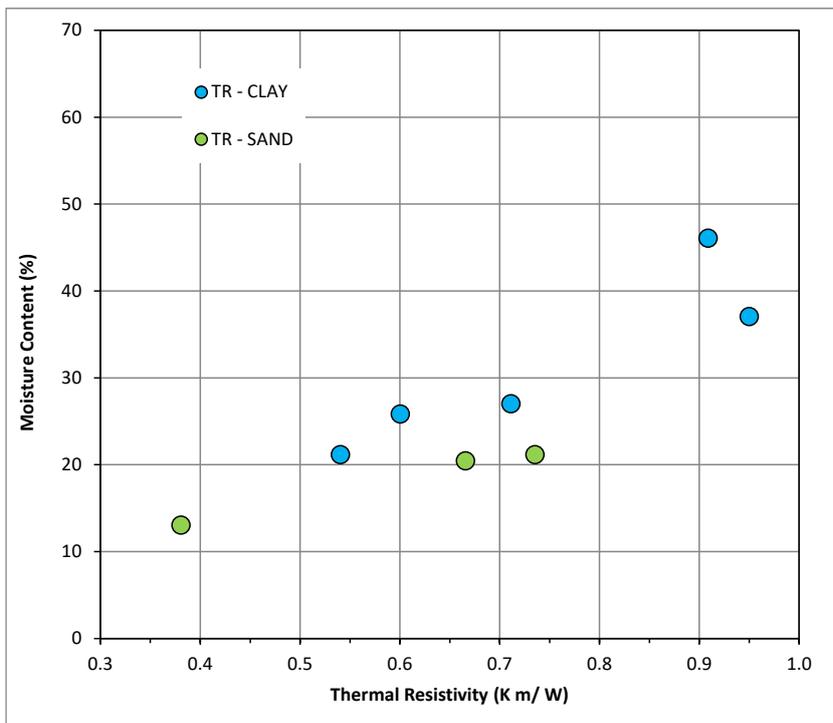
Figure 69 Summary of thermal data for route B-S, Part 1.

A summary of the acquired thermal resistivity data is shown below (Figure 69). The data for cohesive material shows the expected trend of increasing resistivity with increasing moisture content. Data from a single granular material is low, at 0.38 K m/W. Two higher results from granular material from locations B-S-05 and B-S-07, at low moisture contents of 11 and 13 % should be treated with caution.

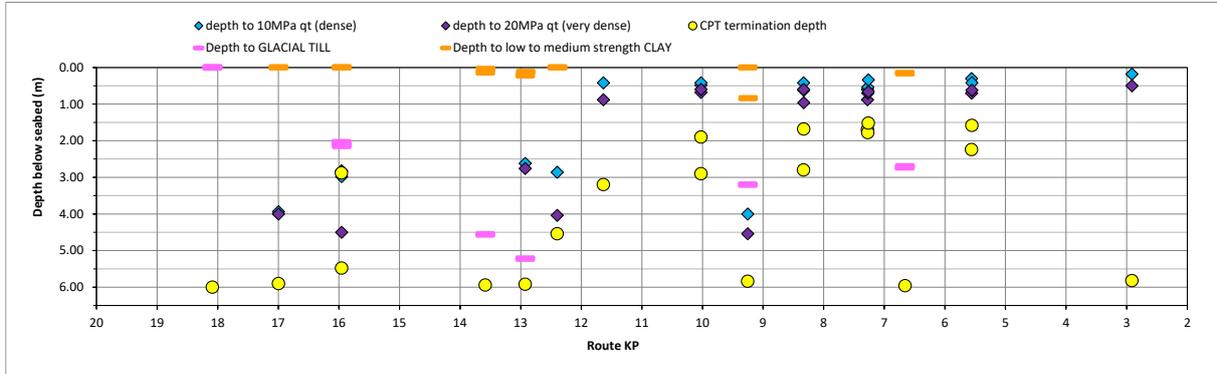
Figure 70 Plot of CPT test depths and interpreted stratum depths for route B-S.

Twenty CPT were carried out at the fourteen locations on this route. Re-attempts were carried out at five locations due to the presence of shallow dense to very dense granular material (Figure 70). Where Glacial Till was encountered along the route CPT penetration was generally good, with some dense to very dense granular layers visible within the glacial deposits. The measured cone responses were good with the resulting sediment interpretation being considered accurate and often close to the ground conditions in the co-located VC locations.

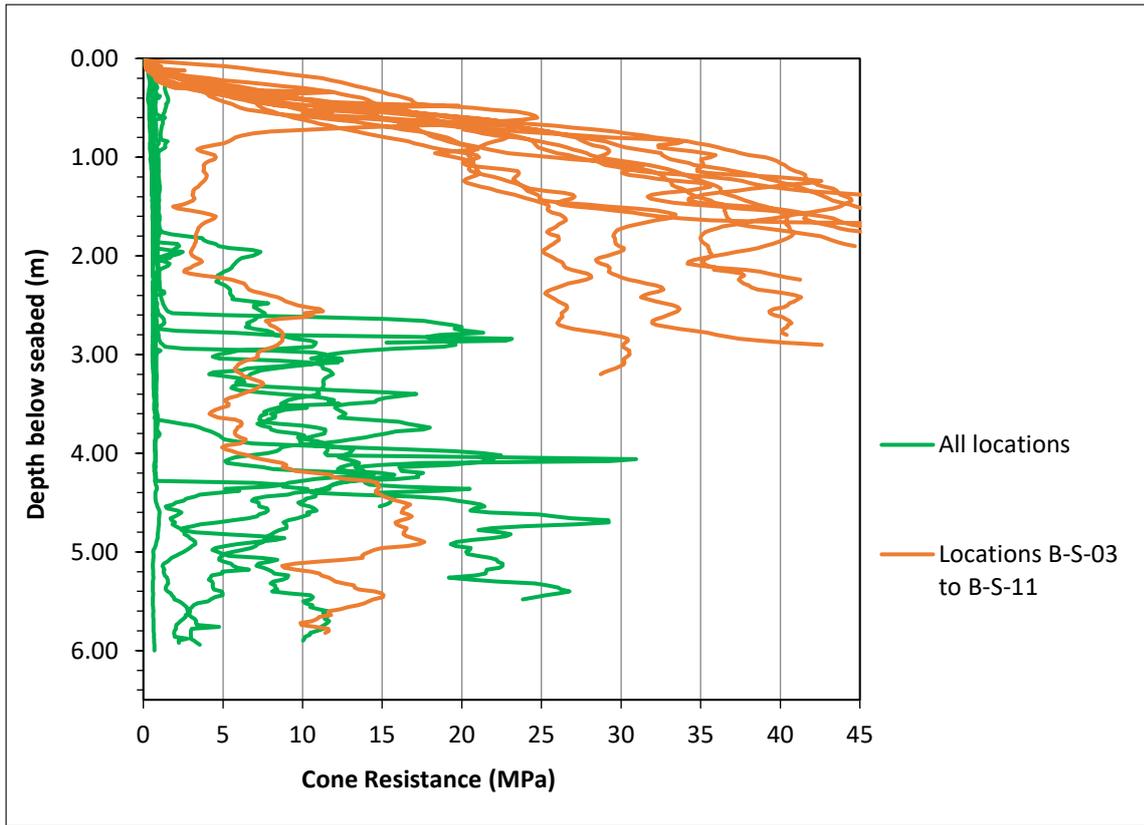
Figure 71 Plot of cone tip resistances for route B-S, Part 1.

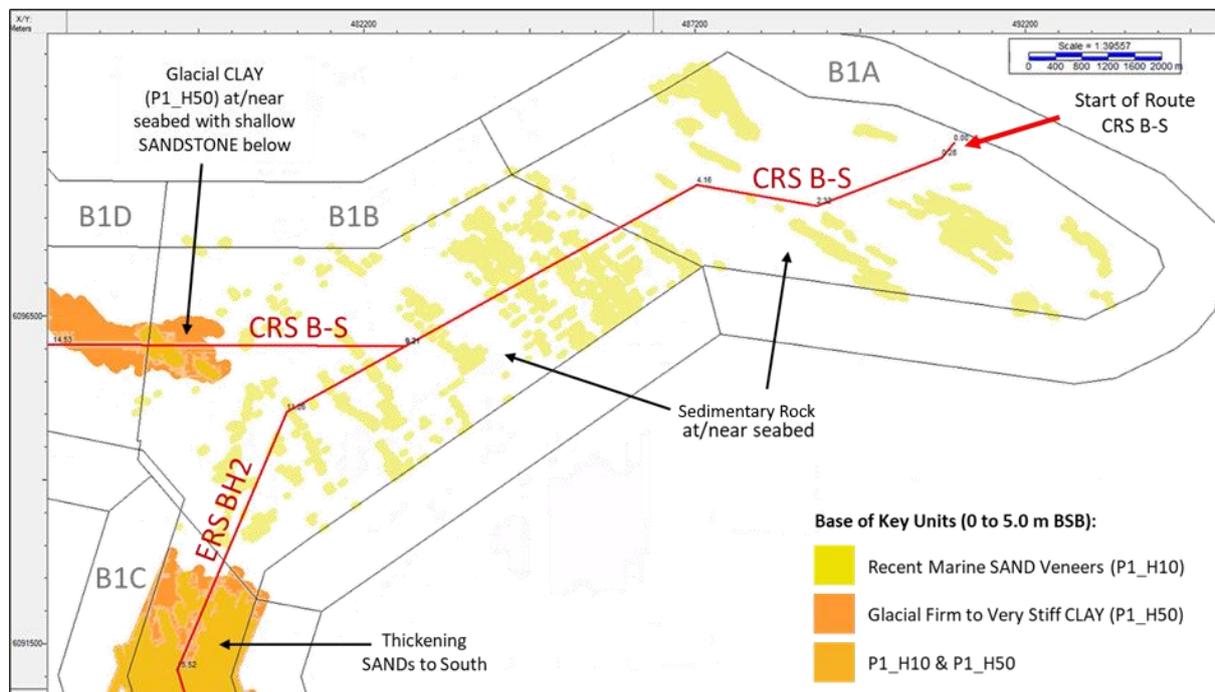
Figure 73 Overview map of the distribution of interpreted geological units along CRS Bornholm-Sjælland KP 0 to KP 15.

The start of the route, in the shallow nearshore area close to Bornholm Island, from KP 0.000 to KP 12.291, is largely dominated by SEDIMENTARY ROCK, either outcropping, present below thin veneers (< 1.0 m) of more recent marine SAND, GRAVEL or TILL, or below channels of late/post glacial SAND and CLAY. Where present, these veneers and channels have been identified as the units P1\_H10 and P1\_H45i respectively. The channels have only been identified on the centre line. Variations in the internal structure of the SEDIMENTARY ROCK are visible on the SBP data but these have not been mapped or interpreted. Between KP 0.000 and KP 15.200 there is significant uncertainty determining the top of Bedrock. This is due to the coarseness of the seabed sediments, weathered interface of the rock and very irregular rock bedding. Geotechnical points have been sited where there is sufficient sediment to sample. Caution should be taken extrapolating the depth of sediment cover between geotechnical sites. An overview of the interpreted shallow geology in this nearshore section at the start of the route can be seen in Figure 73.

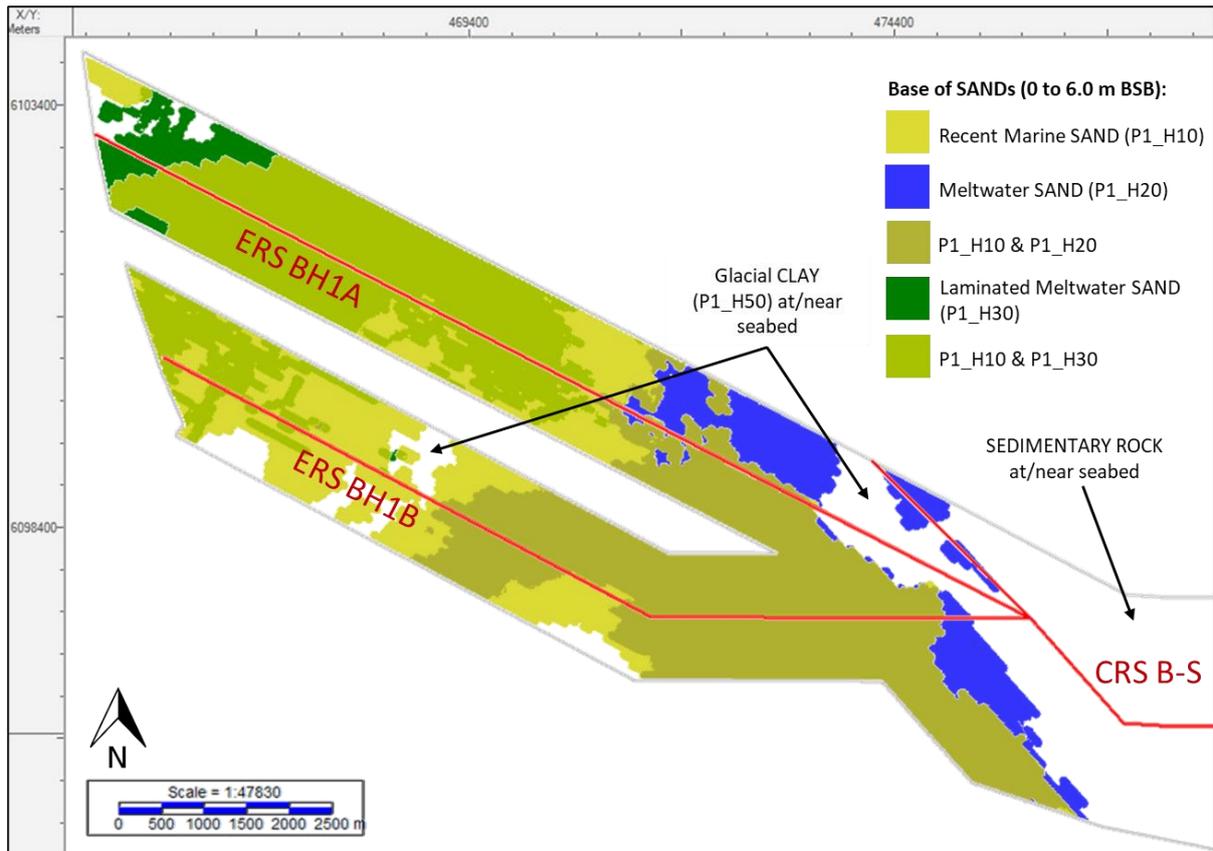
Figure 74 Overview map of the distribution of interpreted SAND units along CRS Bornholm-Sjælland KP 14 to KP 18.

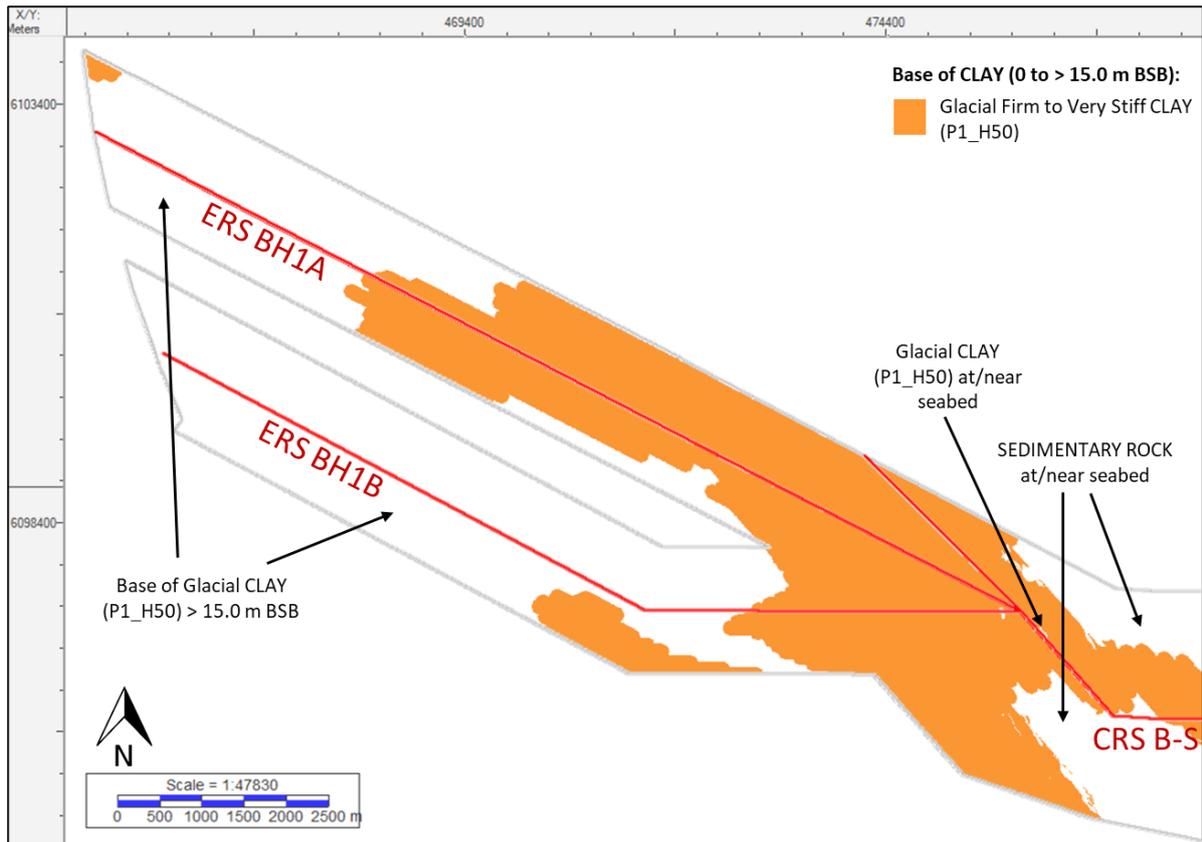
Figure 75 Overview map of the distribution of interpreted Glacial CLAY along CRS Bornholm-Sjælland KP 15 to KP 19.

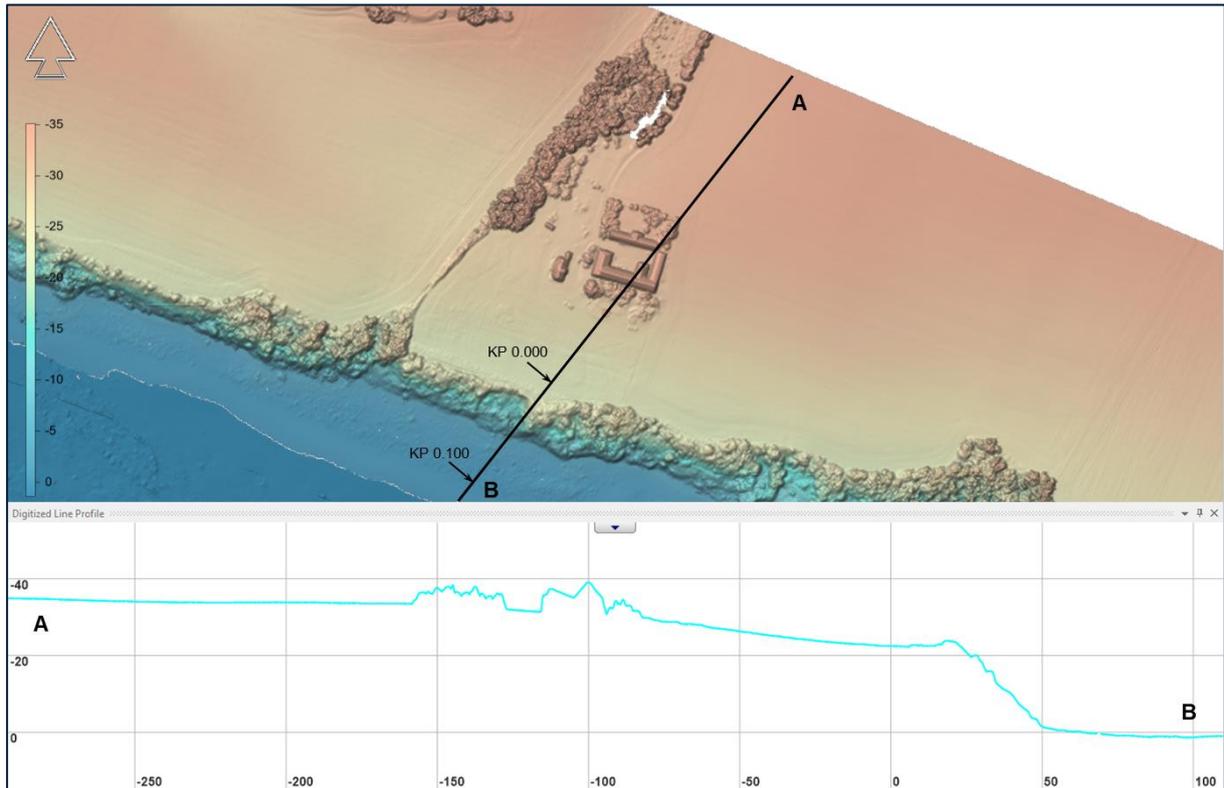
Figure 76 Inshore section of Route Bornholm-Sjælland\_P1 showing LIDAR data and nearshore bathymetry KP 0.0.

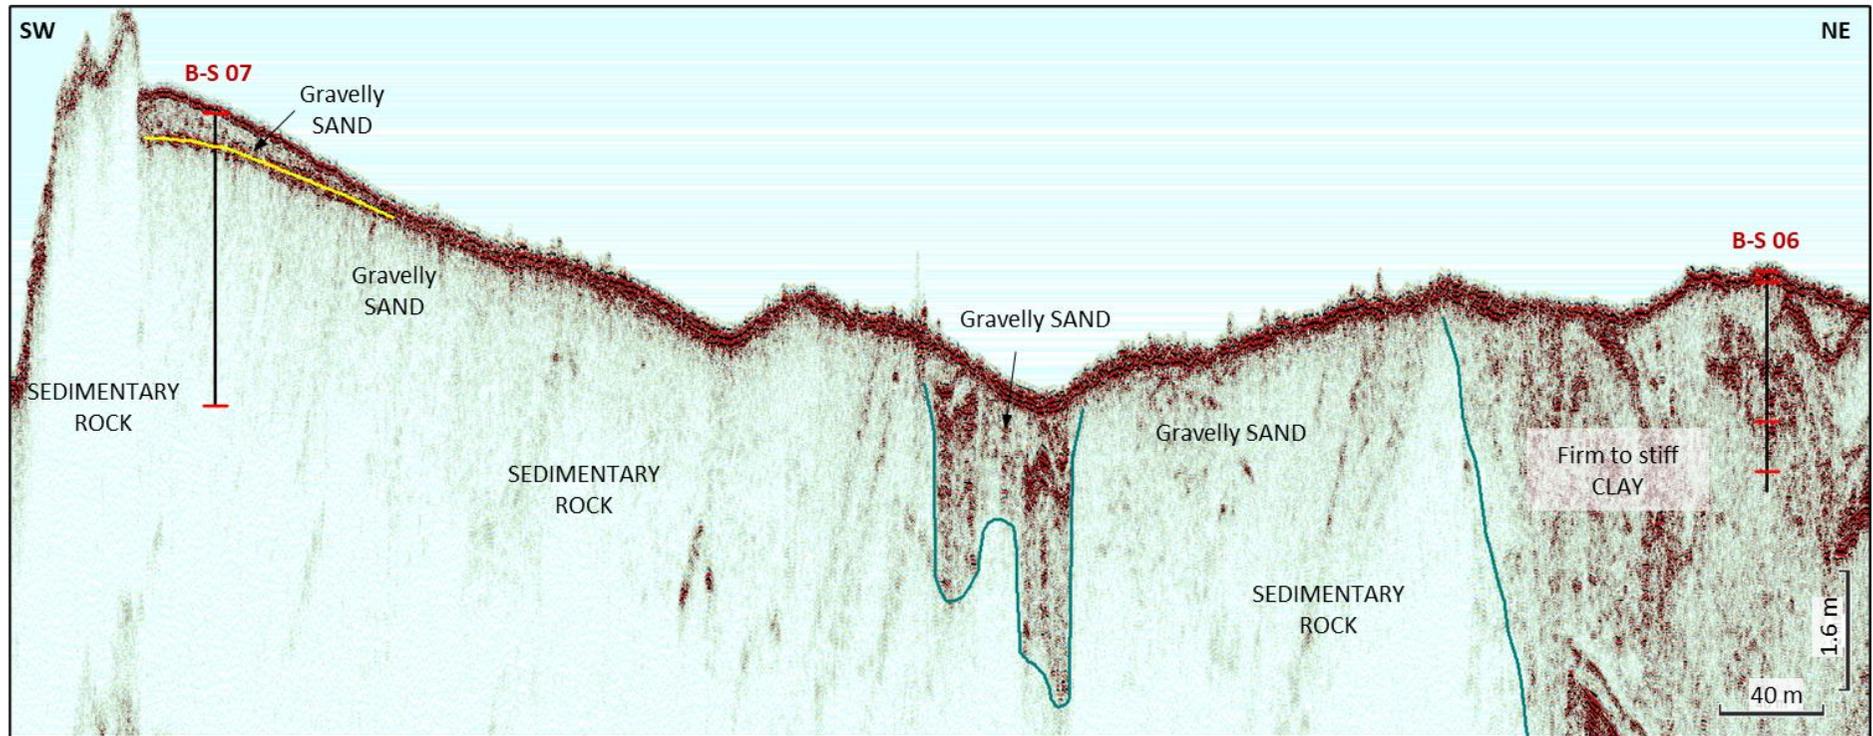
Figure 87 Innomar SBP data example from KP 7.352 (SW) to KP 6.620 (NE).
