# Energy Island Cable Route Survey Baltic Sea

Danish Baltic Sea  
April - August 2022

**DOC NO.**  
103971-ENN-OI-SUR-REP-SURVLOT1-VO

### Baltic Sea OWF and Energy Islands LOT1 Cable Route Survey Overview

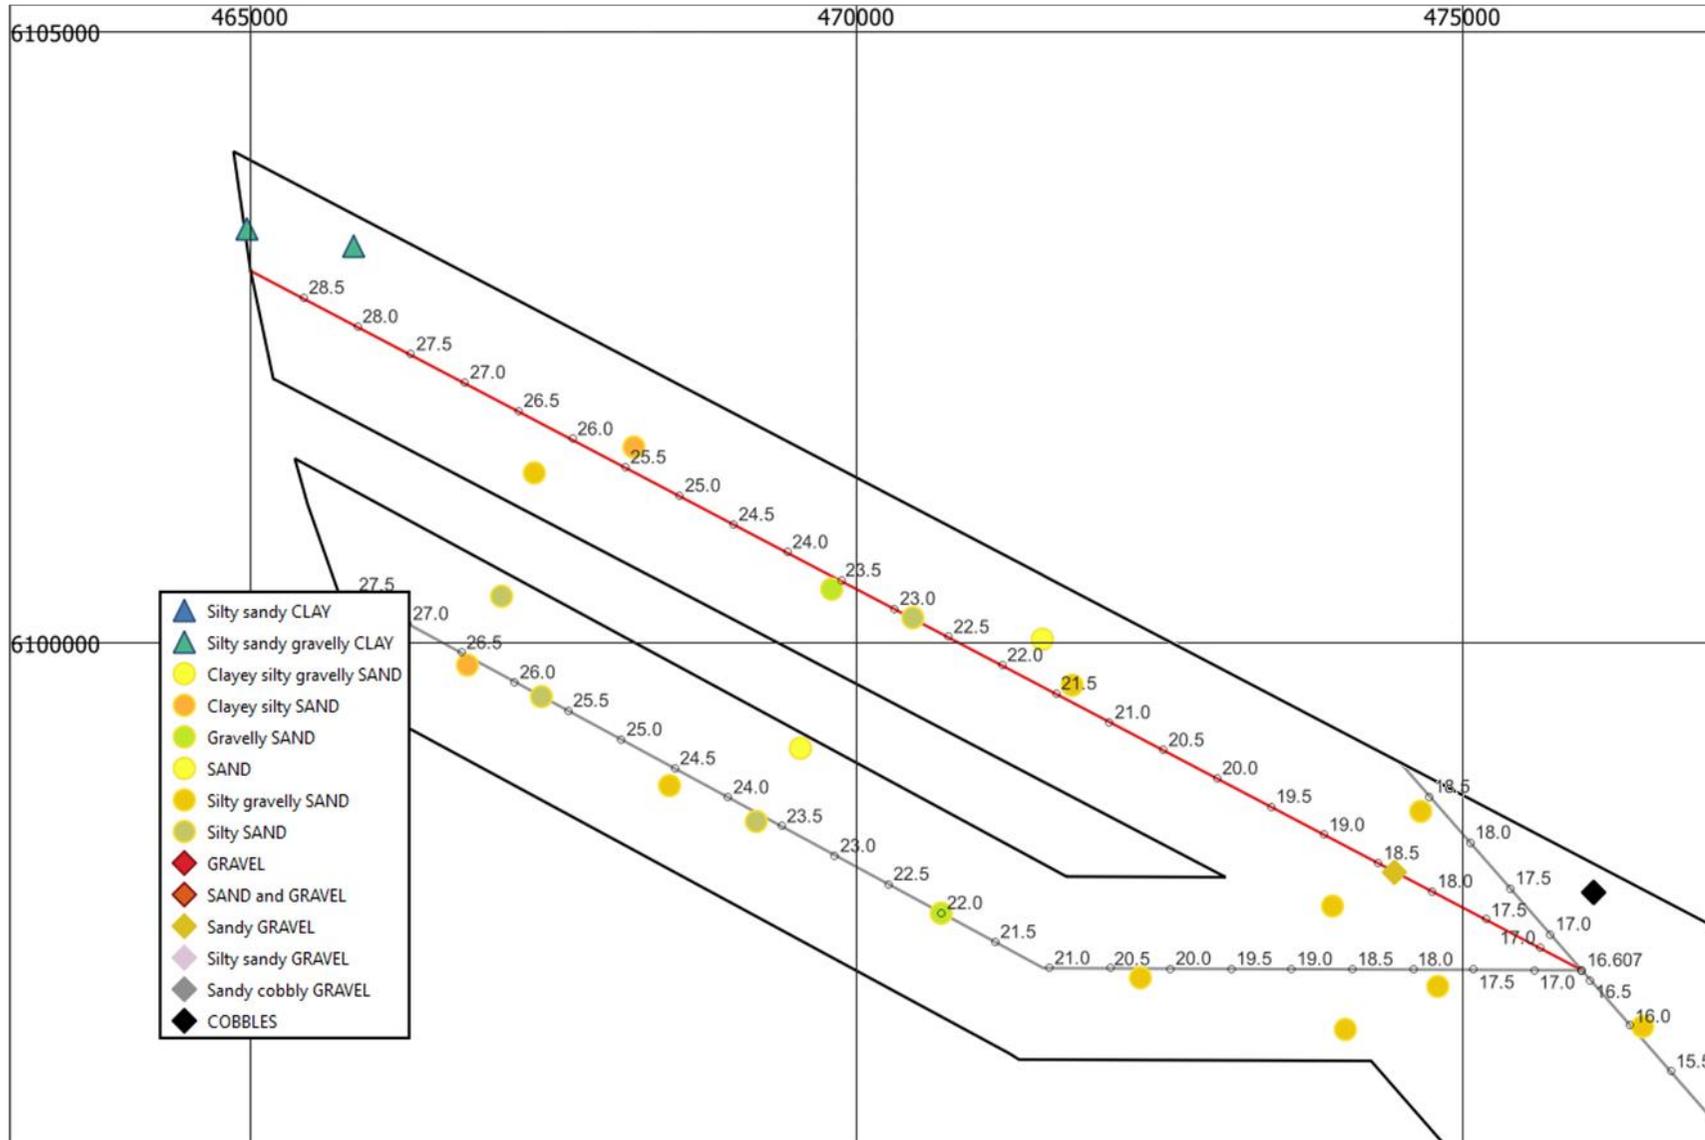
Figure 107 ERS Bornholm 1A grab sampling overview KP 16.607 to KP 28.995.

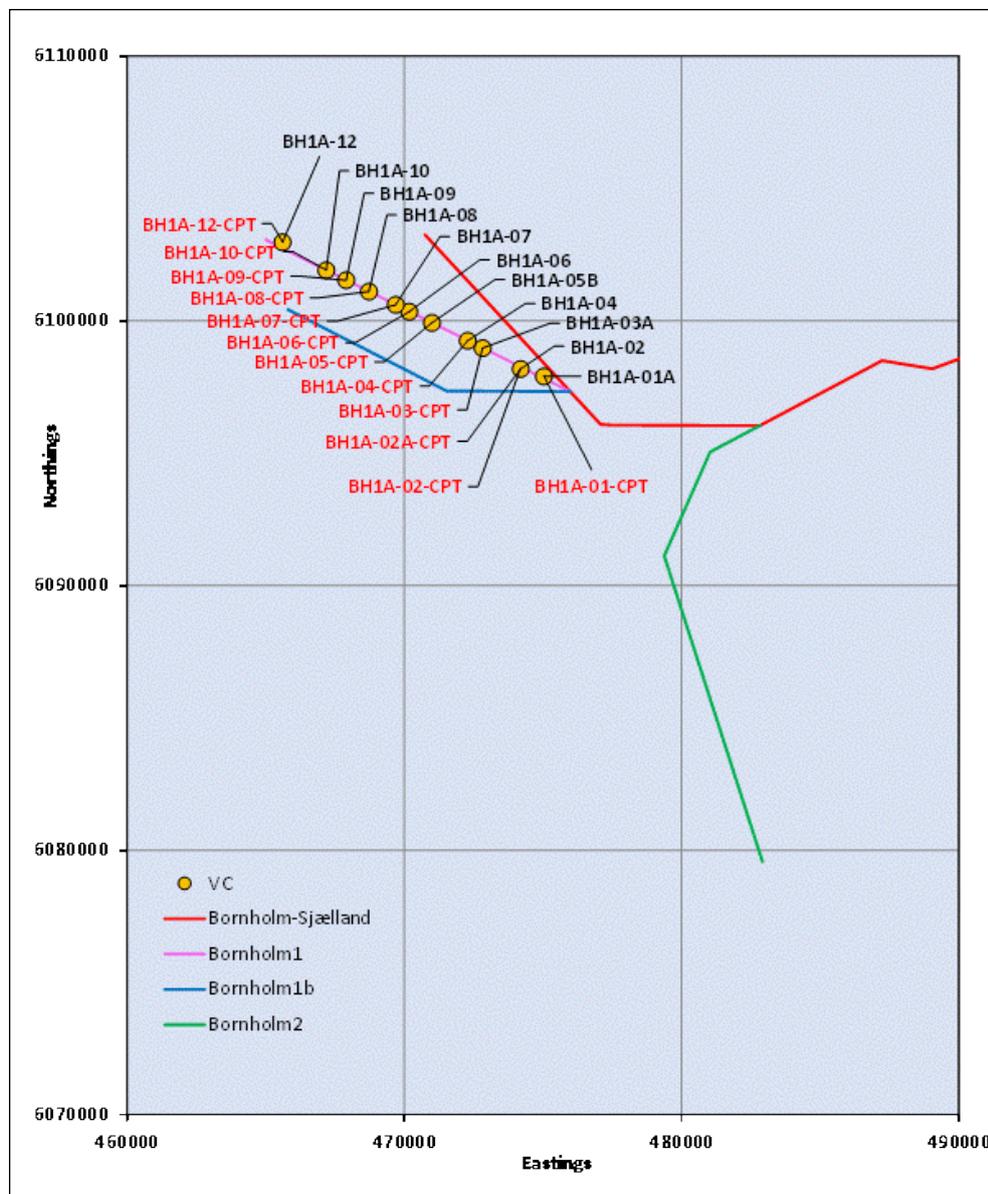
Figure 108 Geotechnical locations on the BH1A route, Part 1.

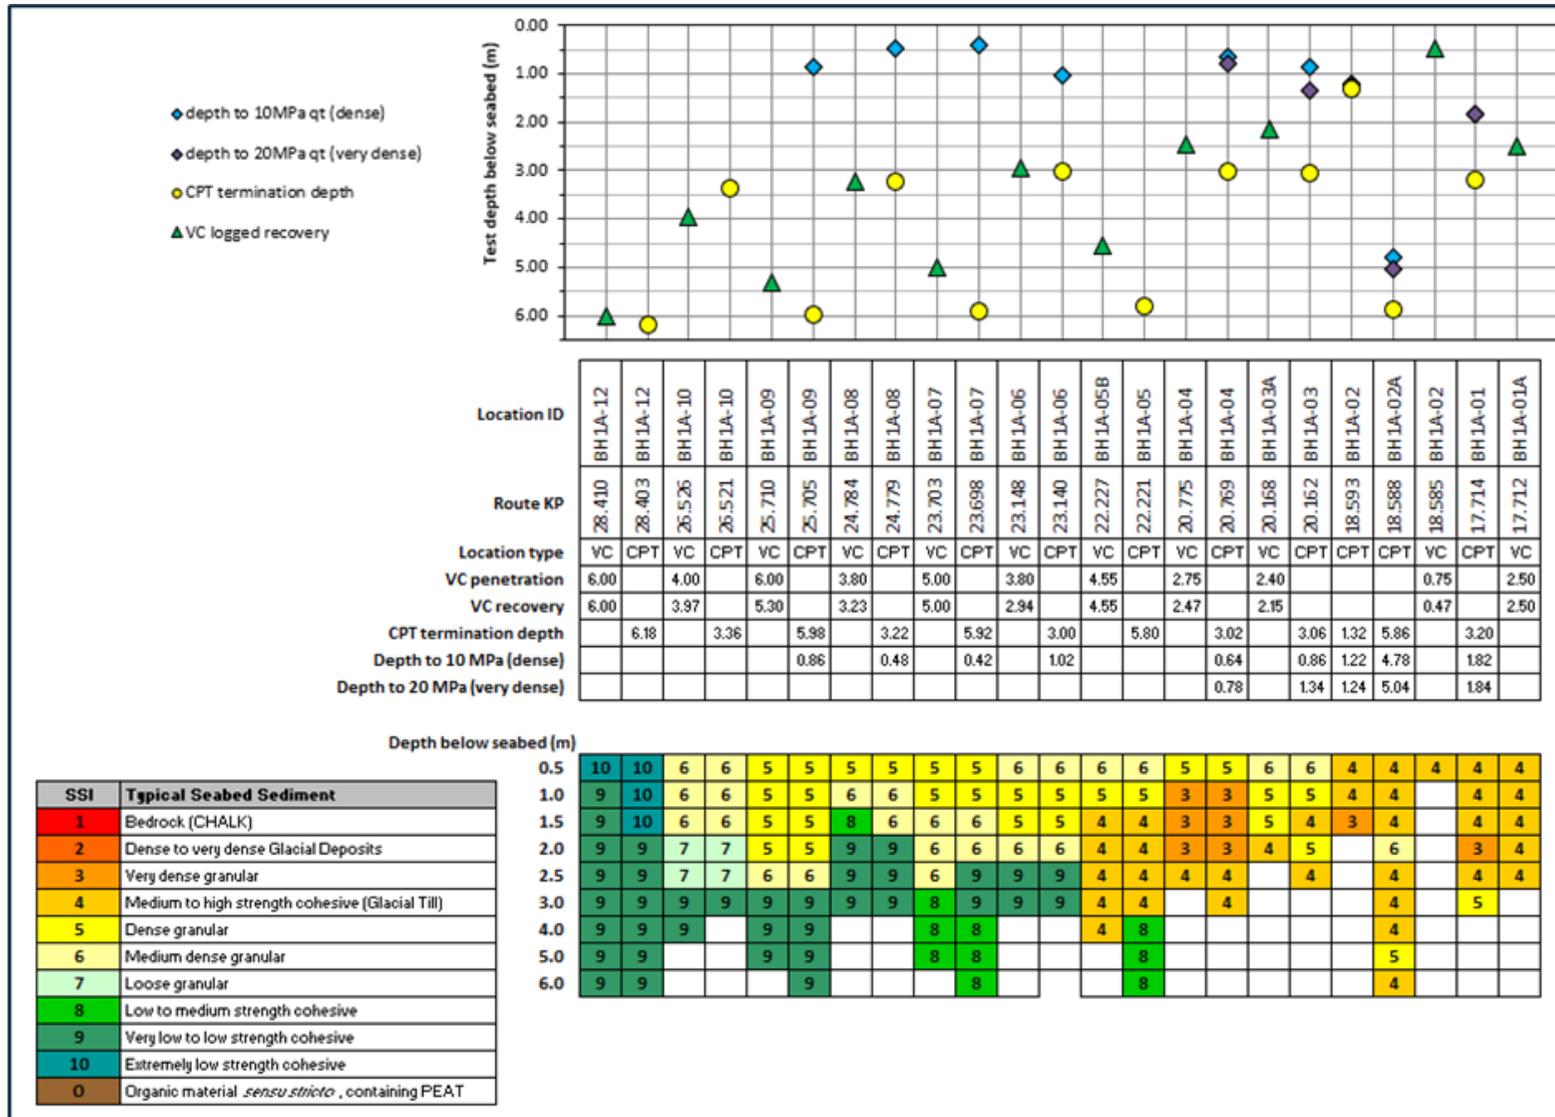
Figure 109 Seabed Sediment Index for BH1A route, Part 1.

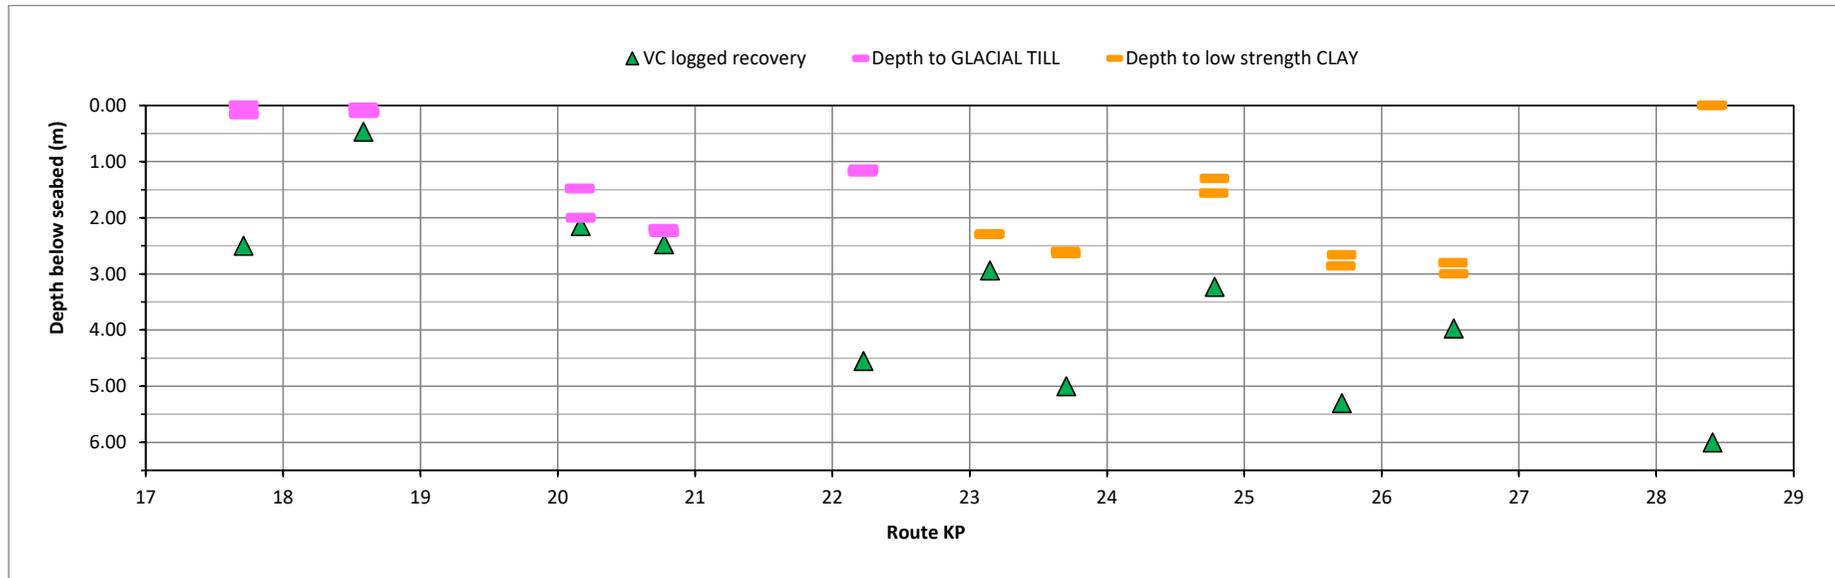
Figure 110 Plot of VC recovery and interpreted strata depths for route BH1A, Part 1.

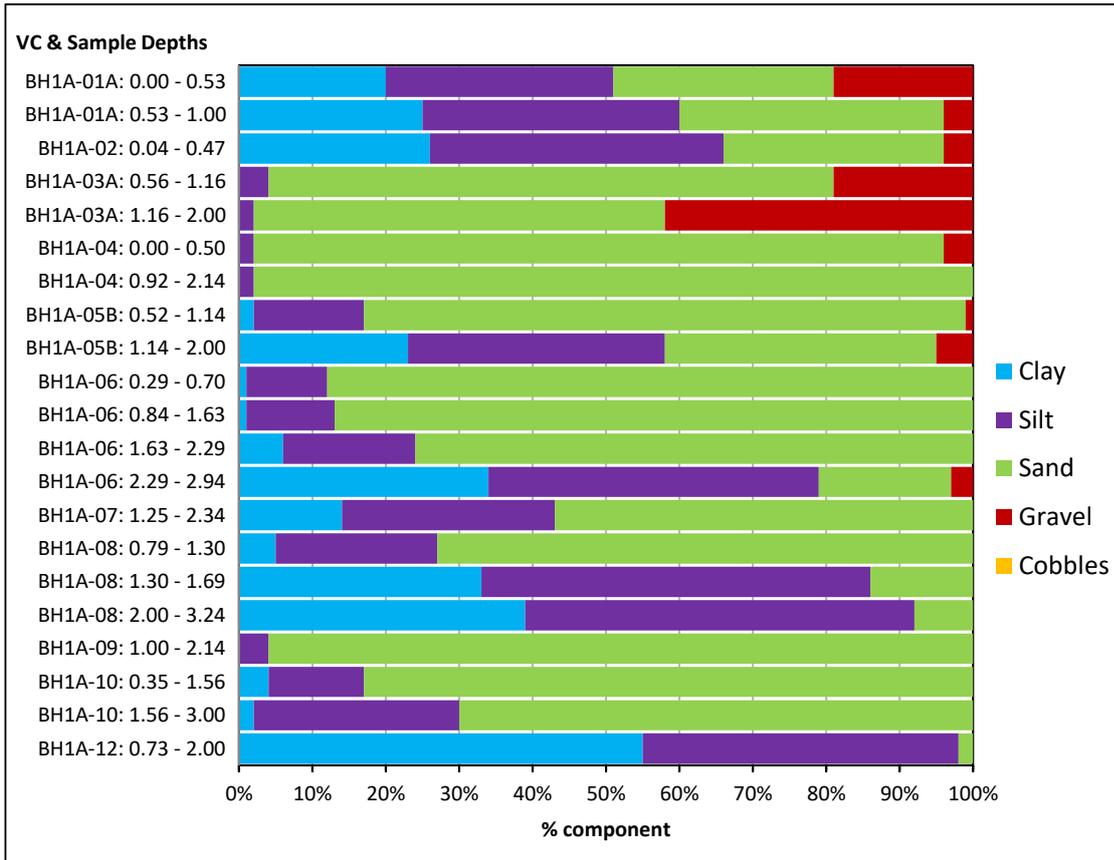
Figure 111 Schematic summary plot of PSD data for route BH1A, Part 1.

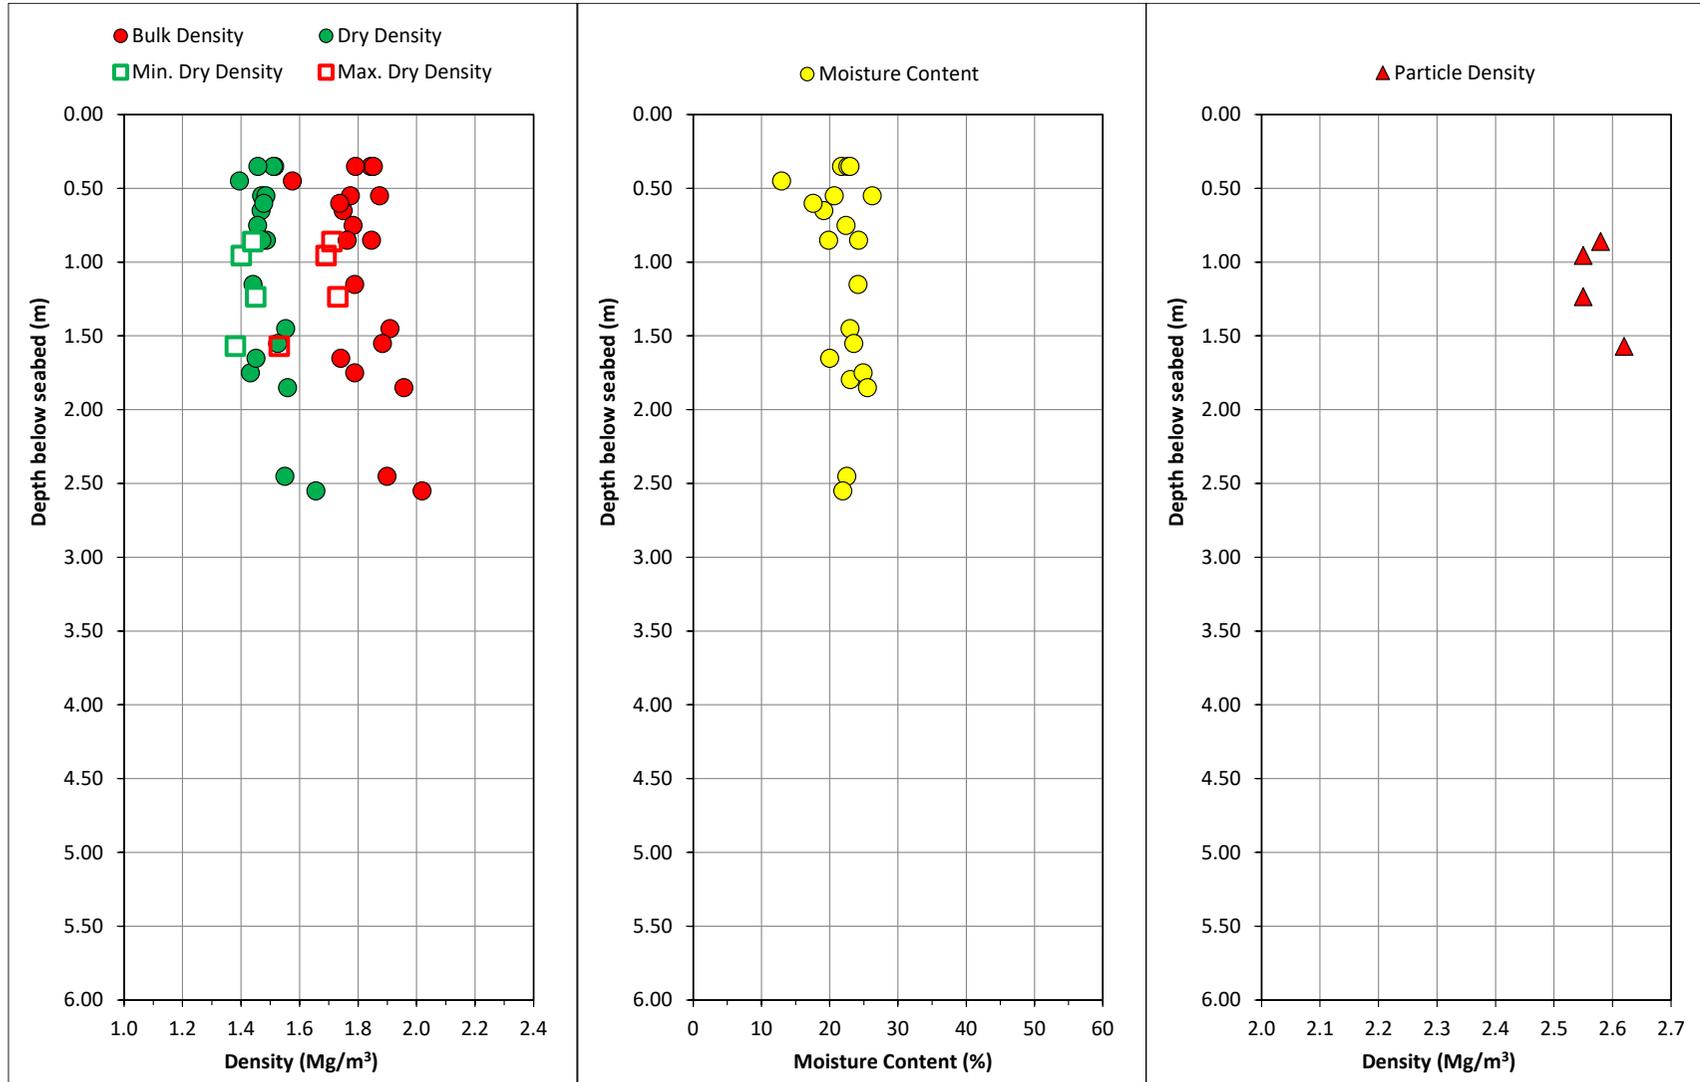
Figure 113 Laboratory test data for granular material, route BH1A, Part 1.

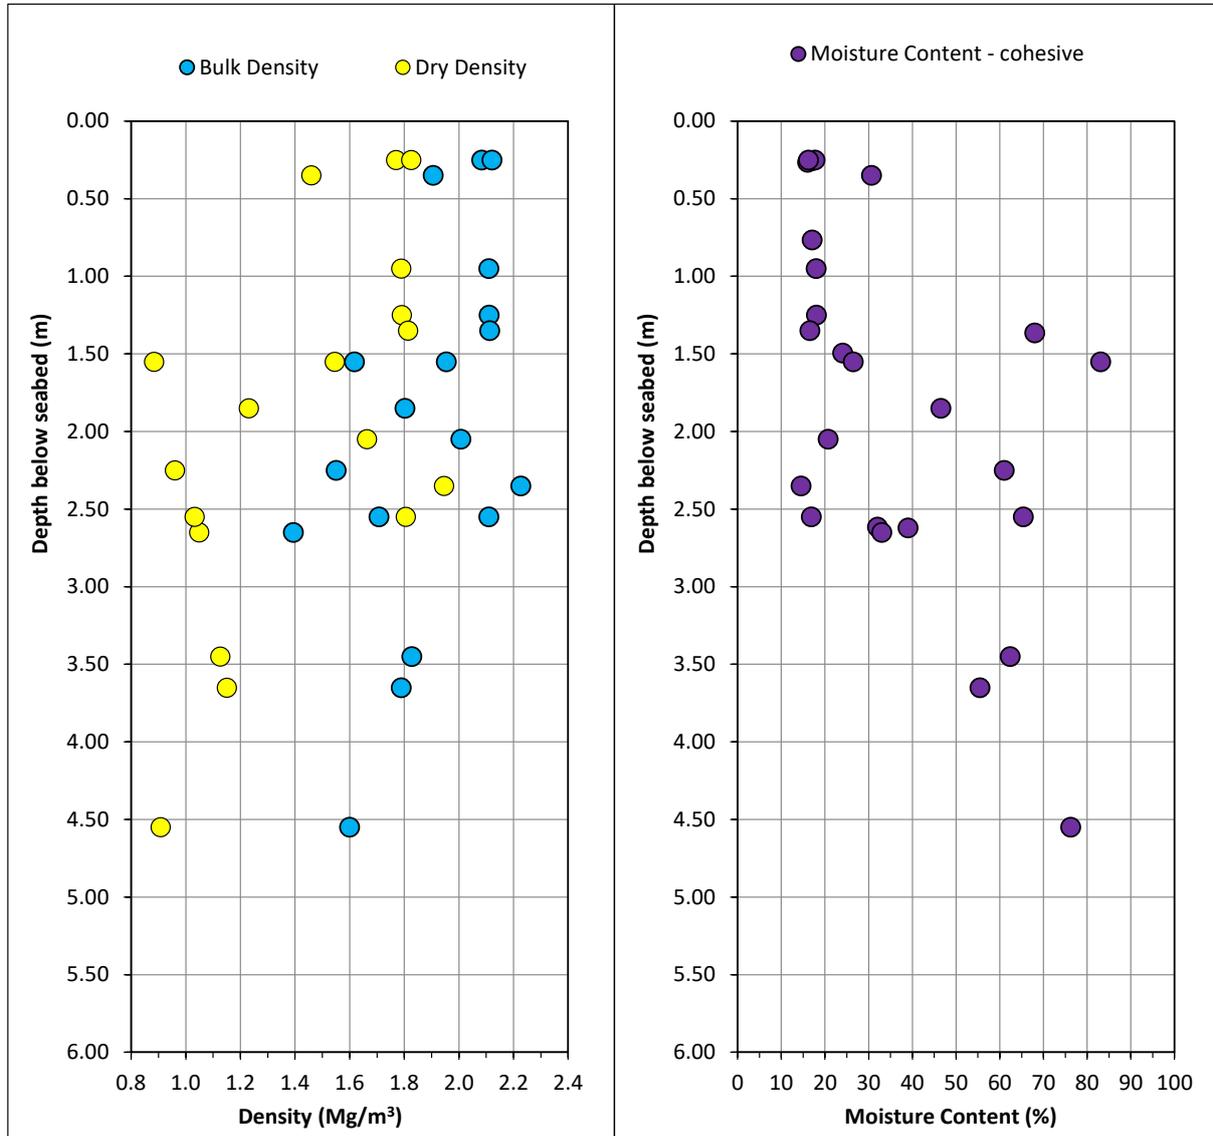
Figure 114 Laboratory test data for cohesive material, route BH1A, Part 1.

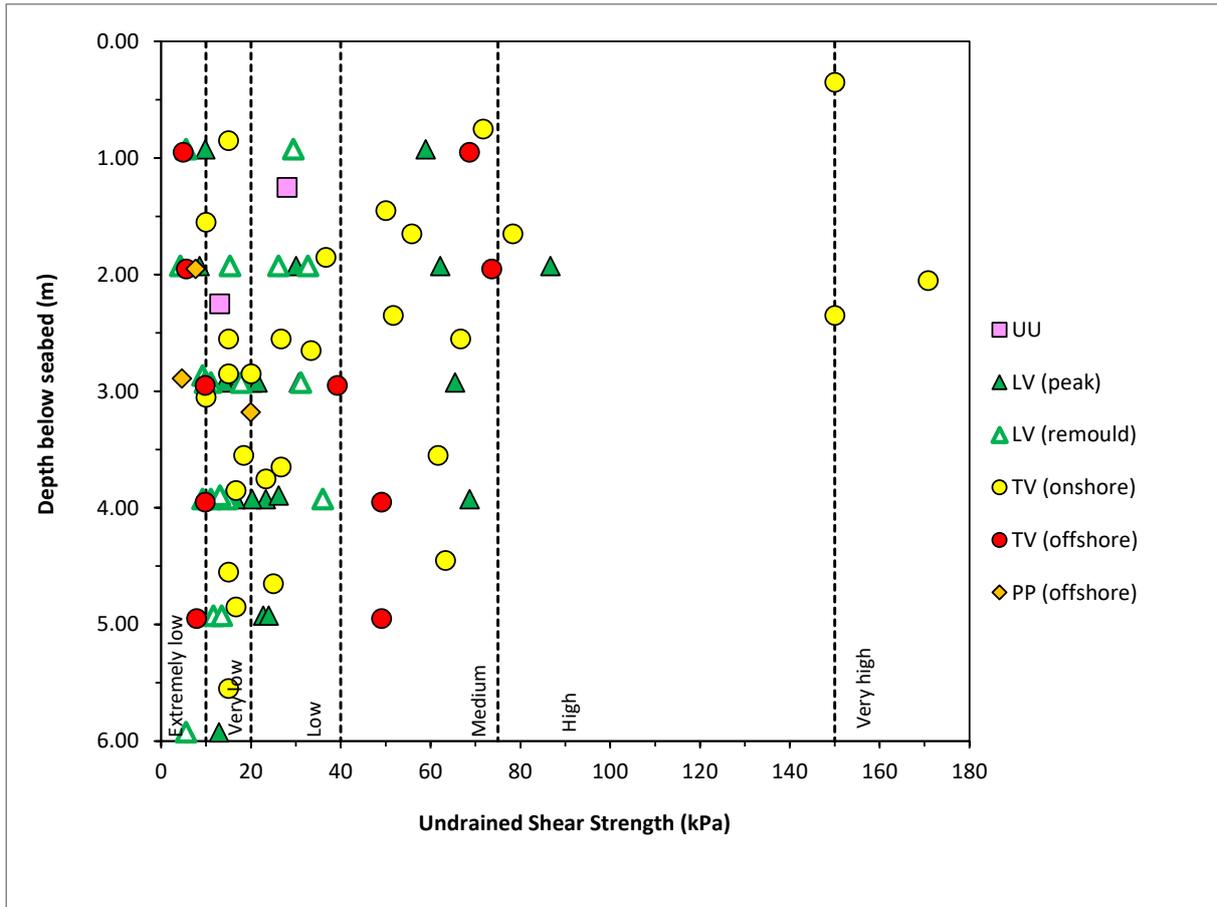
Figure 116 Laboratory shear strength data for route BH1A, Part 1.

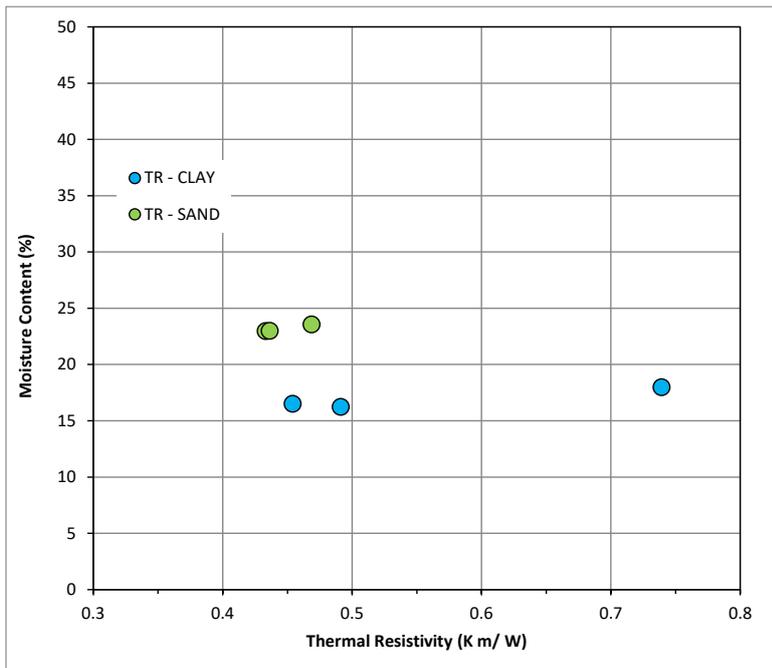
Figure 117 Summary of thermal data for route BH1A, Part 1.

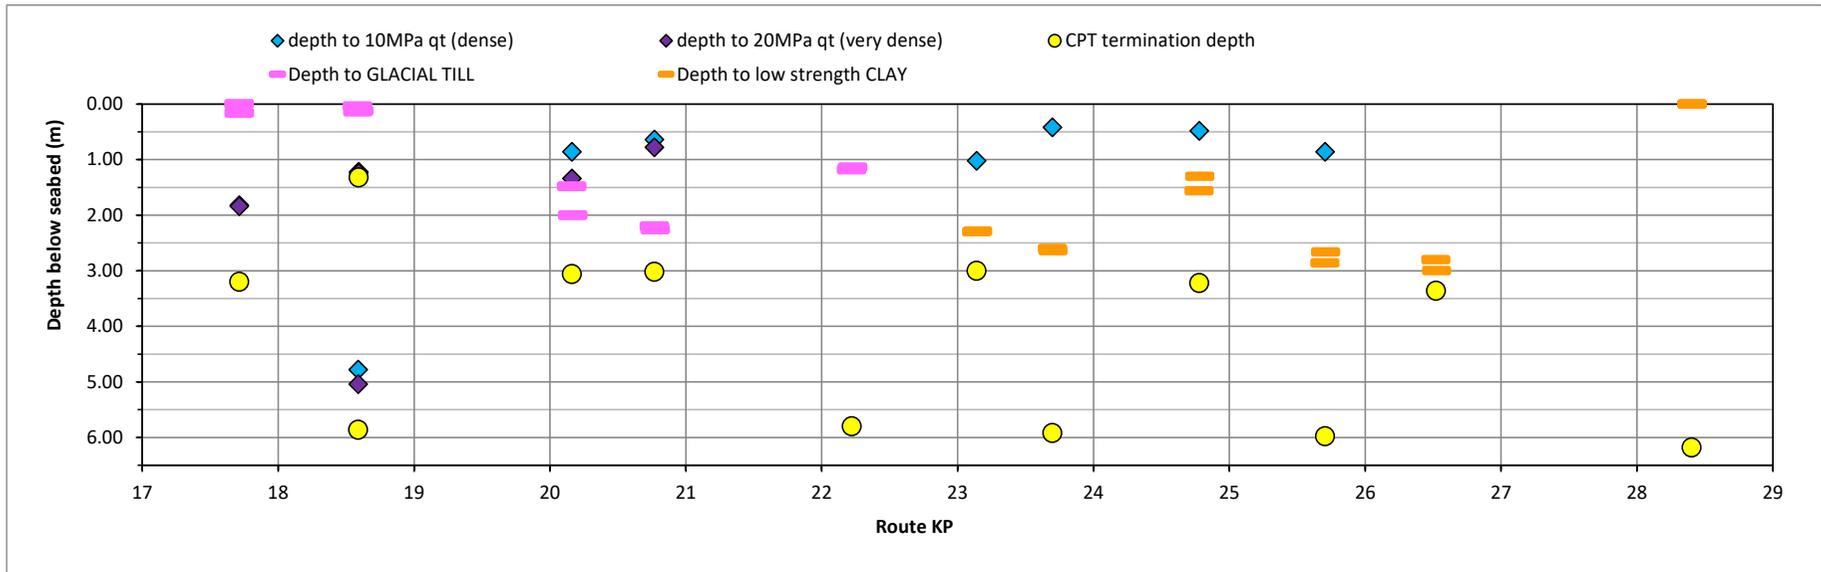
Figure 118 Plot of CPT test depths and interpreted stratum depths for route BH1A, Part 1.

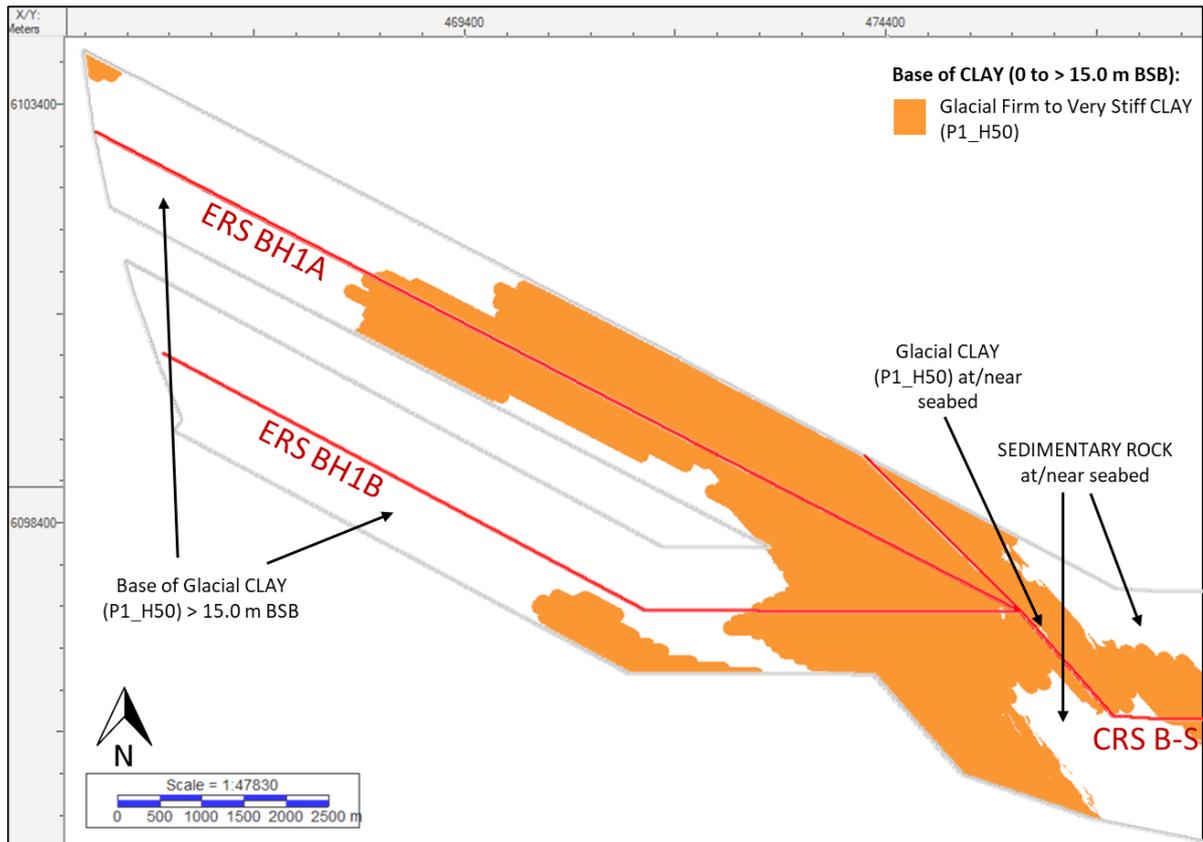
Figure 122 Overview map of the distribution of interpreted Glacial CLAY along ERS Bornholm 1A KP 16 to KP 29.

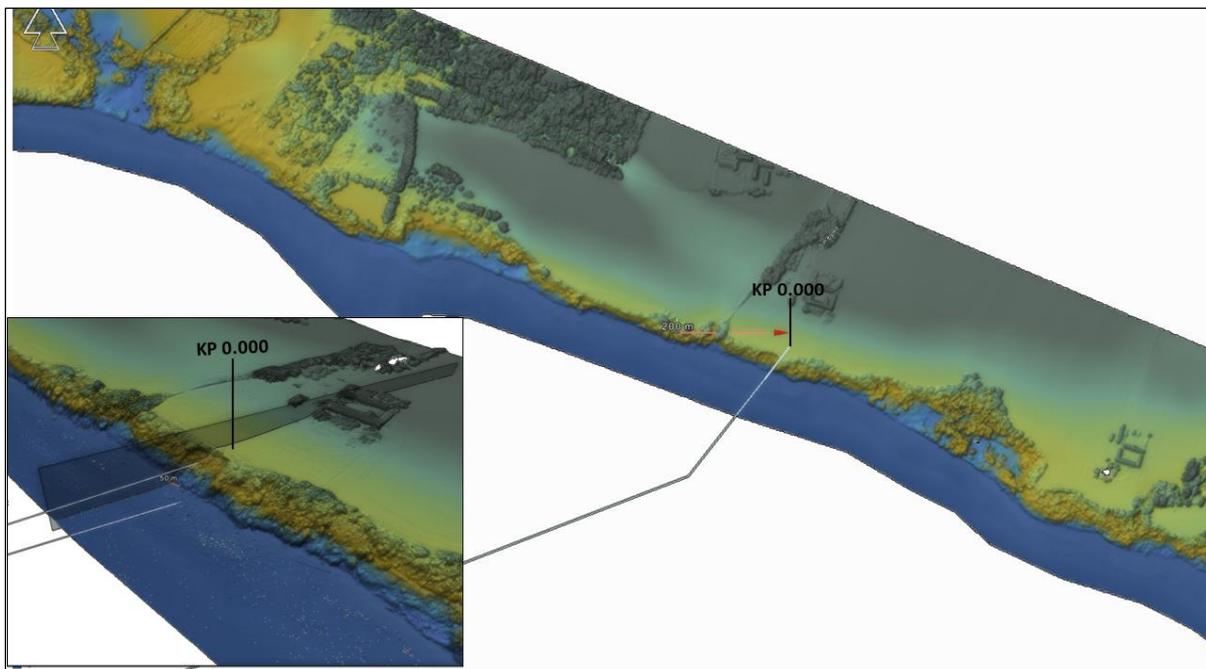
Figure 139 LiDAR image of KP 0.0 at Bornholm. The inset image shows the profile along the route line and the 20 m high cliff.

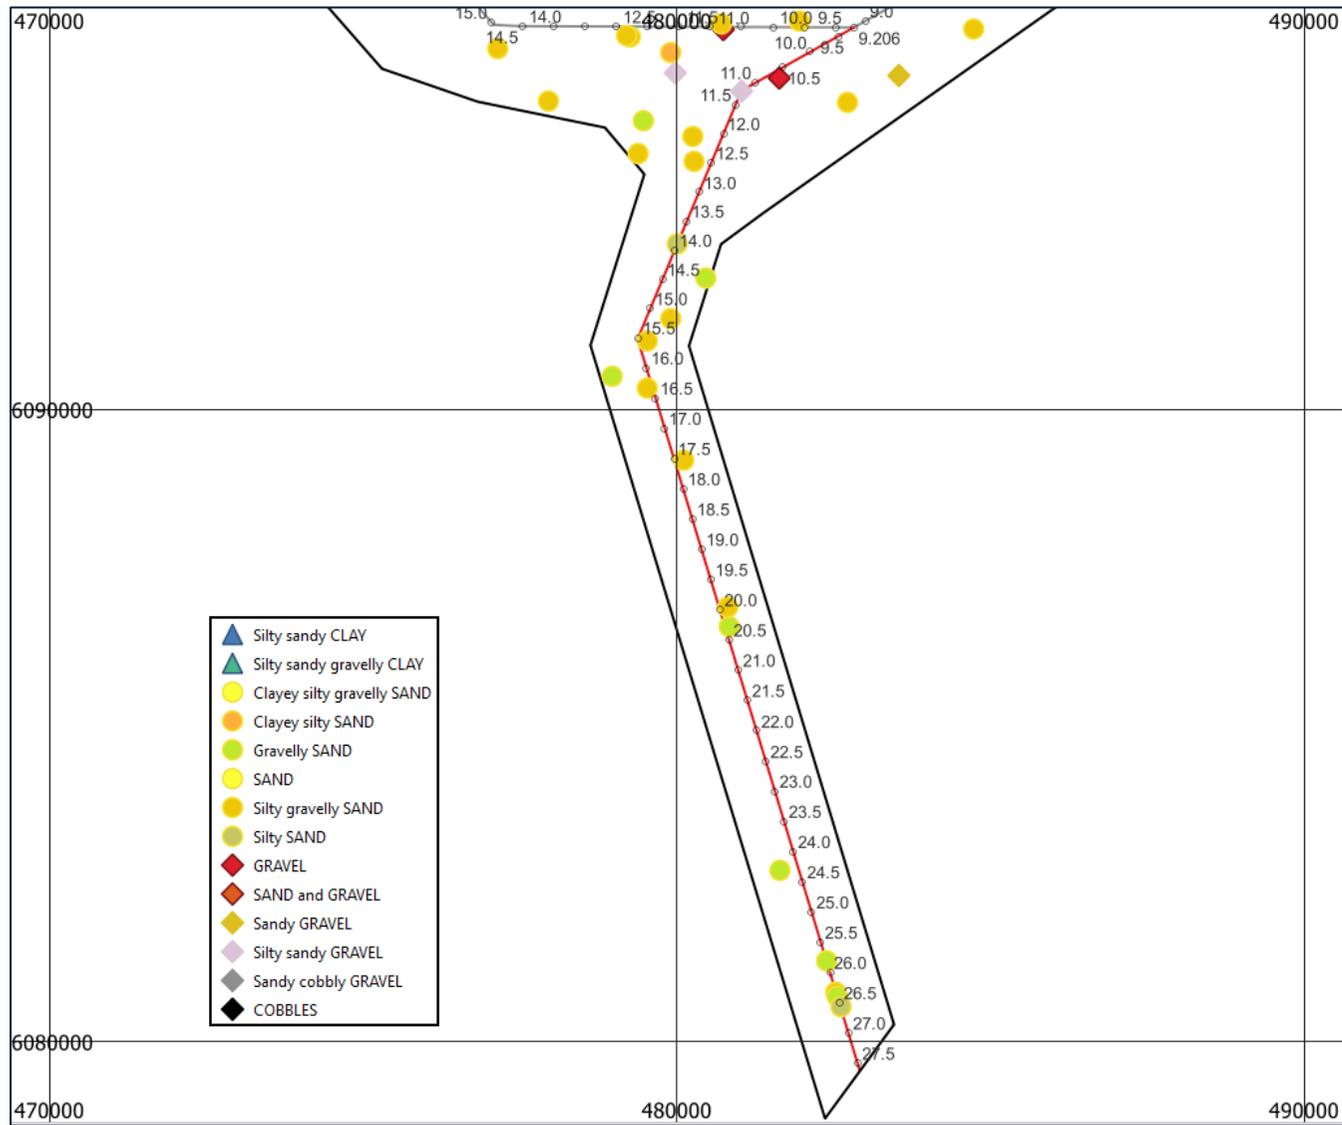
Figure 147 ERS Bornholm 2 grab sampling overview KP 9.206 to KP 27.605

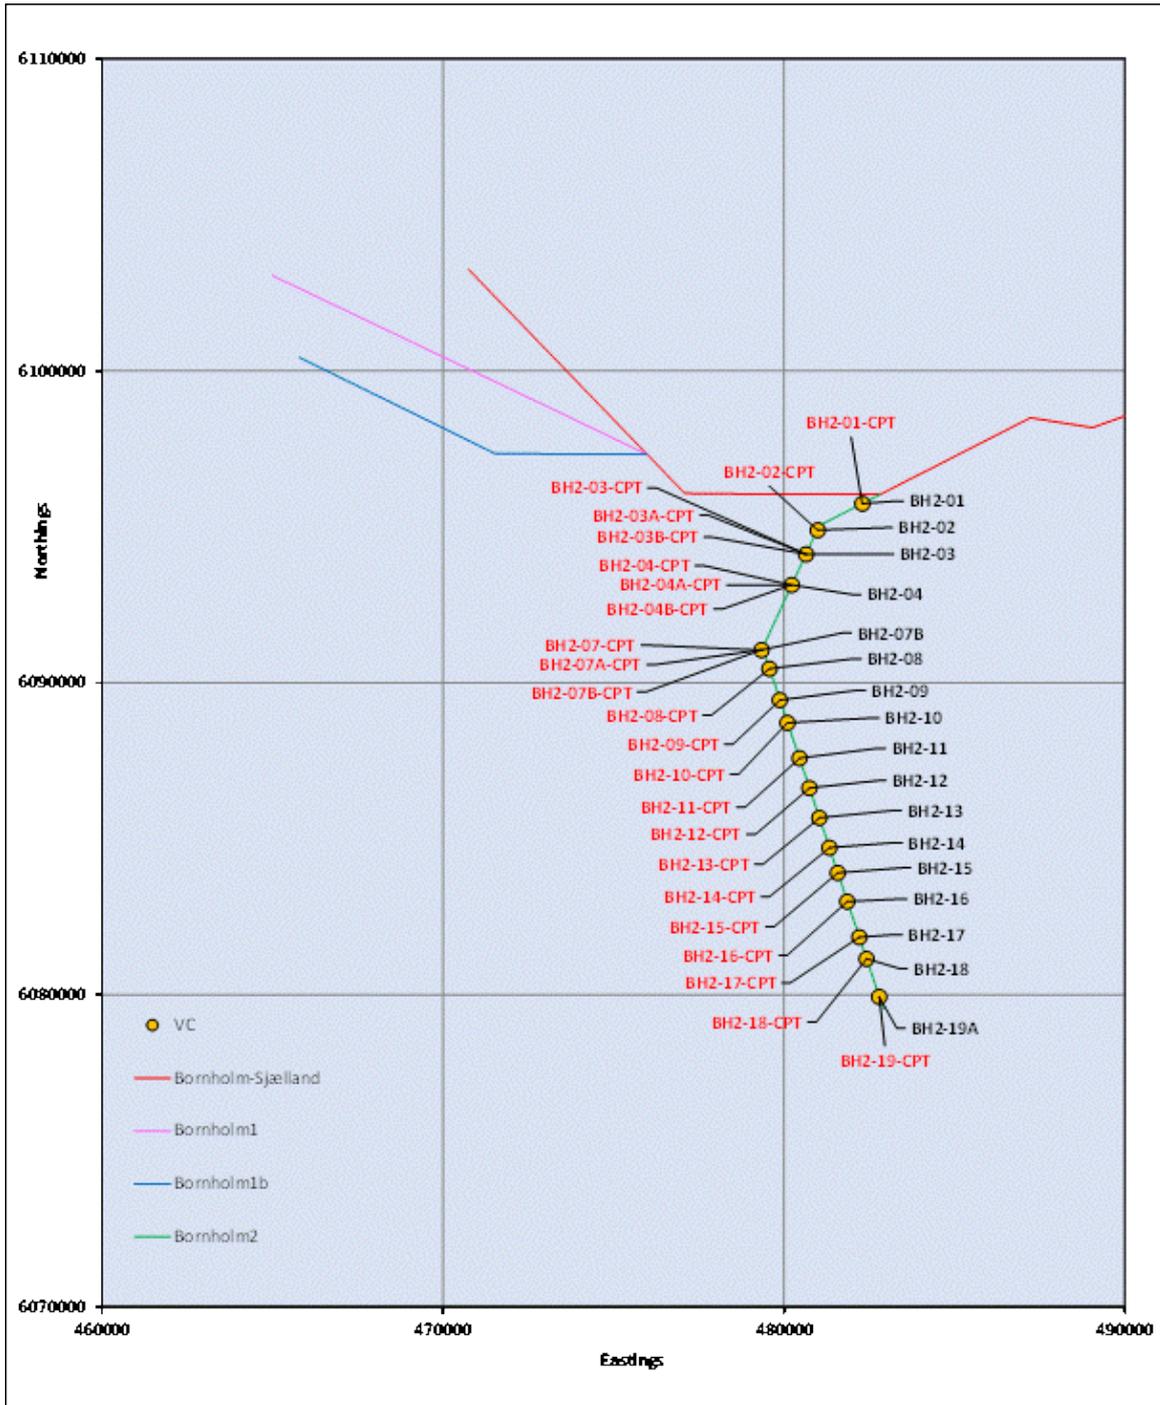
Figure 148 Geotechnical locations on the BH2 route, Part 1.

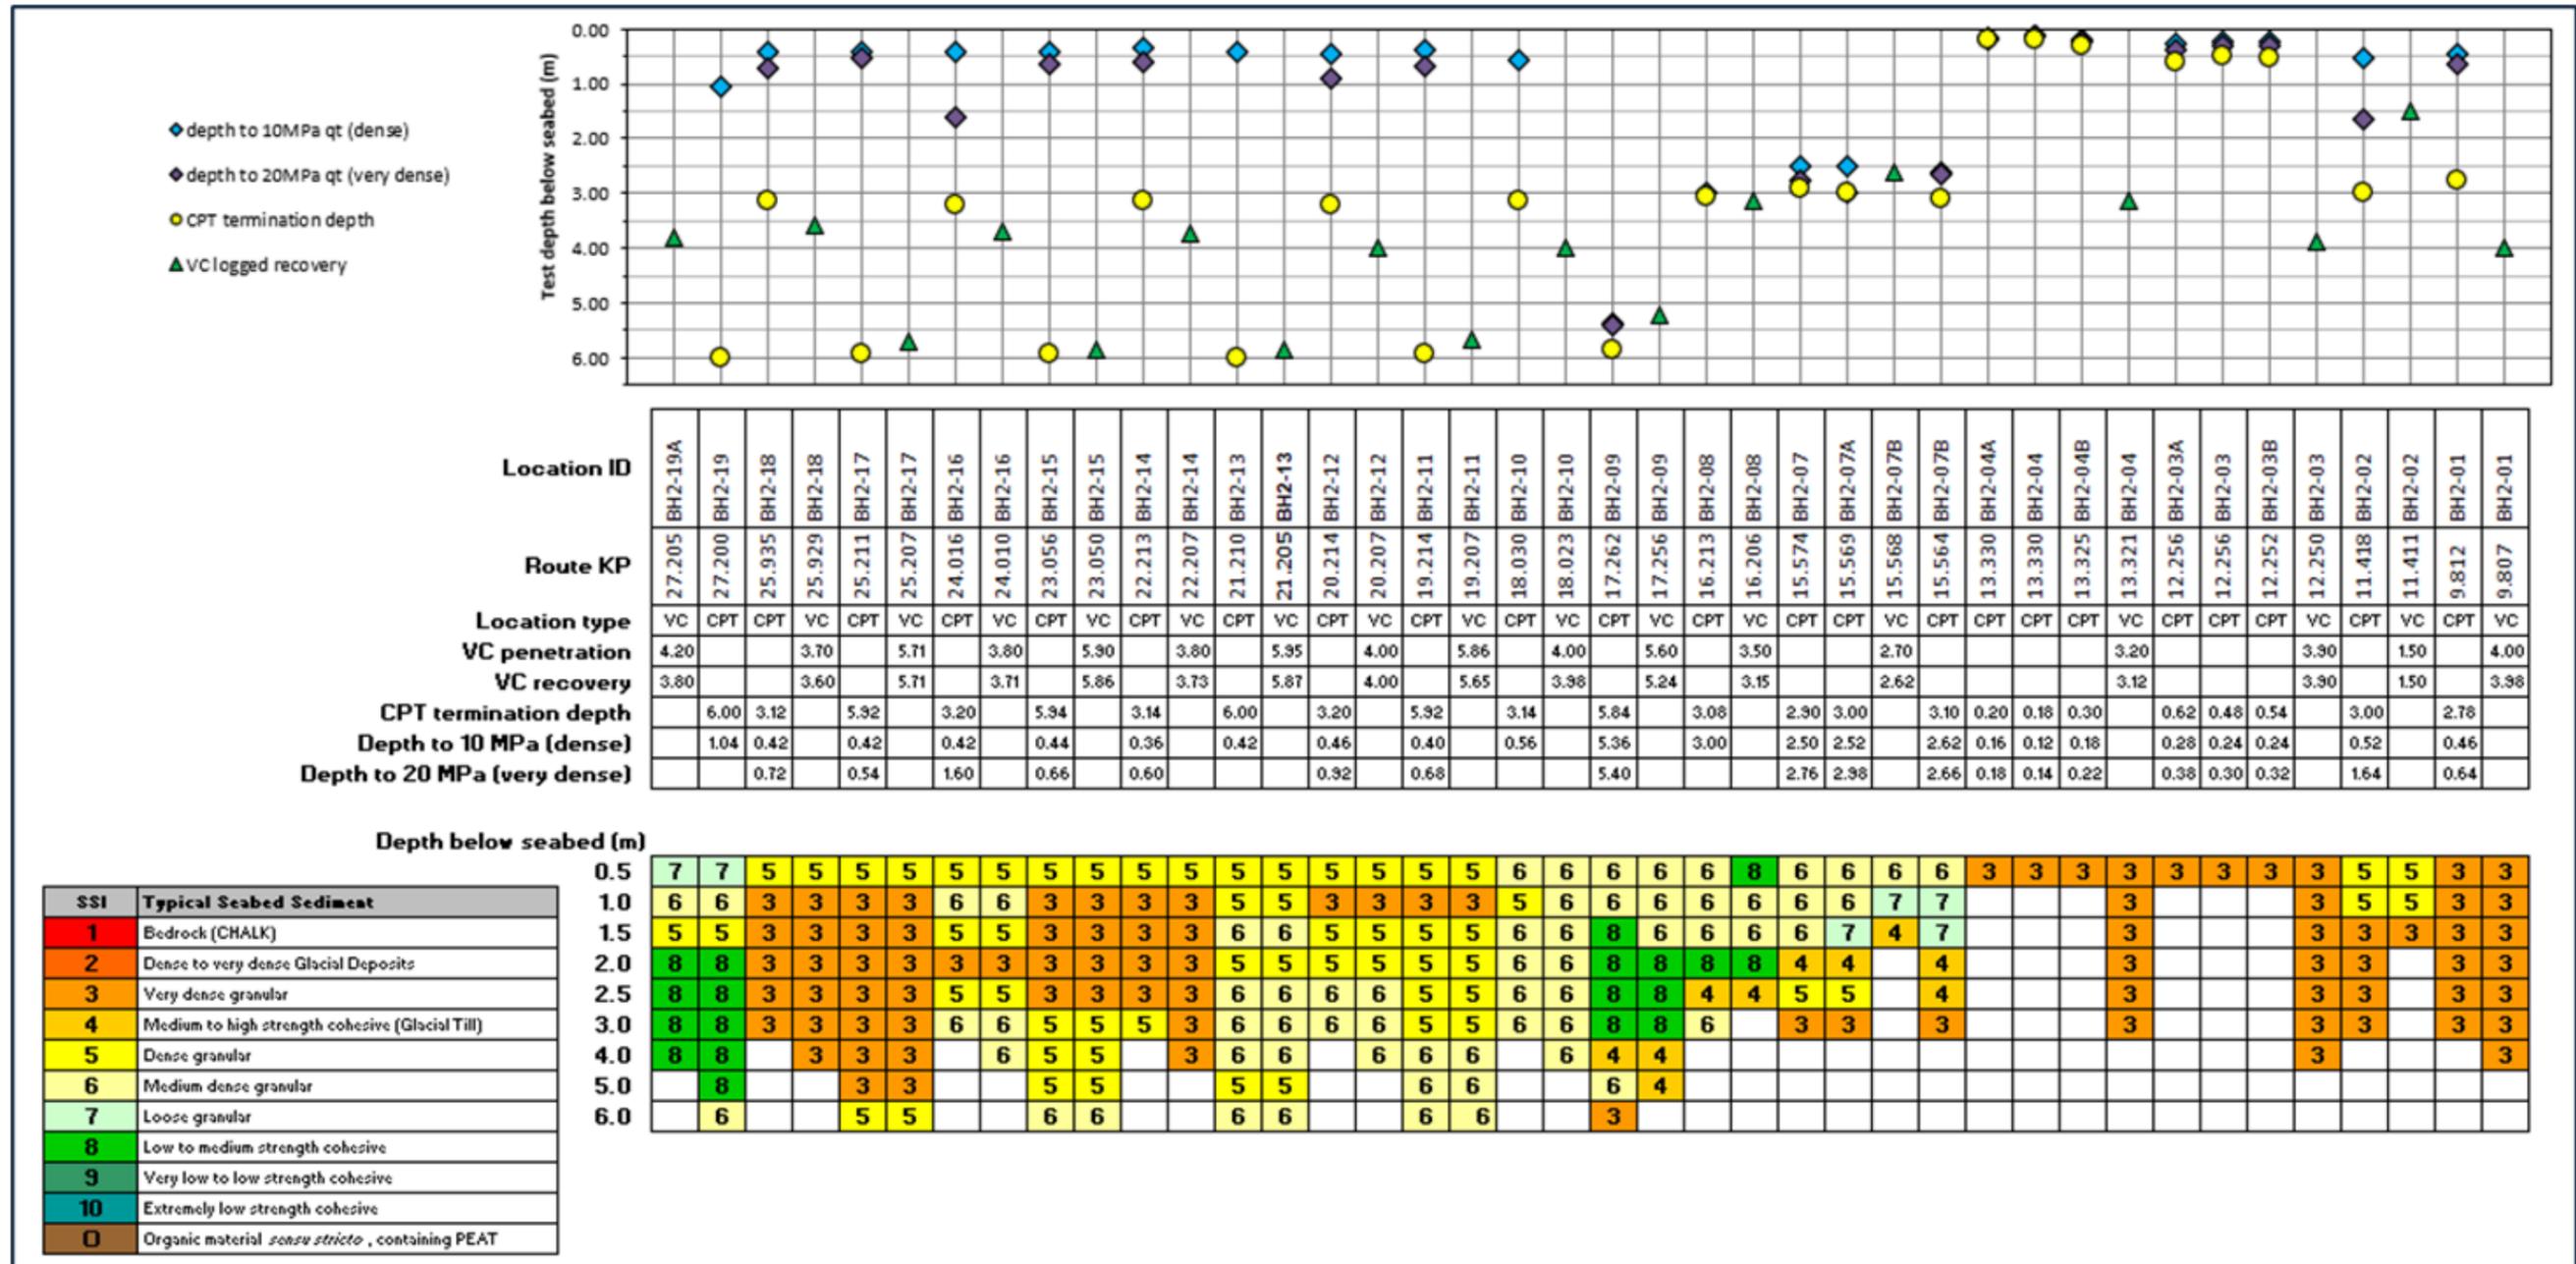
Figure 149 Seabed Sediment Index for BH2 route, Part 1.

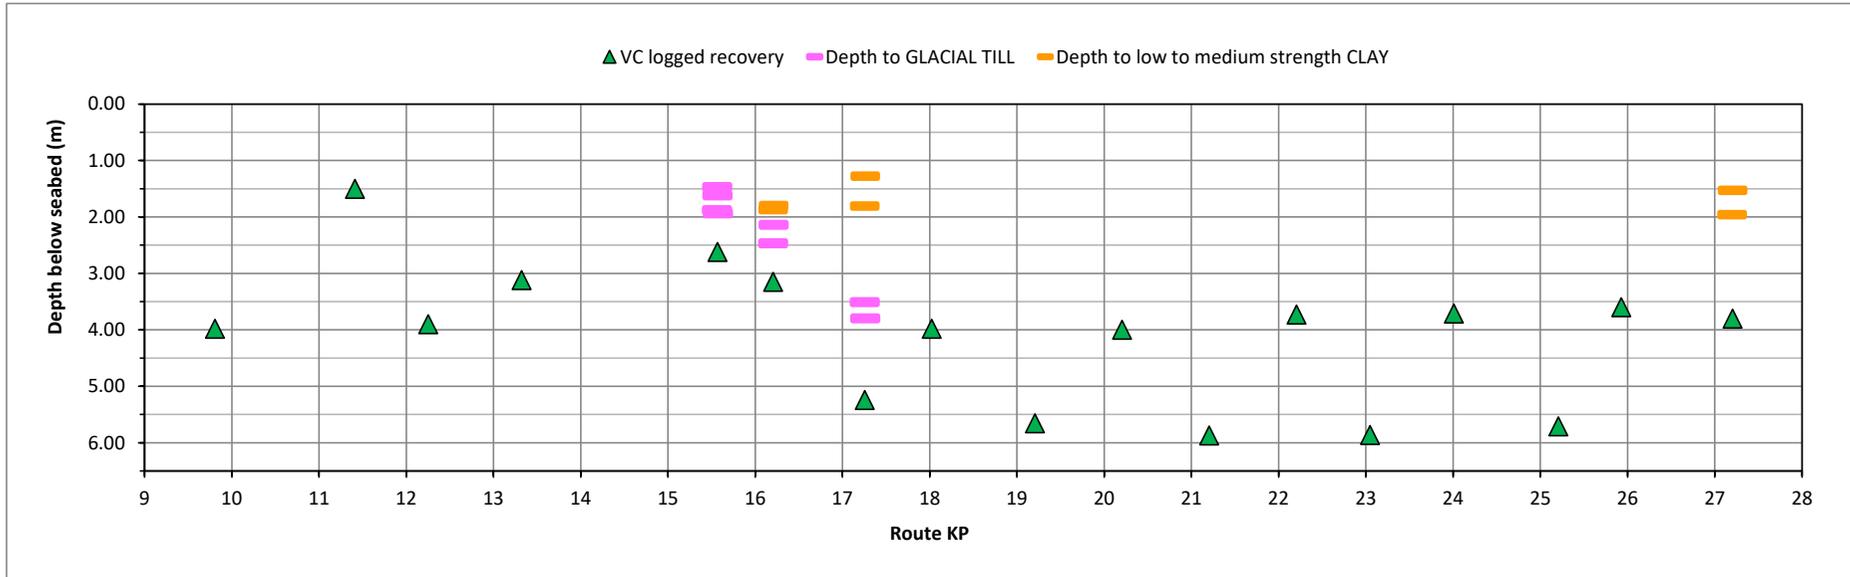
Figure 150 Plot of VC recovery and interpreted strata depths for route BH2, Part 1.
