# Energy Island Cable Route Survey Baltic Sea

Danish Baltic Sea  
April - August 2022

**DOC NO.**  
103971-ENN-OI-SUR-REP-SURVLOT1-VO

### Baltic Sea OWF and Energy Islands LOT1 Cable Route Survey Overview

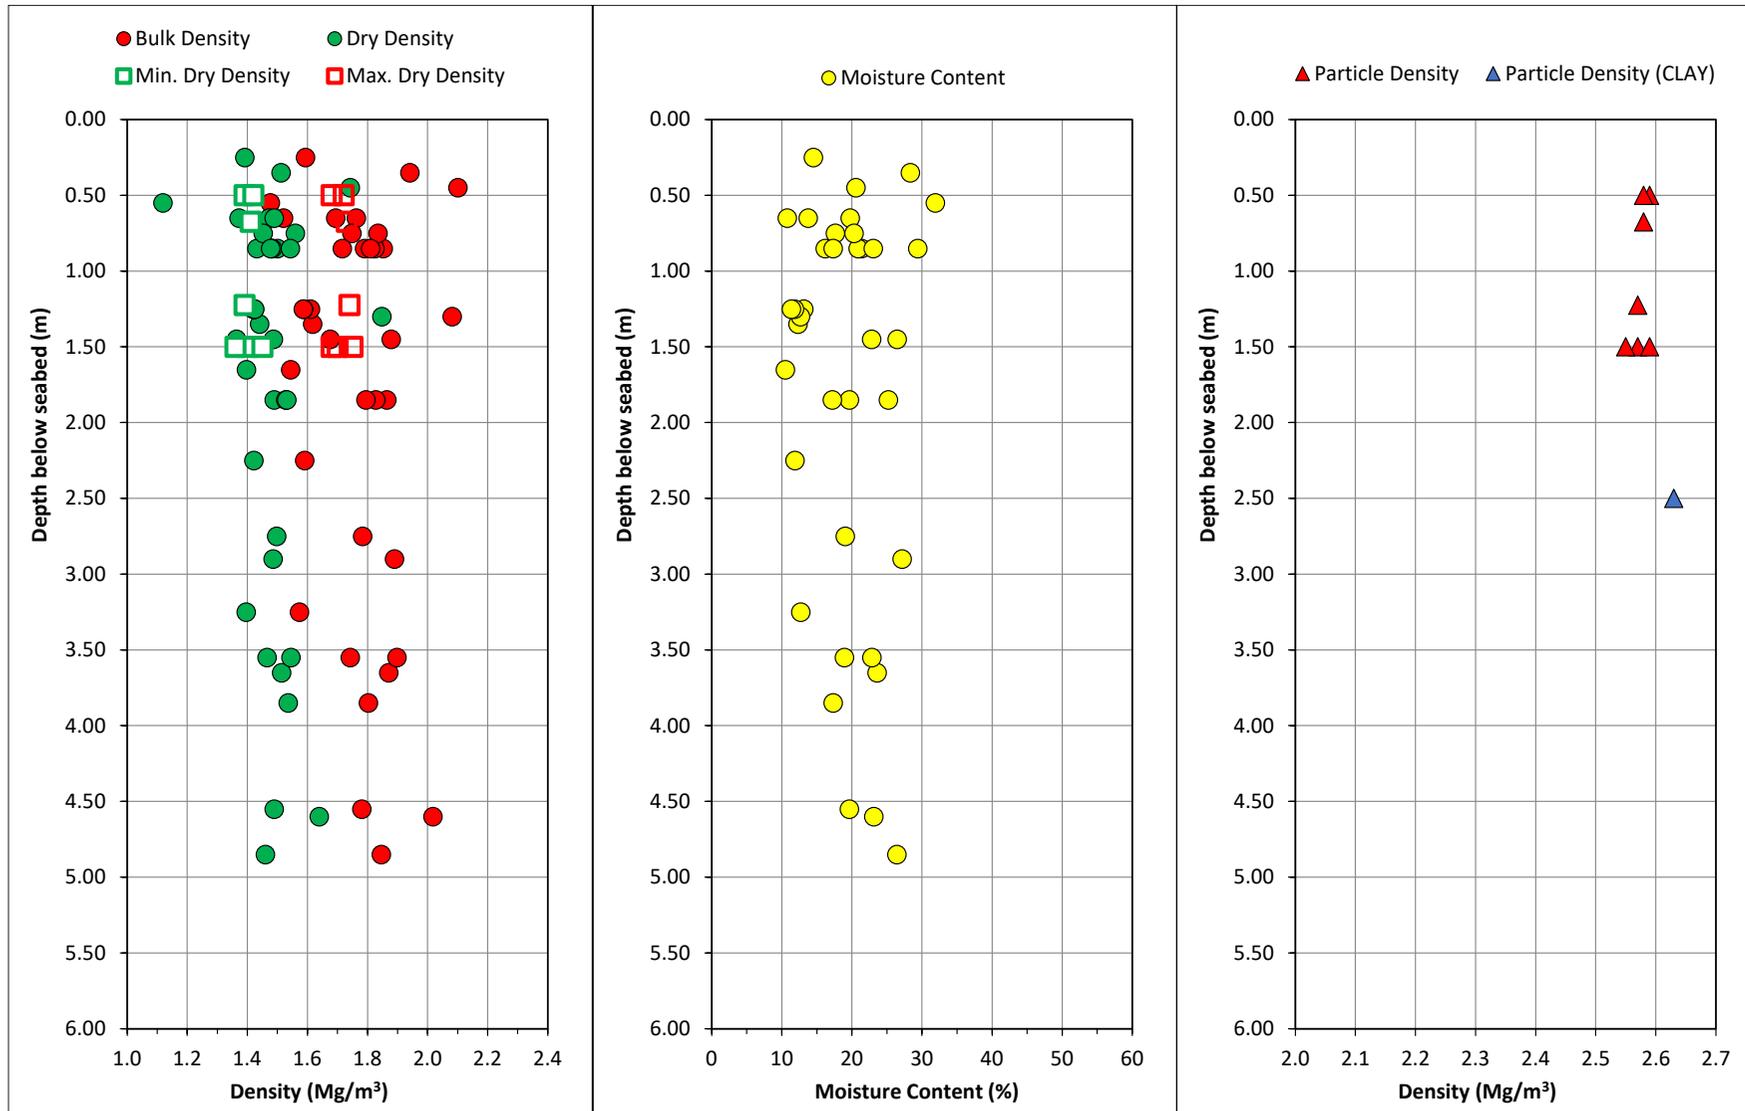
Figure 153 Laboratory test data for granular material, route BH2, Part 1.

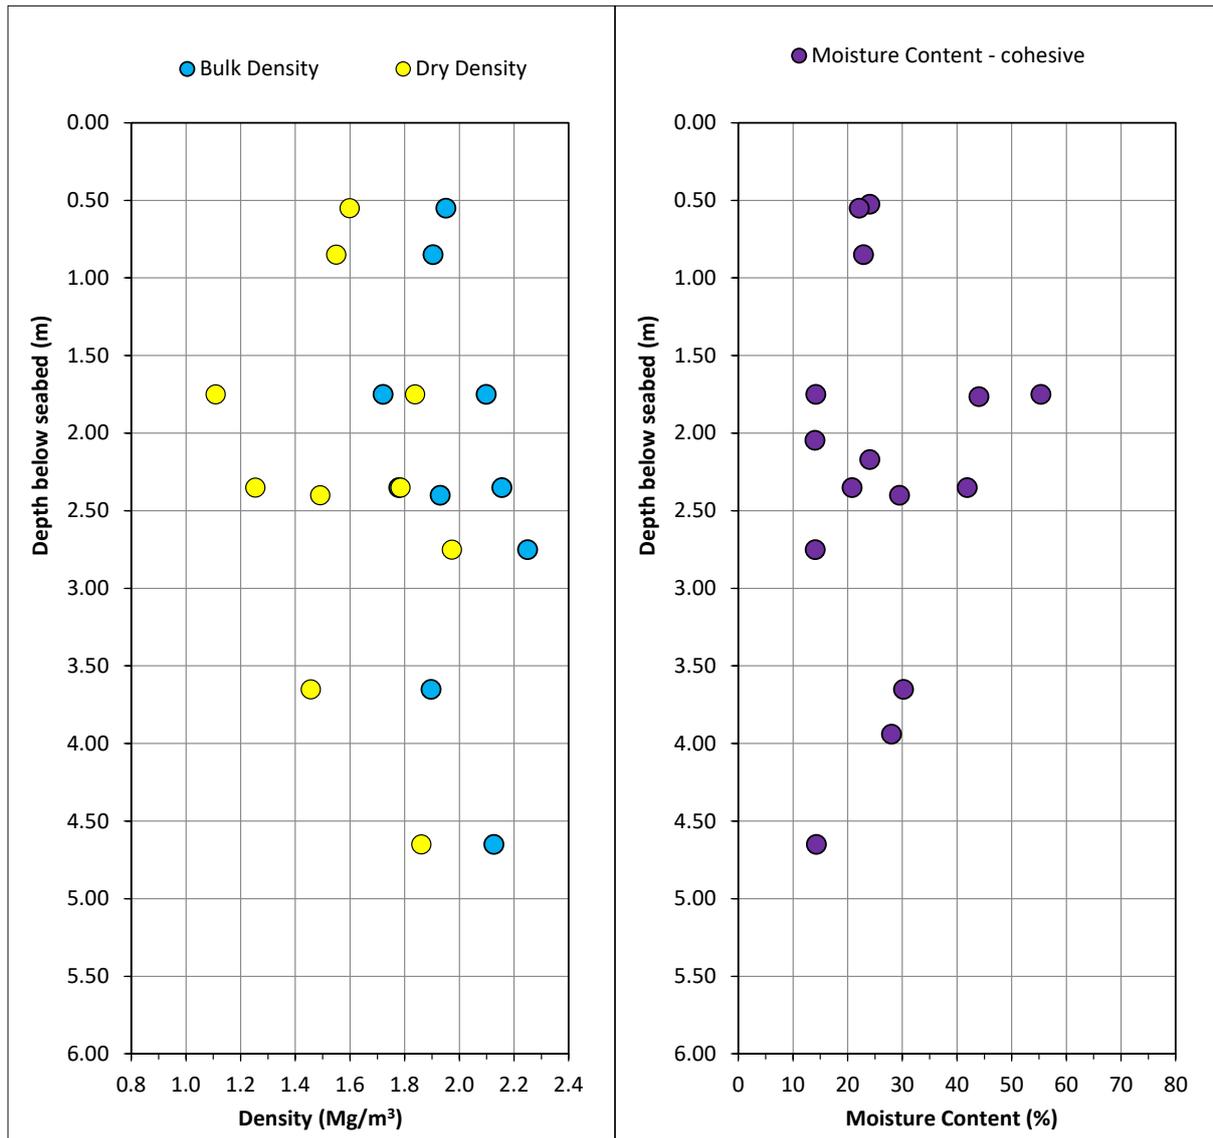
Figure 154 Laboratory test data for cohesive material, route BH2, Part 1.

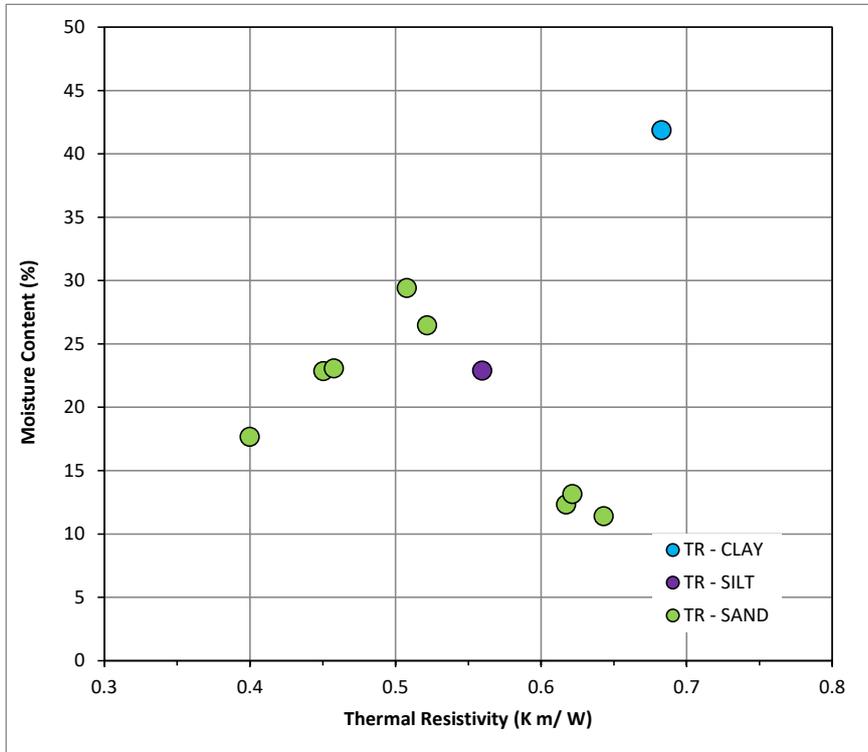
Figure 157 Summary of thermal data for route BH2, Part 1.

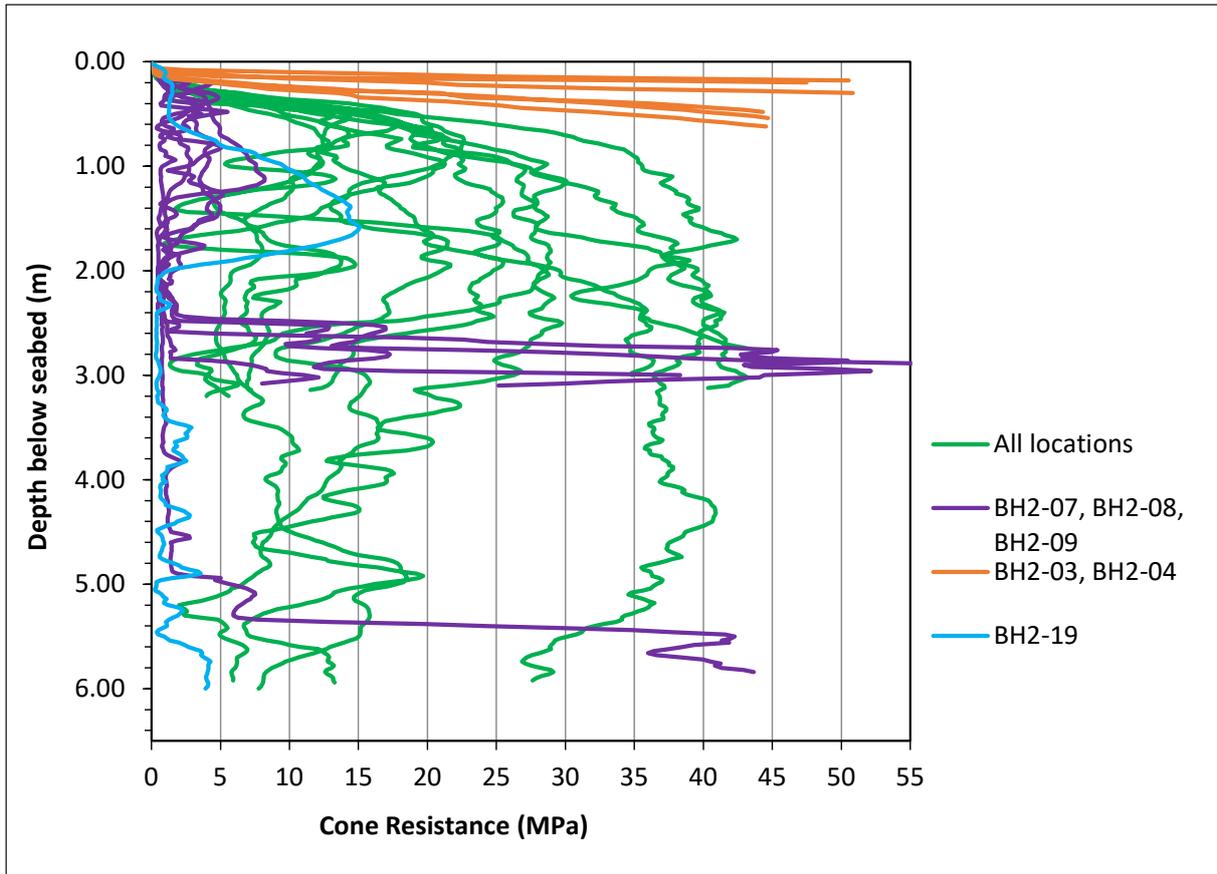
Figure 159 Plot of cone tip resistances for route BH2, Part 1.

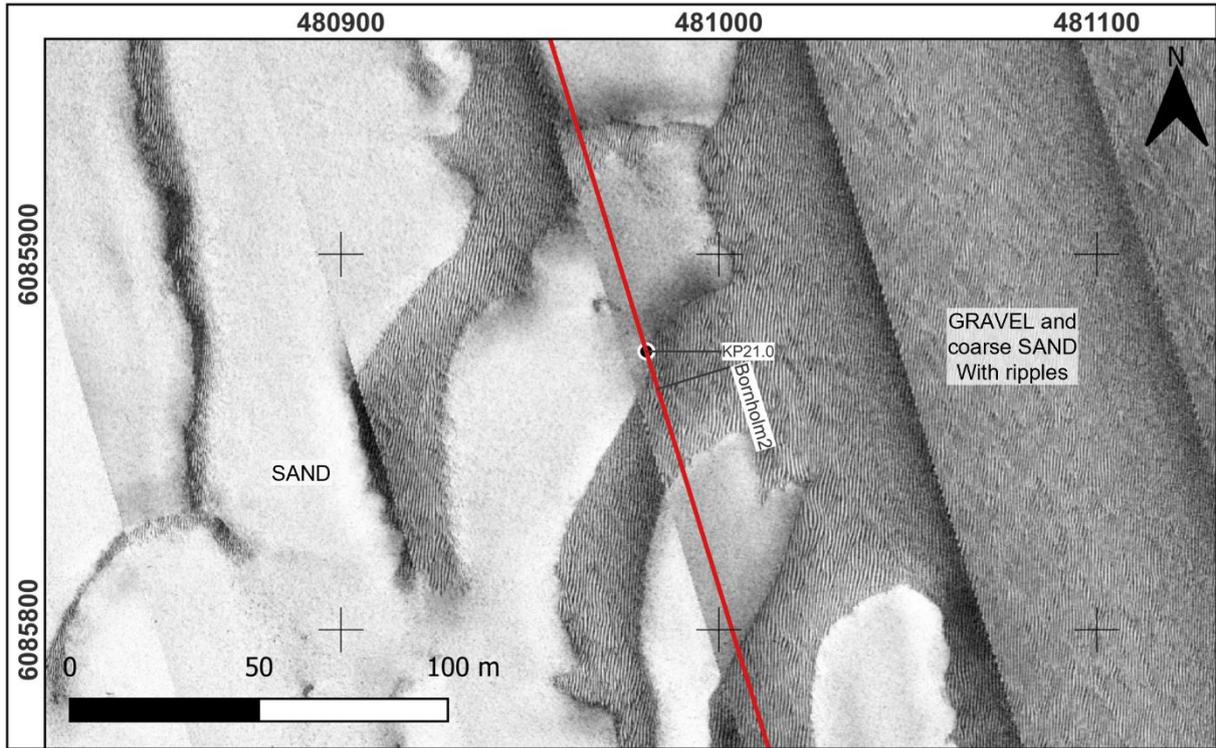
Figure 169 Overview of surficial geology at KP 21.0 as seen on SSS.

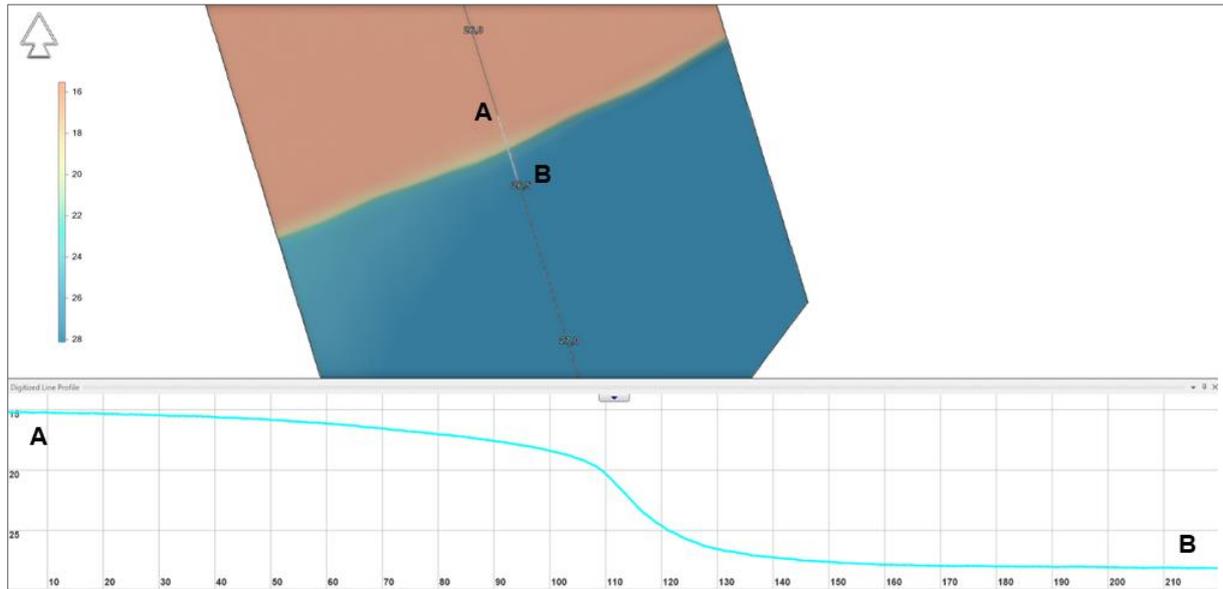
Figure 174 Showing very steep slope at KP 26.5. Vertical exaggeration of profile x3.2.

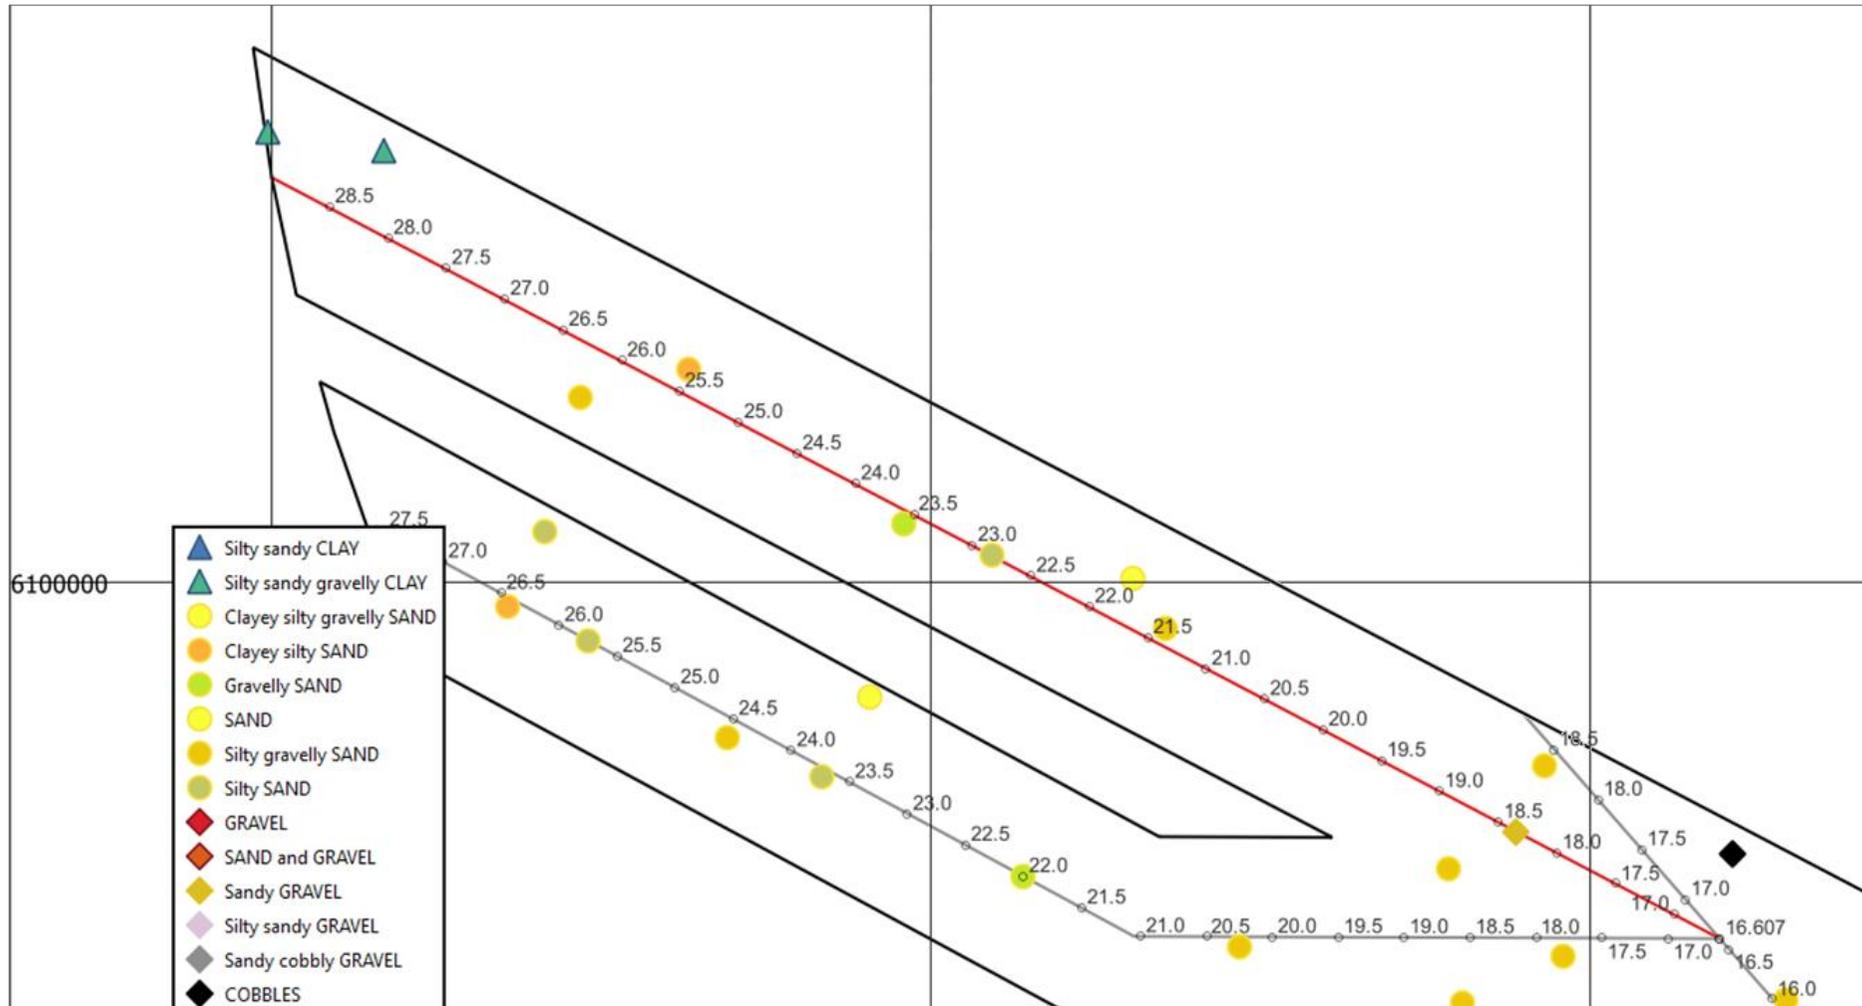
Figure 180 ERS Bornholm 1B grab sampling overview KP 16.607 to KP 27.560

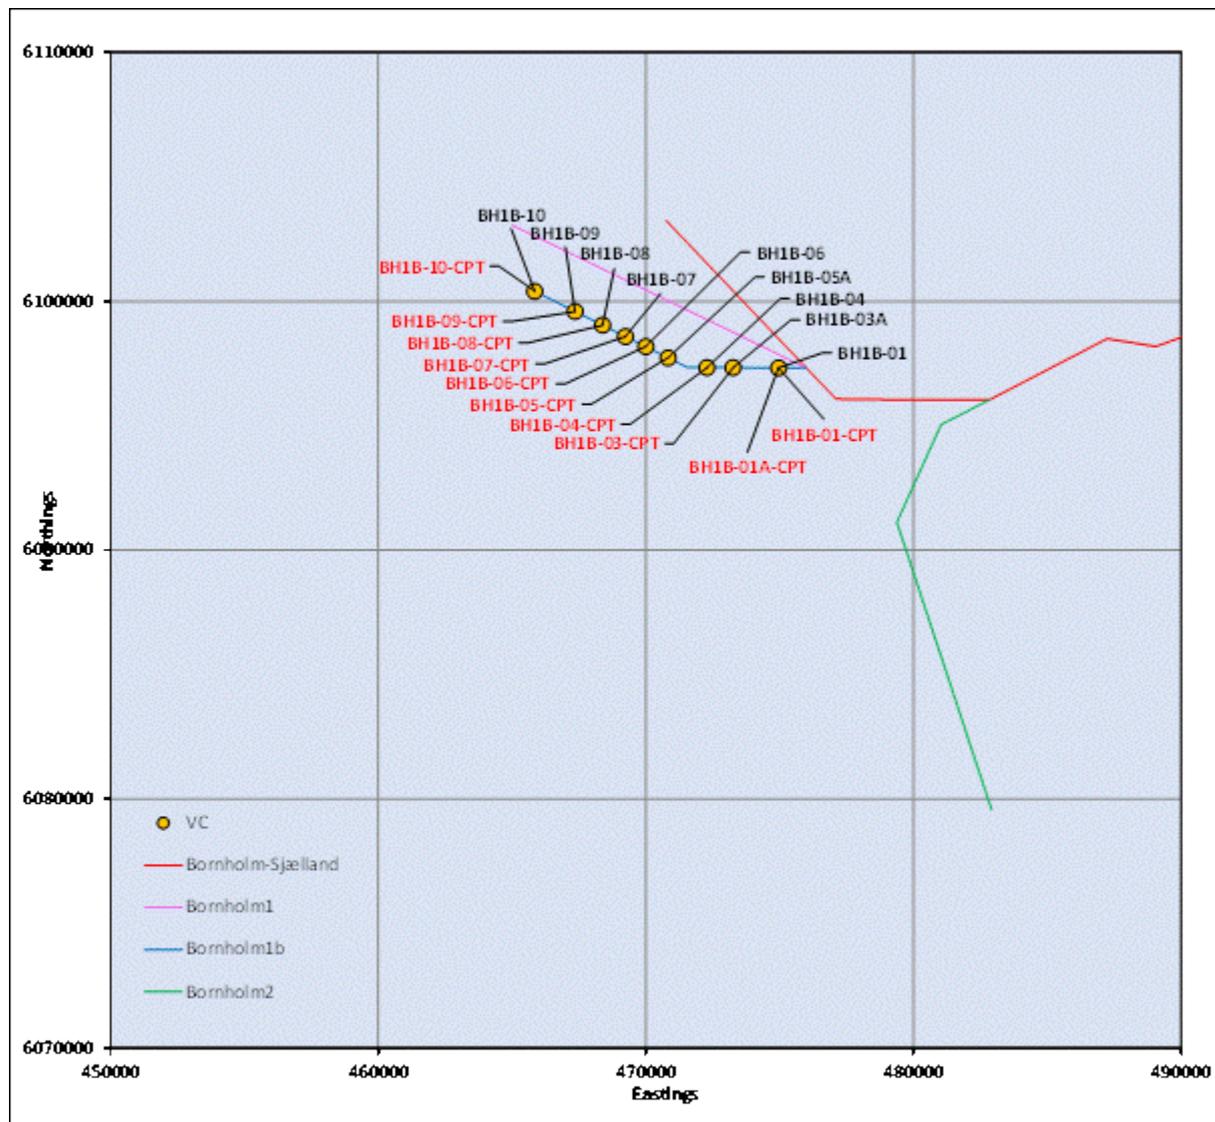
Figure 181 Geotechnical locations on the BH1B route, Part 1.

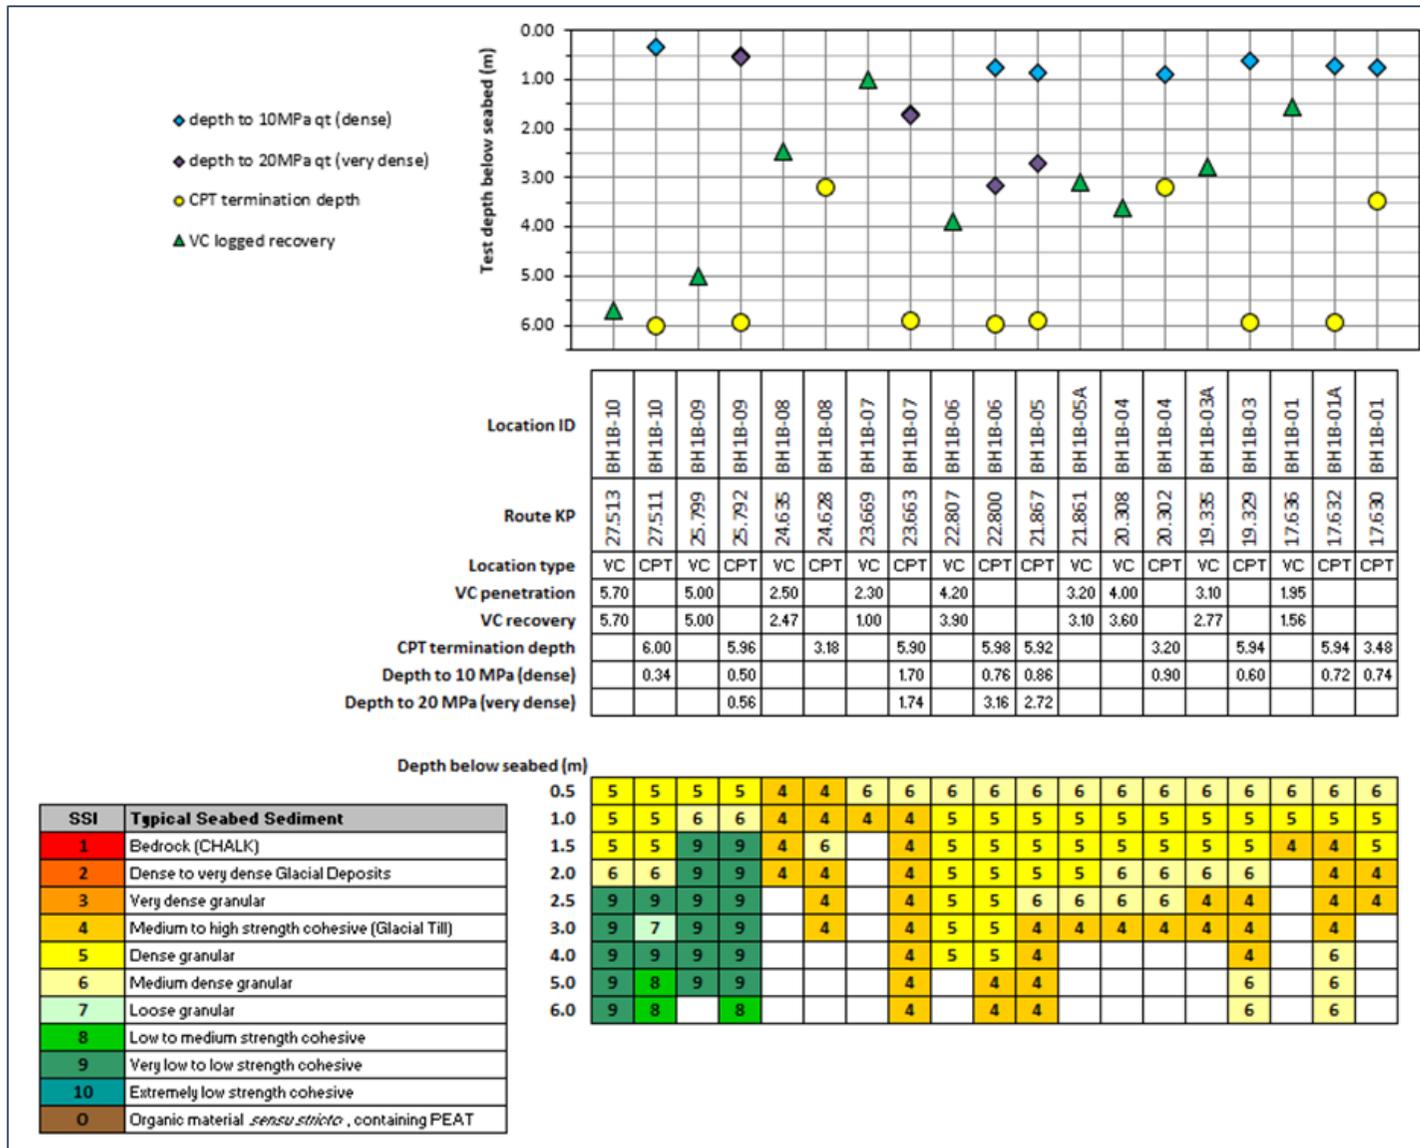
Figure 182 Seabed Sediment Index for BH1B route, Part 1.

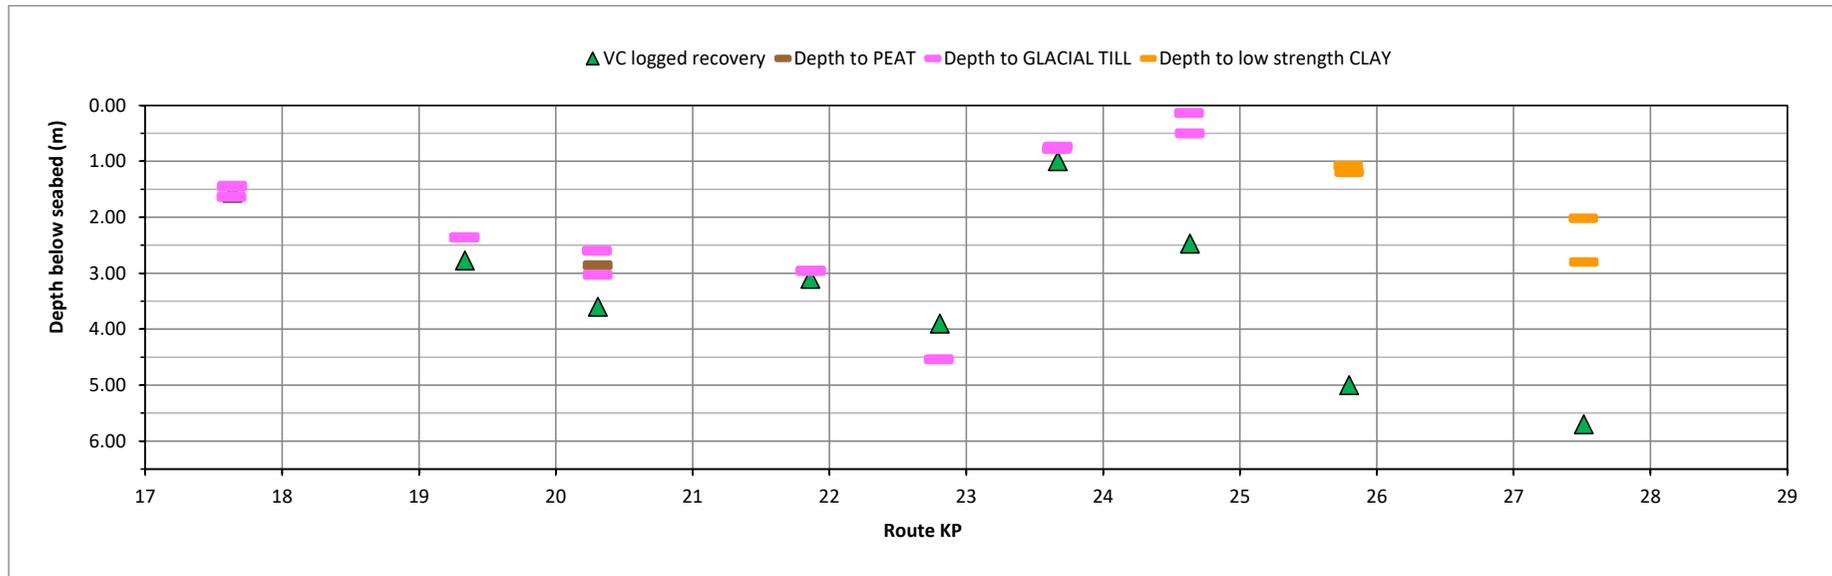
Figure 183 Plot of VC recovery and interpreted strata depths for route BH1B, Part 1.

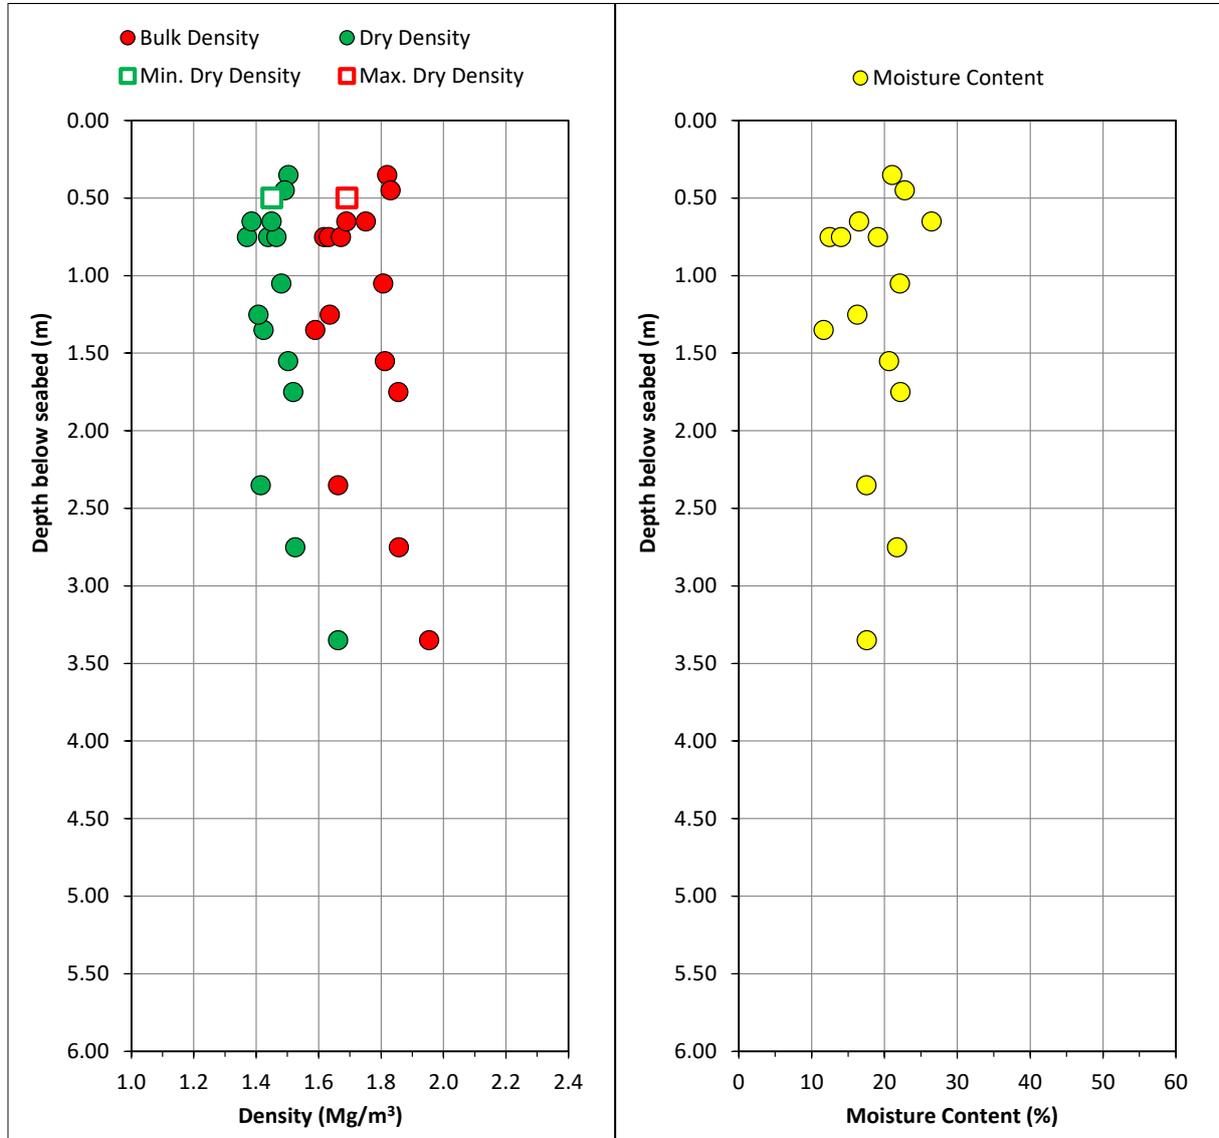
Figure 186 Laboratory test data for granular material, route BH1B, Part 1.

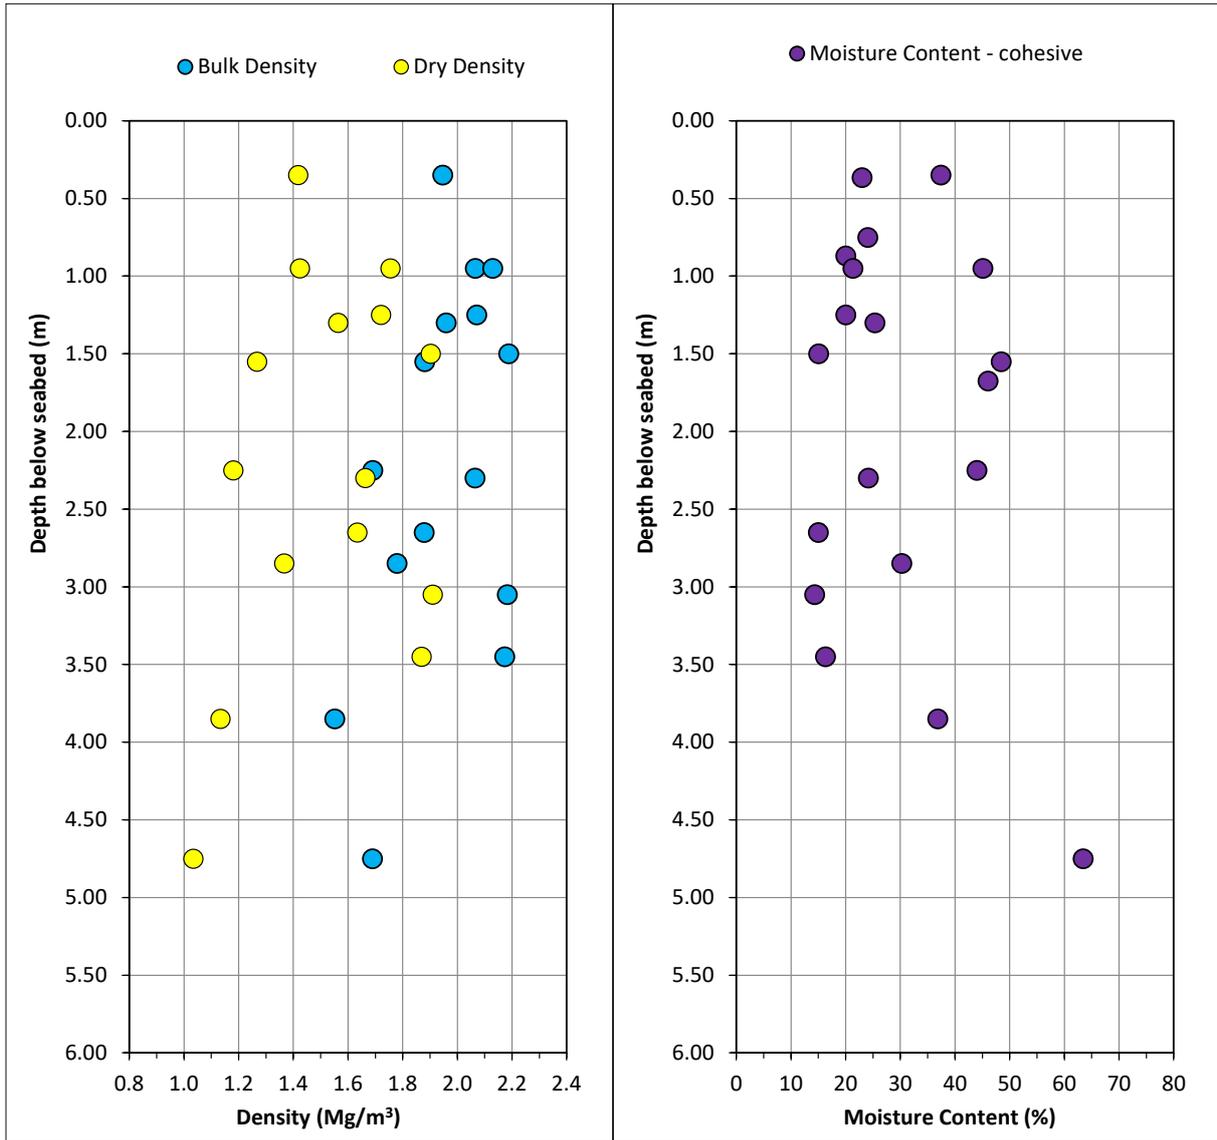
Figure 187 Laboratory test data for cohesive material, route BH1B, Part 1.

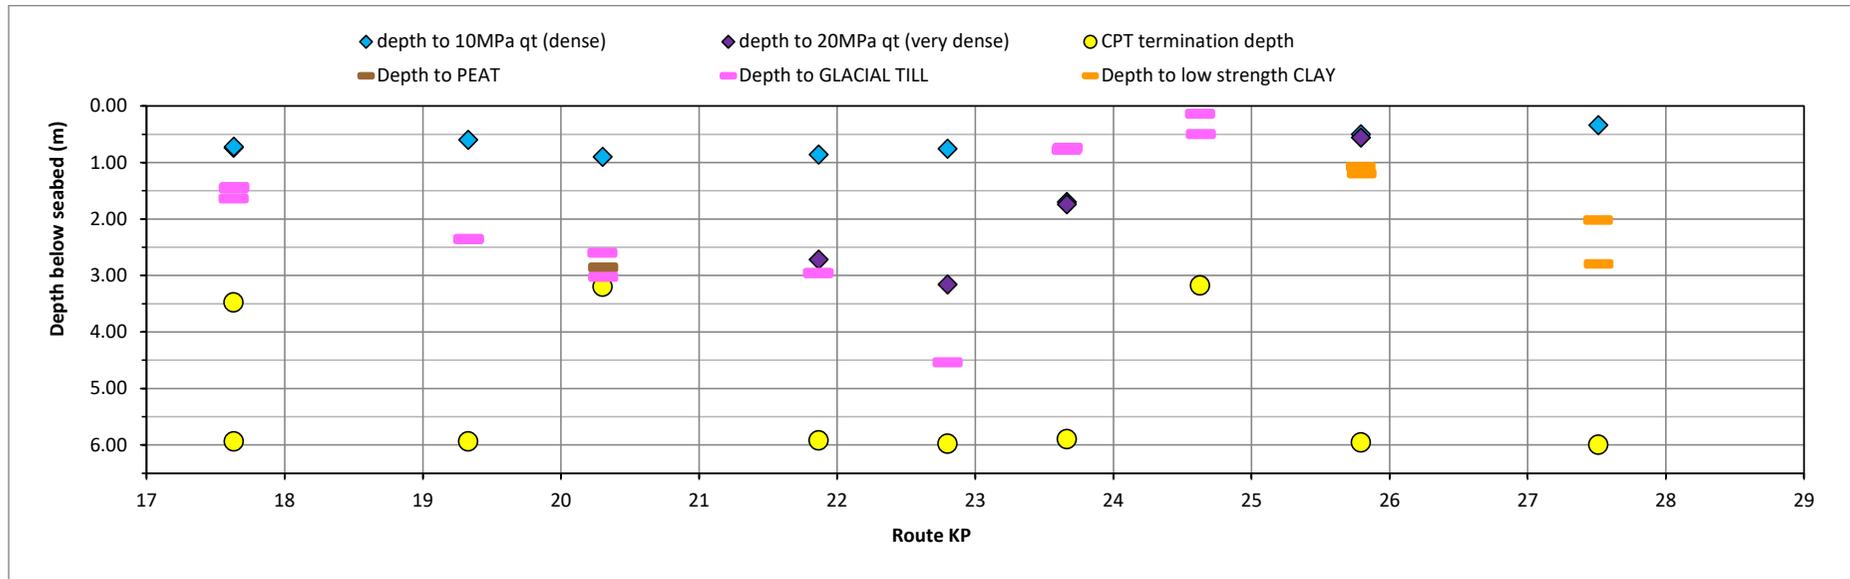
Figure 191 Plot of CPT test depths and interpreted stratum depths for route BH1B, Part 1.

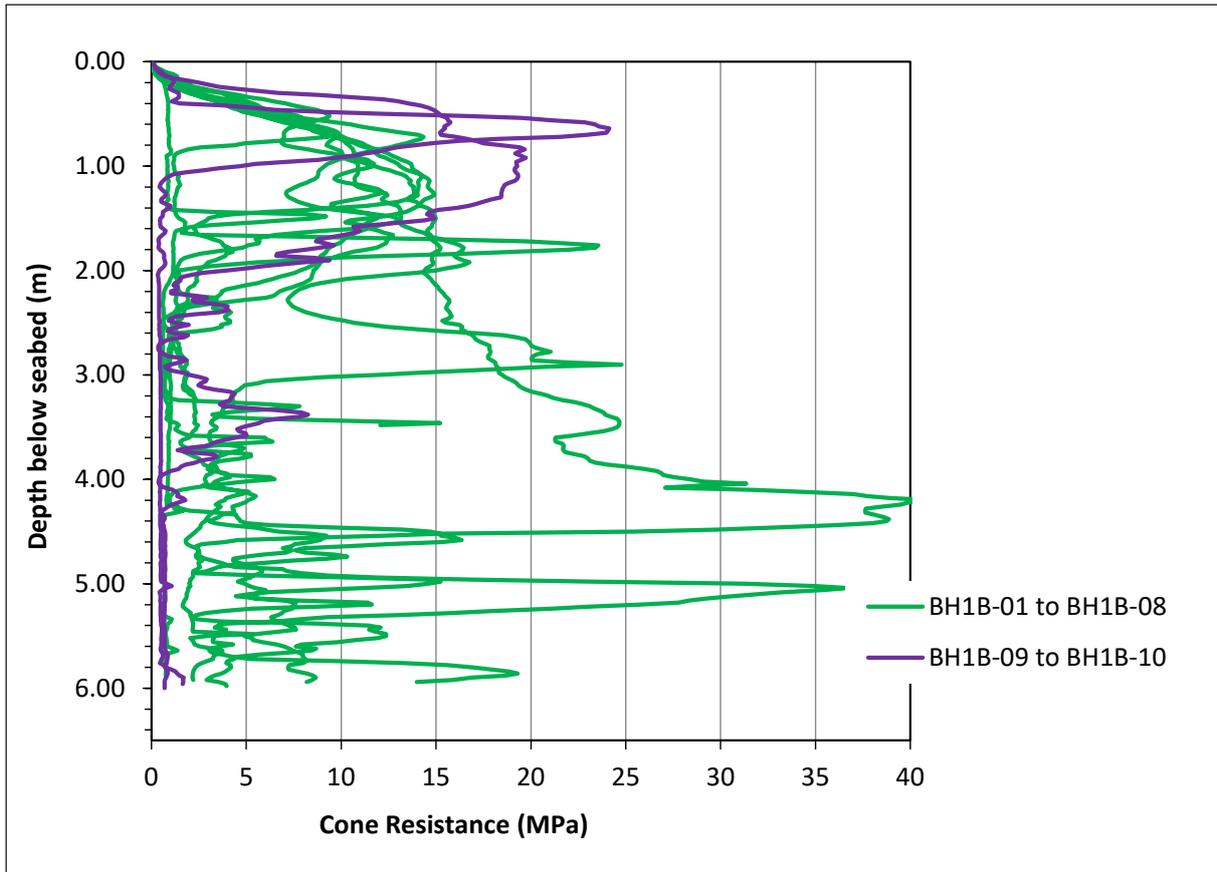
Figure 192 Plot of cone tip resistances for route BH1B, Part 1.

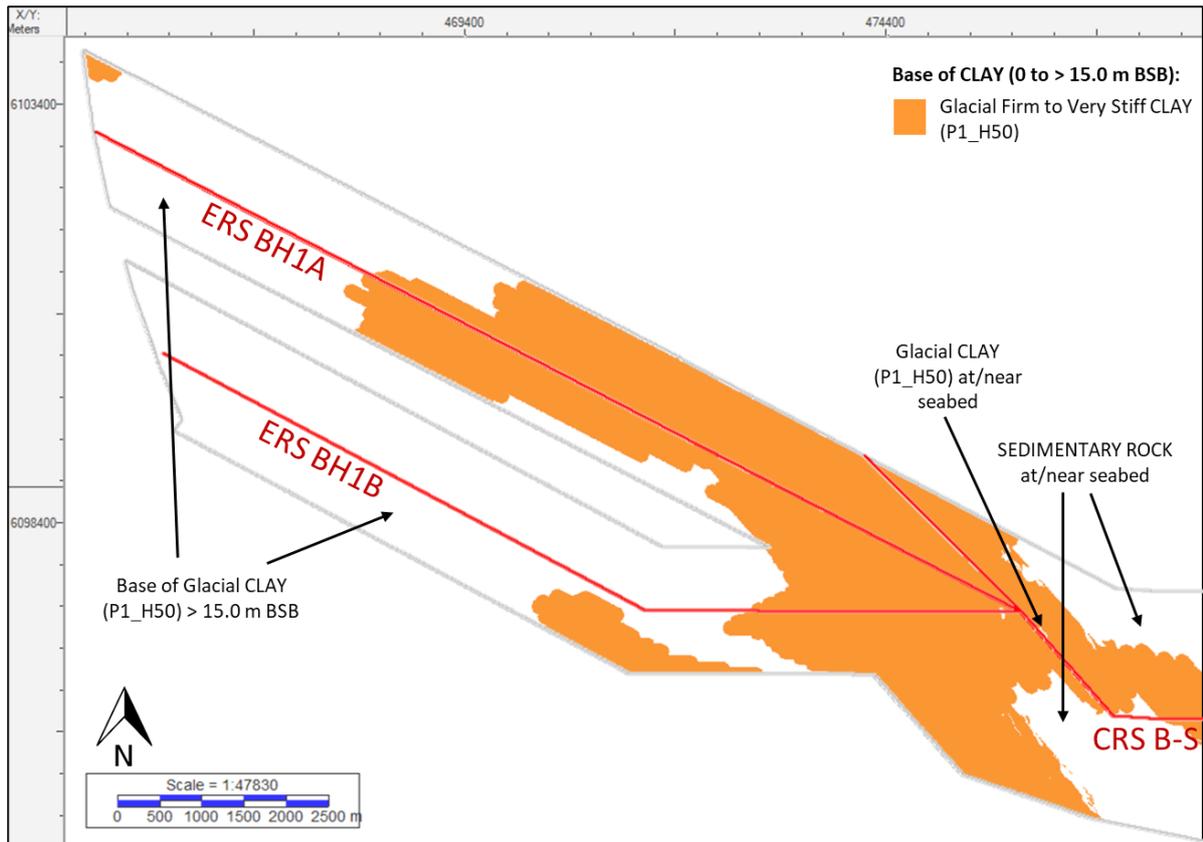
Figure 195 Overview map of the distribution of interpreted Glacial CLAY along ERS Bornholm 1B KP 16 to KP 19.

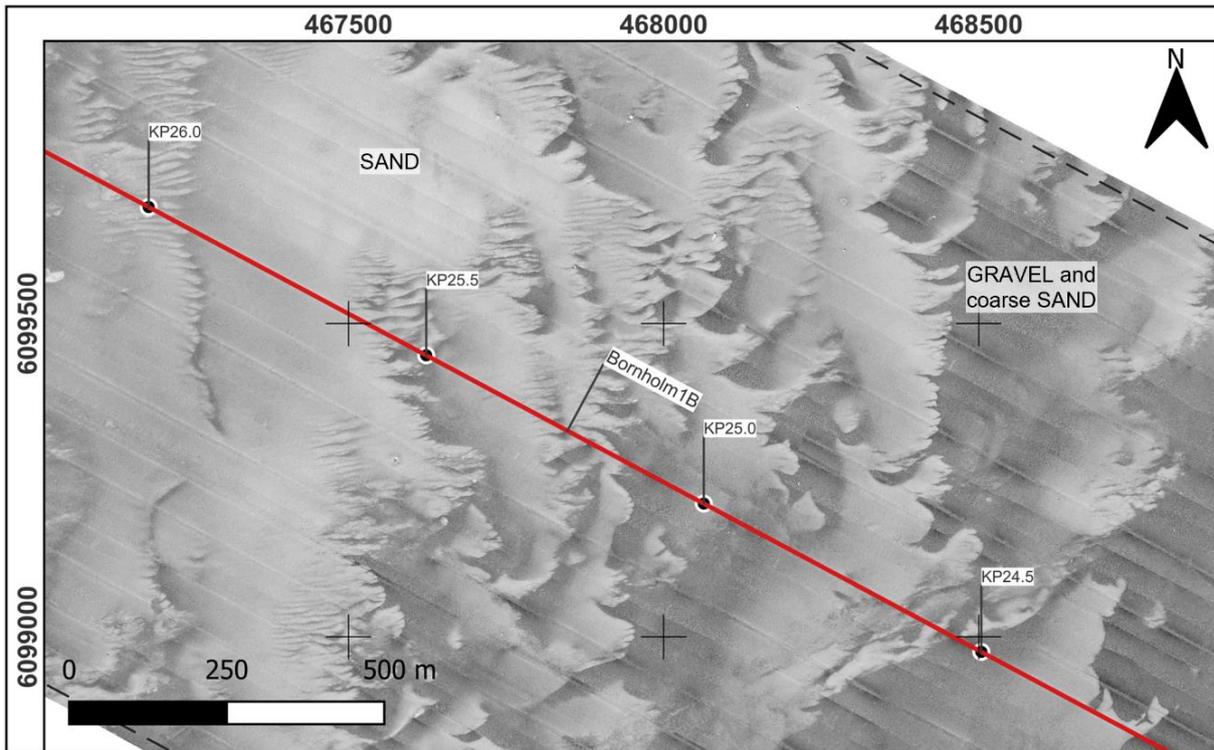
Figure 205 Overview of surficial geology from KP 24.0 to KP 26.2 as seen on SSS.
