Danish Offshore Wind 2030 – Kriegers Flak II – Rødvig – Ringsbjerg

Location 5A – Landfall Rødvig

Site Investigations for Horizontal Directional Drilling (HDD)

Geo project no. 208116
Report 72, 2024-12-20

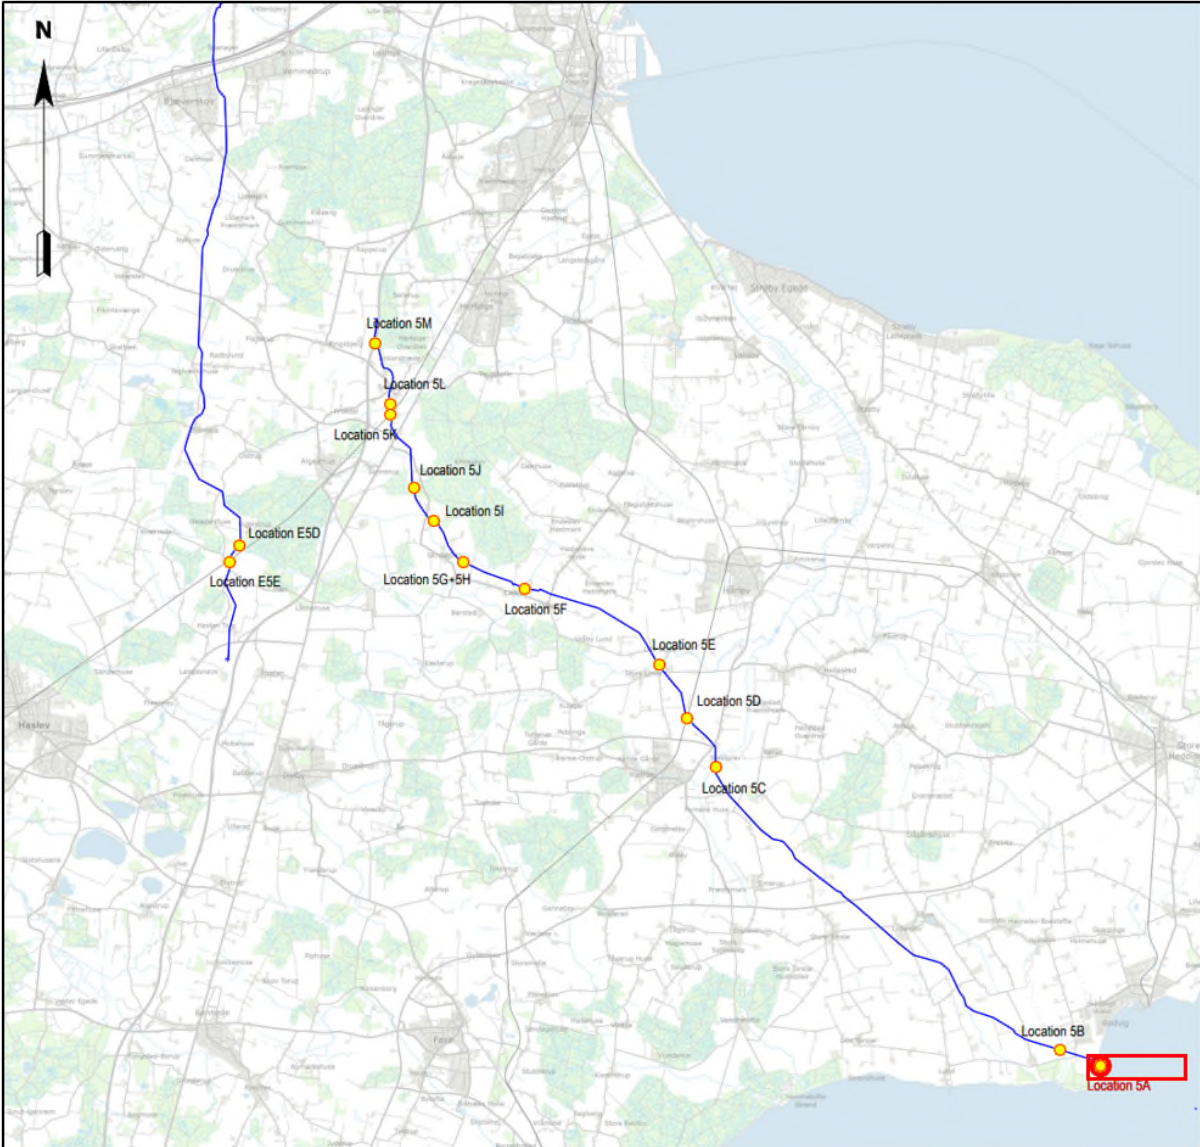
Figure 72.2: Overview map of cable route 5. Location 5A marked with red and the landfall with a red box.

This report concerns the cable route from Rødvig to Ringsbjerg (cable route 5) at location 5A as illustrated in Figure 72.2 (and in the overview map cf. enclosure 72.1.1), and at the landfall at Rødvig using HDD. The cable depth for this location 5A is - according to Energinet - approximately 5-10 m b.g.l.

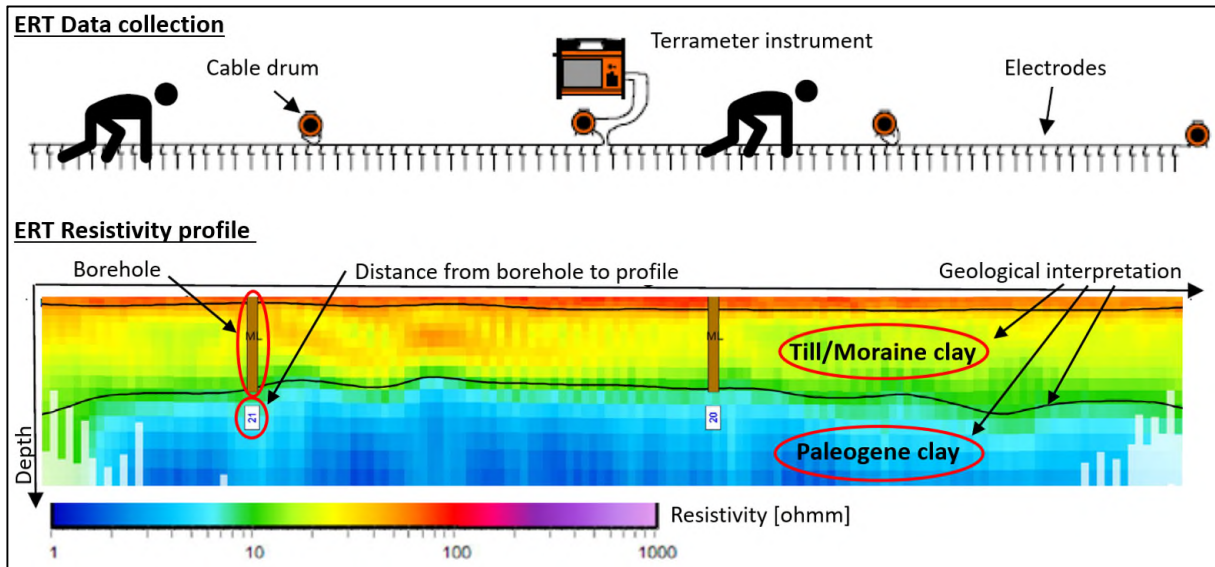
Figure 72.3: An illustration of the ERT workflow from data collection during fieldwork to the resistivity section and finally the geological interpretation.

Following the data collection process, data is imported and processed in Aarhus Workbench (version 6.9.0.0). Data are inspected and data points, either directly faulty or heavily influenced by noise, are removed. Subsequently, the complete profile is inverted by 2D inversion in two different parameter settings and layer models.

In Aarhus Workbench, the inverted resistivity models are visualised along with geological information from boreholes in the vicinity of the profile. Based on this comparison, a geological interpretation can be performed and visualized along with a geophysical model. Figure 72.3 summarizes this workflow.

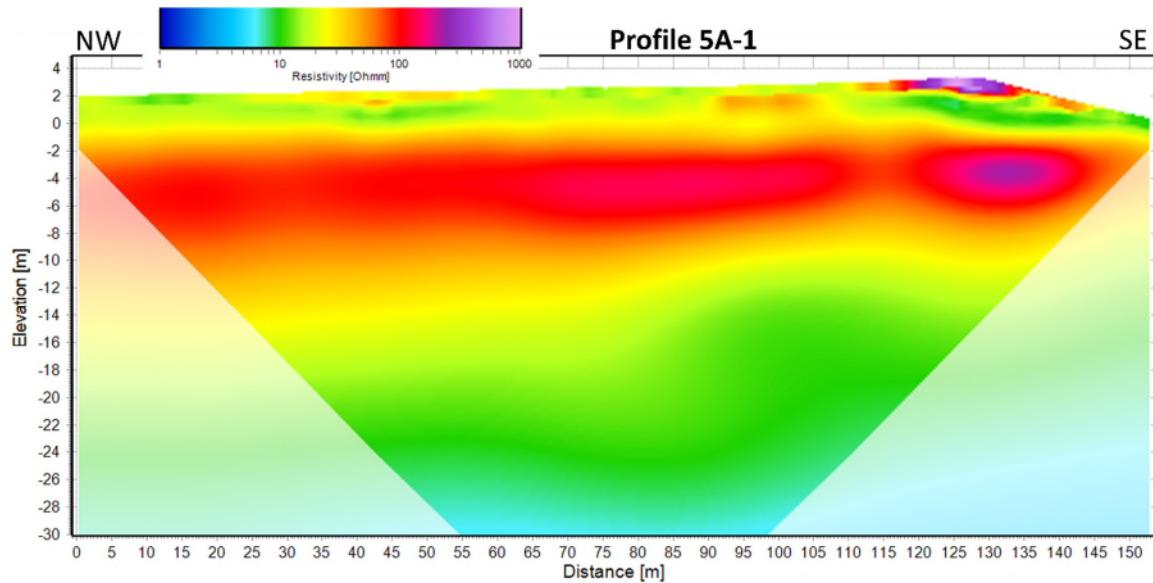
ERT profile 5A-1 (see figure 72.5 below) has a length of 155 m. Data were collected with an electrode spacing of 2.5 m. The inverted profile has a data residual of 0.81. A residual under 1 indicates that the measured data are in good accordance with the determined 2D model and subsurface structures are expected to be well resolved.

In Profile 5A-1, low resistivities (10-20 ohmm) dominate in the most shallow 2-3 m for most of the profile, however for distances of 110-145 m high resistivities of 100-500 ohmm are seen on top of the low resistivity layer. Underneath, resistivities of 100-200 ohmm are seen throughout the profile in the interval between elevations of -2 down to -8 meters. From an elevation of -8 and downwards, low resistivities of 7-25 ohmm are then seen down to the bottom of the profile. The upper boundary of these resistivities gently dips towards the northwest.

Figure 72.5: ERT Profile 5A-1.

During data collection of cable route 5 there was a fair amount of precipitation resulting in generally good electrode contact while measuring.

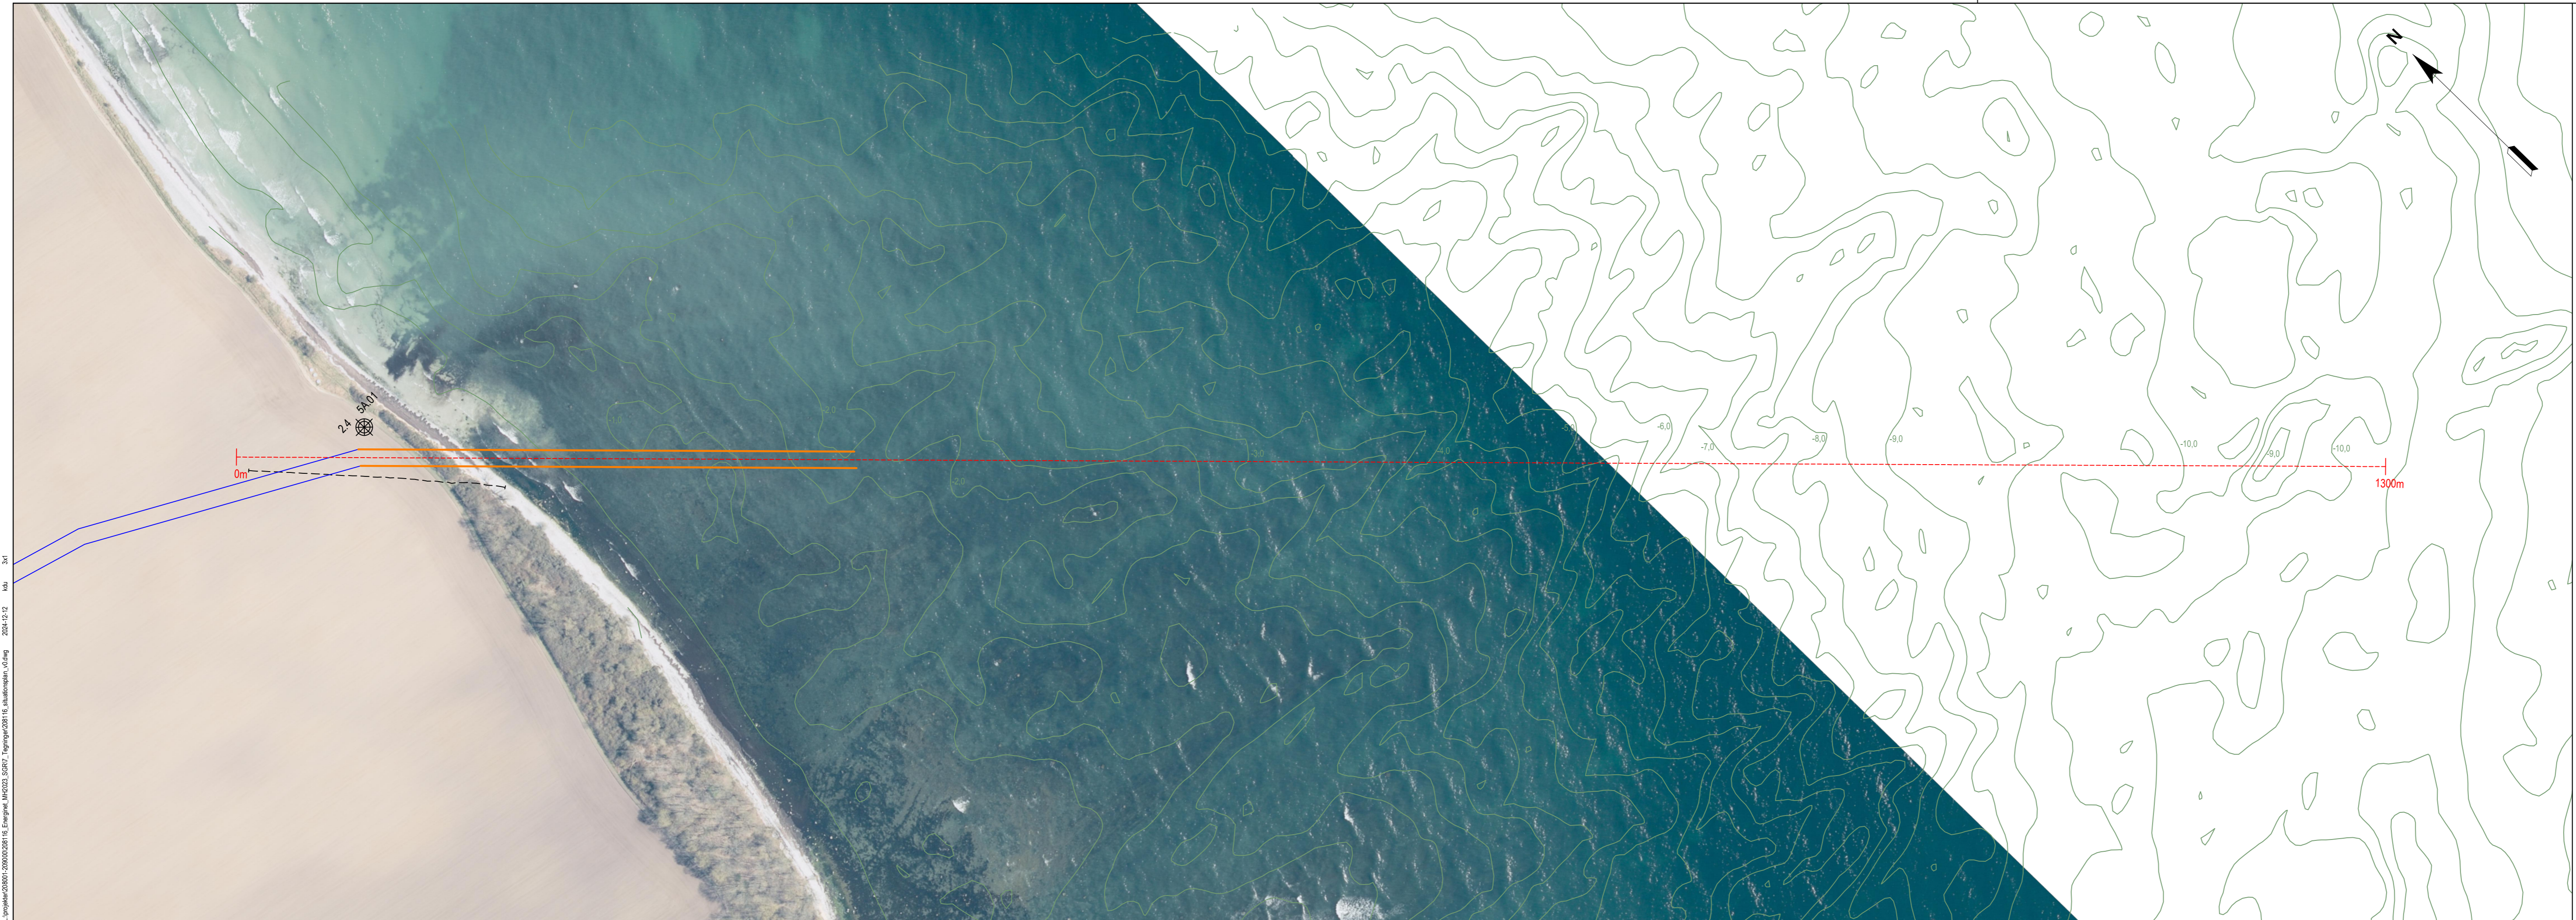
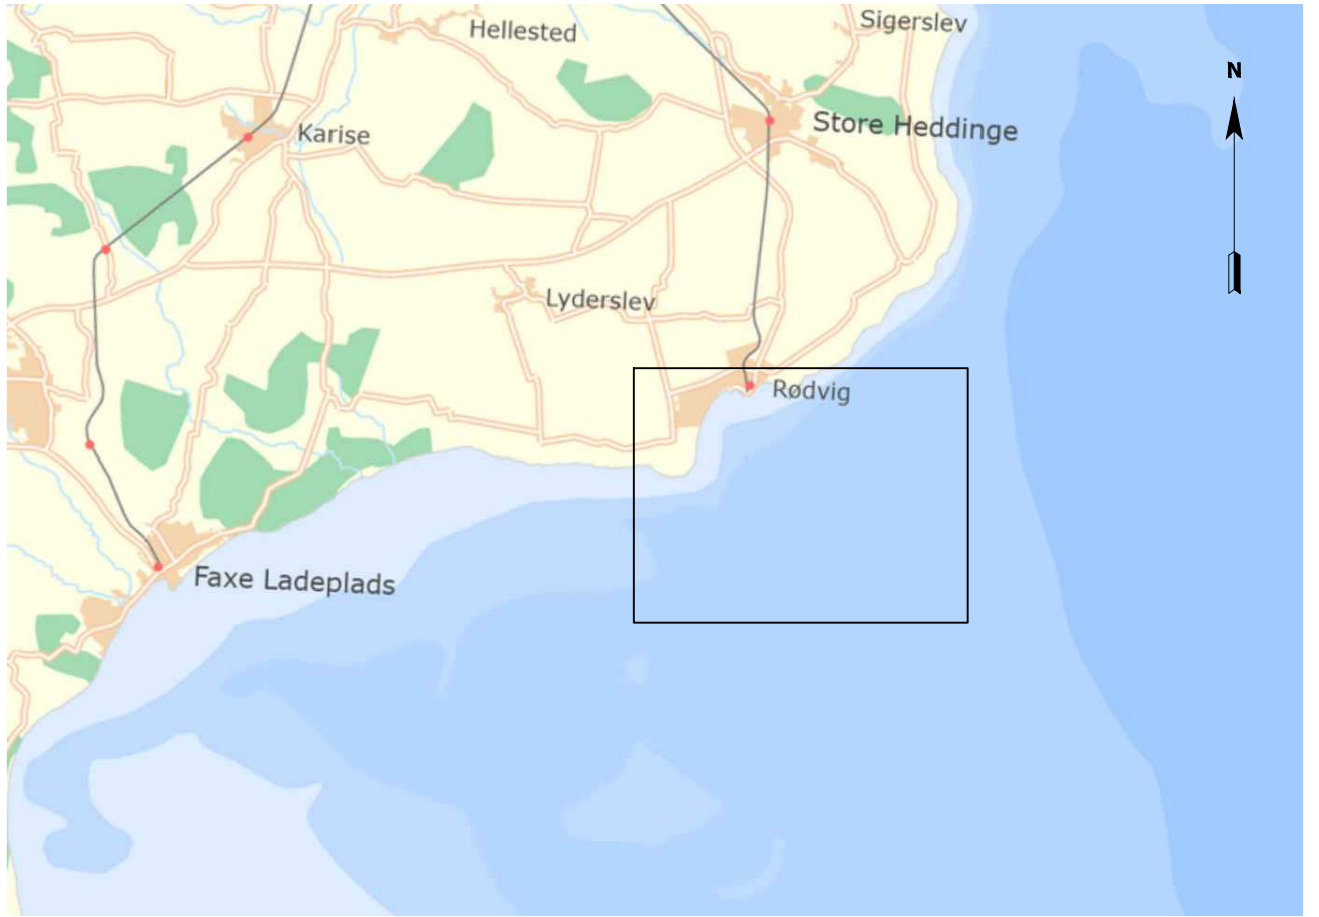
Project: 208116. Mere Havvind 2030	Scale 1:2000	Page 1 / 1
Subject: Landfall. Rødvig 5A	Report 72	Encl. 72.1.2 Rev.
Geo Copenhagen Aarhus	+45 4588 4444 +45 8627 3111

- Borehole with CPT
 - a: Point no.
 - b: Terrain level
- a: Point no.
b: Terrain level
- Planned cable route
- Planned HDD
- Location of longitudinal profile (Encl. 72.1.3)
- Seabed level 0,5 m

At the location, one geotechnical borehole has been executed. The target depths of the investigation point has been reached. The terrain level and coordinates of the investigation point has been measured using GPS in system UTM32N/ETRS89 and with DVR90 as vertical reference. The location of the point is shown on the site plan cf. enclosure 72.1.2.

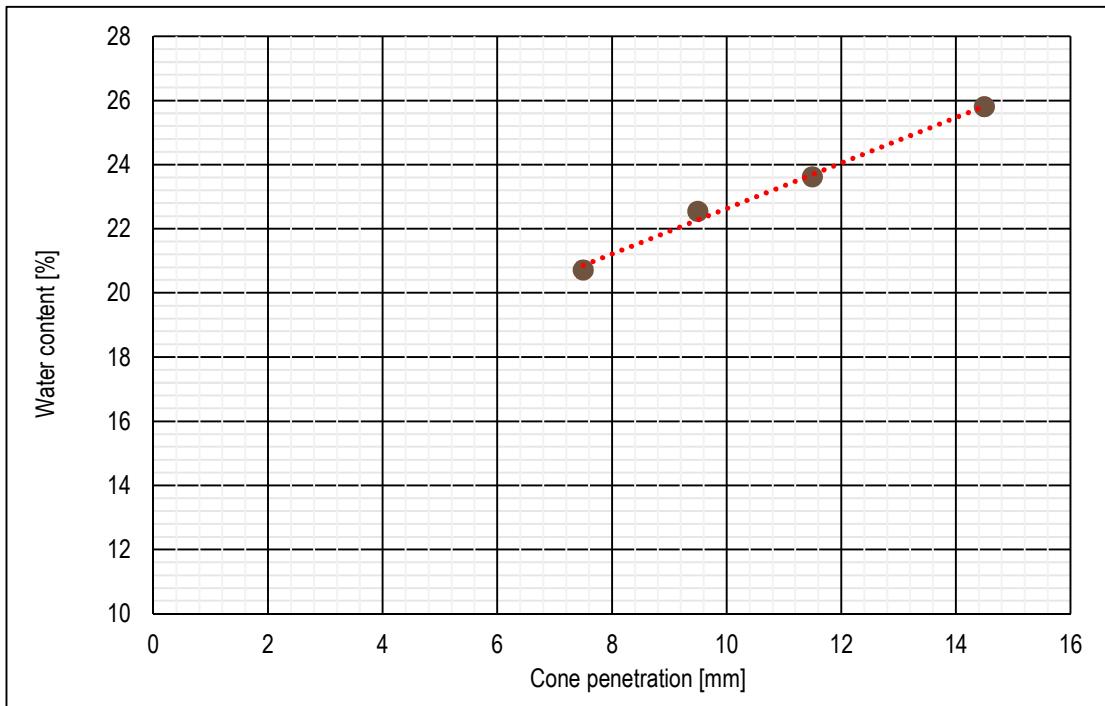
Borehole	5A.01	CLAY TILL, medium plasticity
Specimen no.	6	
Depth [m]	2,50

Initial water content	$w_{initial}$	[%]	14,7
Liquid limit	w_L	[%]	22,6
Plastic limit	w_P	[%]	11,0
Plasticity Index	I_P	[%]	11,6
Particles >0.425 mm	-	[%]	13,4

Results of the laboratory classification tests are presented either on the borehole profile and/or in enclosure 72.4 (plasticity index.).
