Danish Offshore Wind 2030 Cable Route Survey

Title	North Sea - Cable Route Integrated Report
Project document code	BE5950H-711-RR-02
Client document code	SN2023_027-IR-NS
Revision	2.0

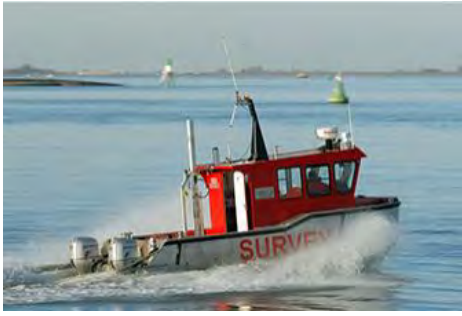
Table 13: GSV survey vessel specification

Owner	GEOxyz
	Length	7.2 m
	Width	2.45 m
	Maximum draught	0.75 m
	Cruising Speed	5 knots
	Propulsion	2x outboard motorblock
	Endurance	< 12-hour operations, day vessel
	Accommodation	6

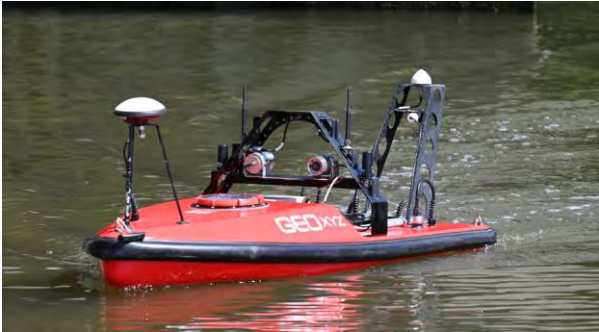
Table 14: Geo Drone 1800 specification

Owner	GEOxyz
	Length	1.80 m
	Width	0.66 m
	Draught	0.15 m
	Operational depth below waterline	0.30 m
	Weight	35 kg
	Max. payload	40 kg
	Steering	Autopilot line steering
	Survey speed	3 knots
	Autonomy	5 hours

Additional bathymetric data were acquired in the intertidal area using the Geo Drone 1800 (Table 14).

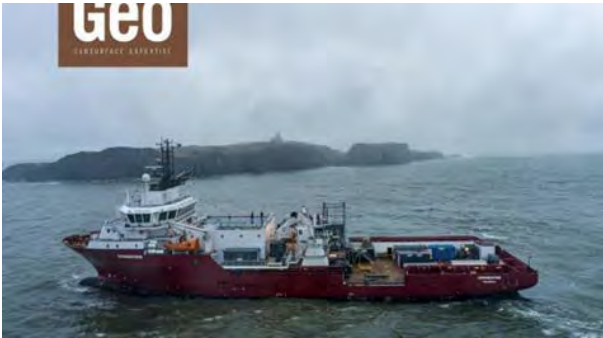
Table 15: DP II Connector vessel specifications

Owner	Geo DK
	Length	90.2 m
	Width	7.0 m
	Maximum draught	5.53 m
	Cruising speed	16 knots
	Propulsion	Fixed Pitch Propellers
	Endurance	24 h day operations (20 days)
	Accommodation	60

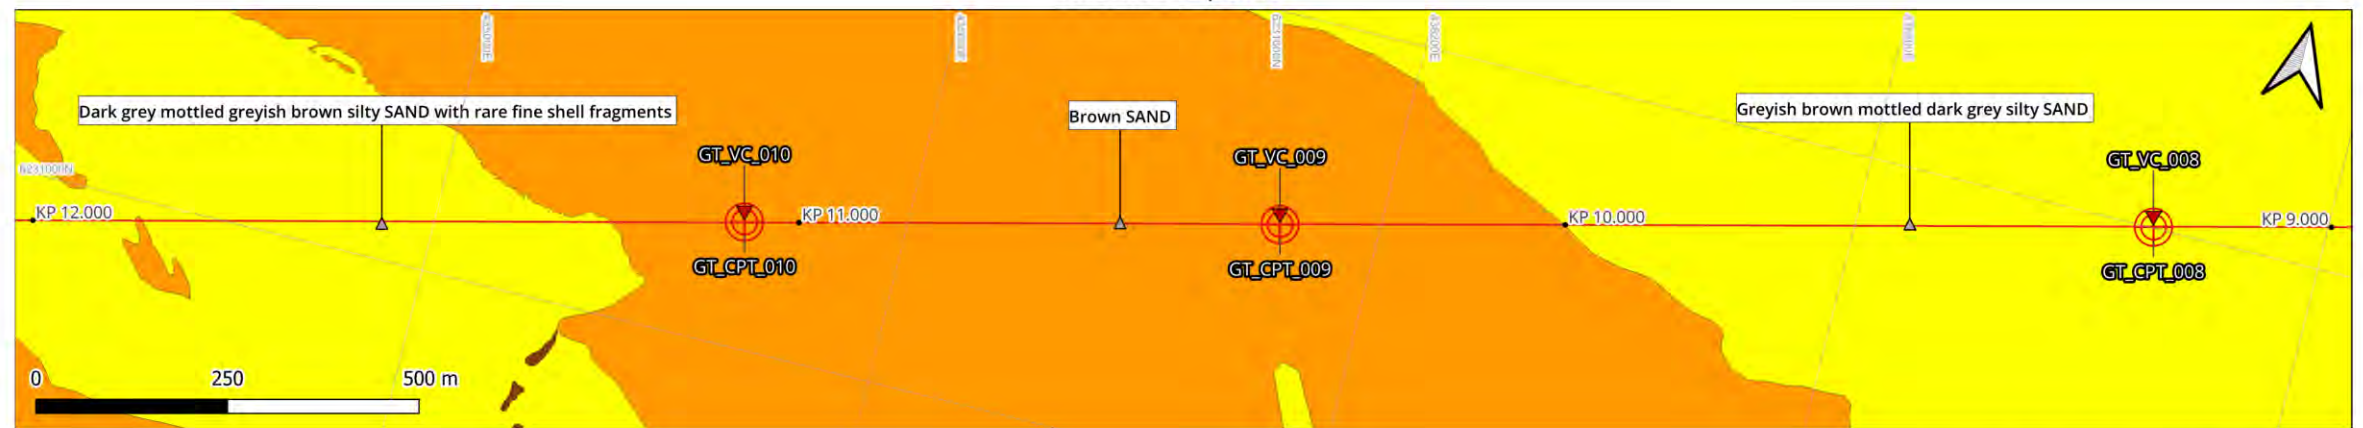
Figure 98: Integrated geotechnical panel KP 9.000 – KP 12.000

NS_ECR1 (KP9.000 - KP12.000)

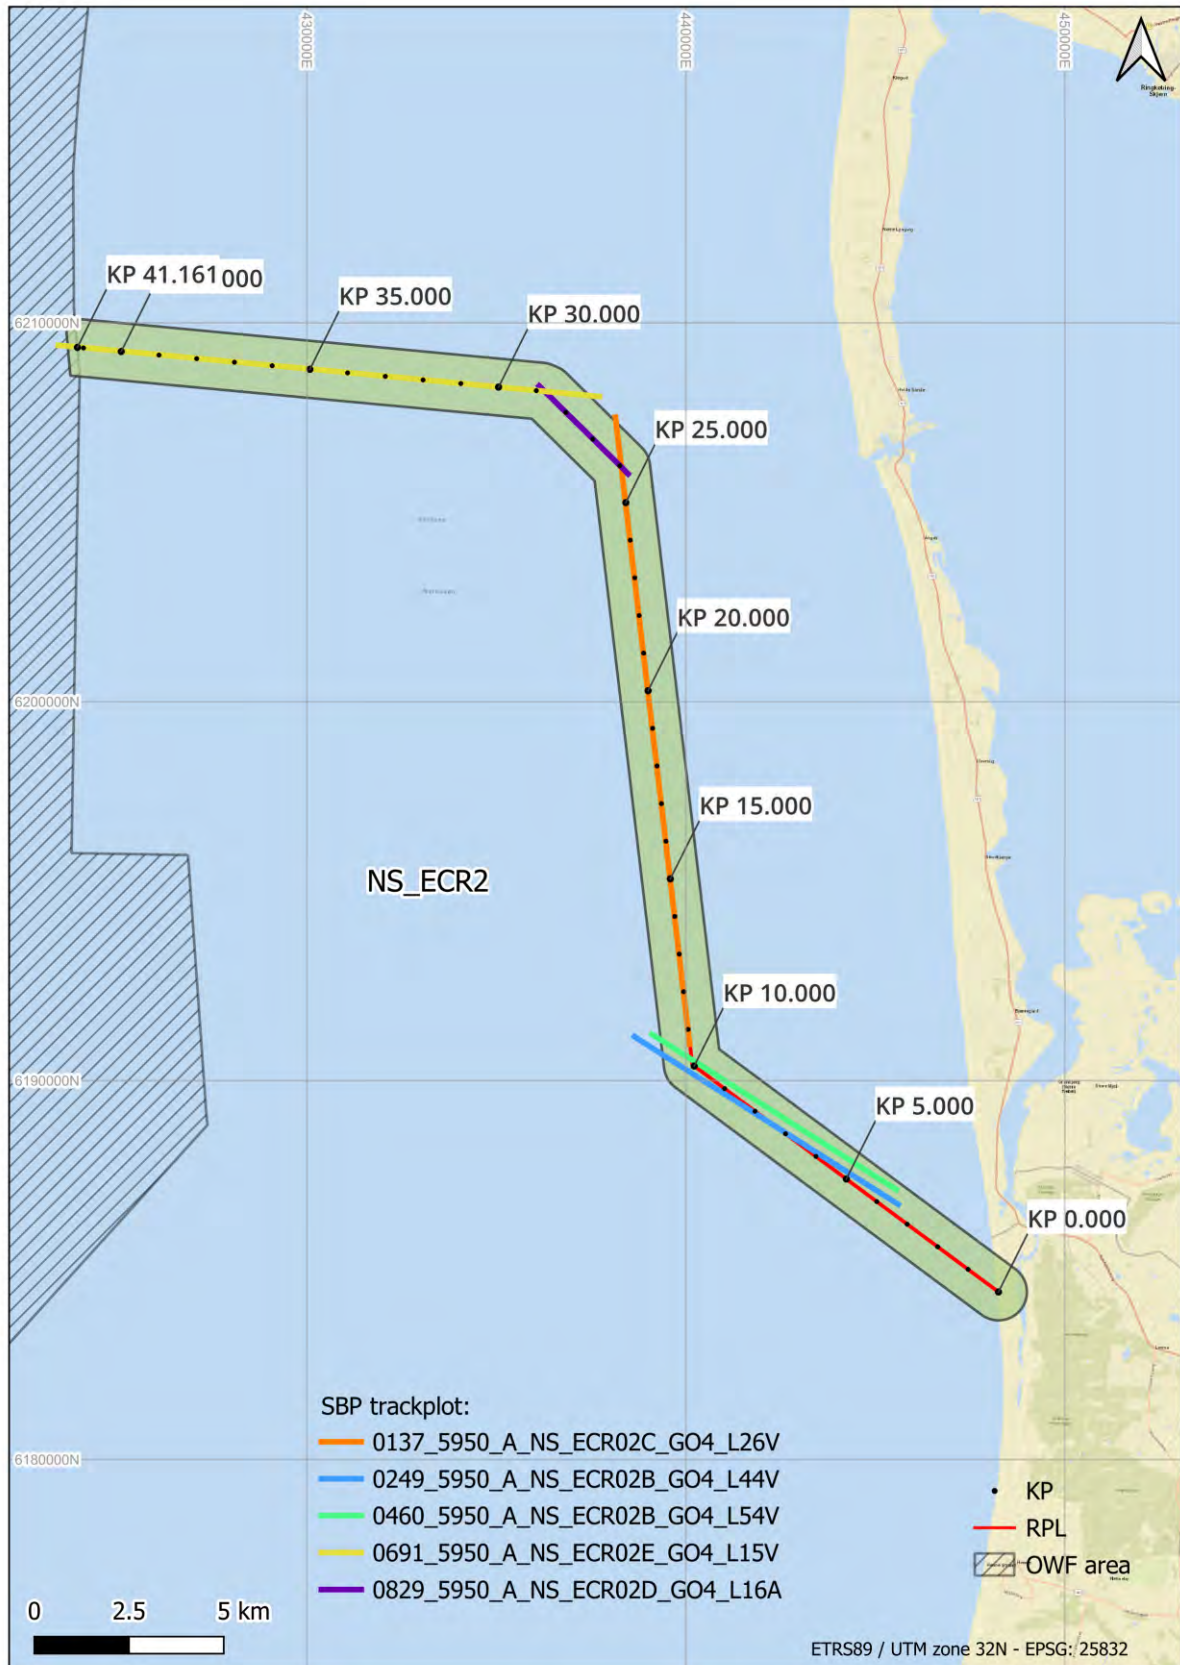
Figure 130: Location of the seismic profiles along NS ECR2 presented throughout the report

The location of seismic profiles, which are presented throughout the report, are displayed in Figure 130 below.

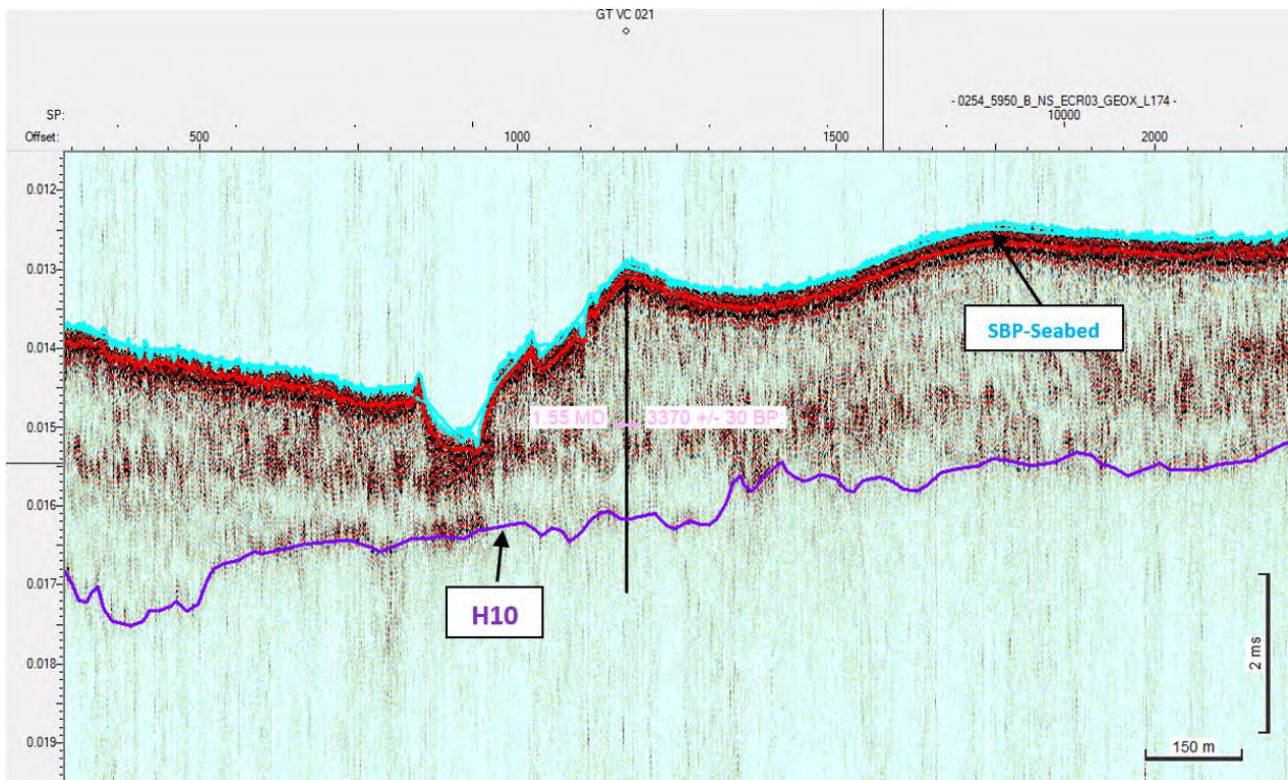
Figure 136: C14 result on SBP profile at VC_021

Figure 136 shows the C14 result at VC_021 plotted on the SBP data. The sample has been taken above the interpreted post glacial interface (H05). The derived age of $3,370 \pm 30$ BP matches with the expectation of post glacial soils at this location.

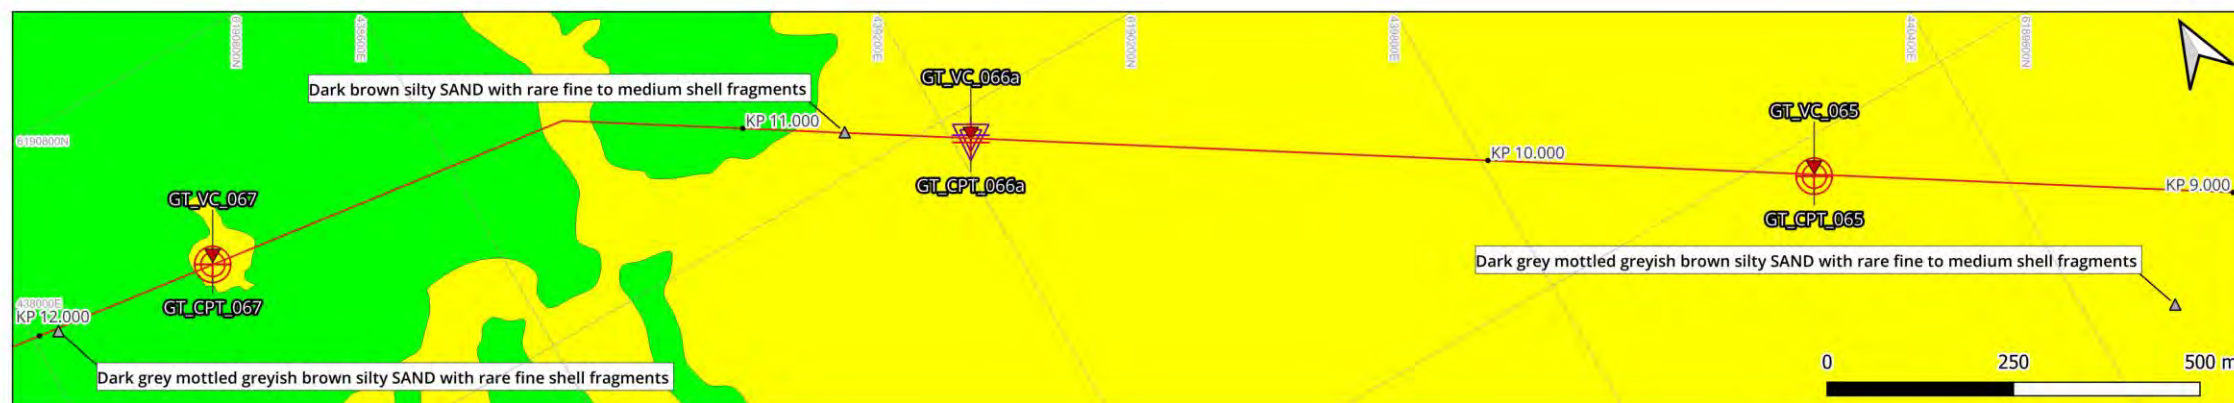
Figure 210: Integrated geotechnical panel KP 9.000 – KP 12.000

NS_ECR3 (KP9.000 - KP12.000)
