# GEOPHYSICAL SURVEY REPORT

103282-ENN-MMT-SUR-REP-SURVLOT2  
REVISION B | FOR USE  
MAY 2020

### THOR OFFSHORE WIND FARM EXPORT CABLE ROUTE INVESTIGATIONS LOT 2

DANISH NORTH SEA  
AUGUST-DECEMBER 2019

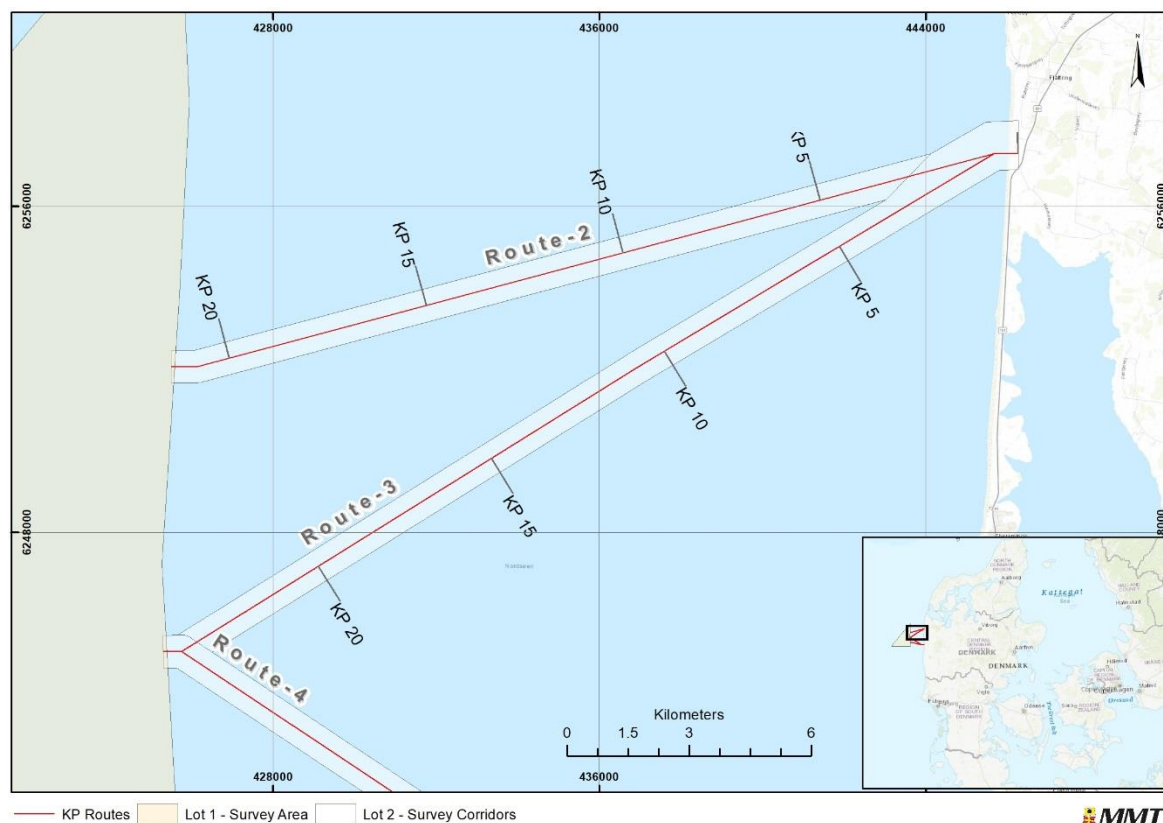
Figure 1 Overview of routes R2 and R3.

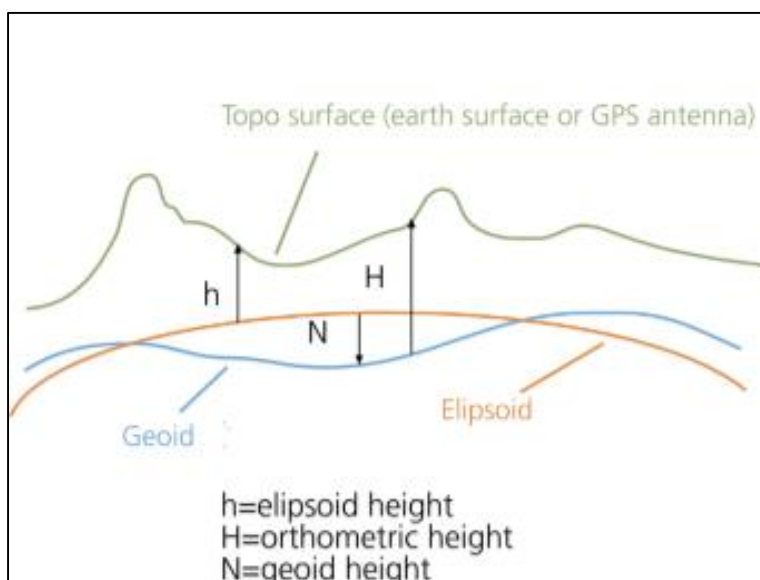
Figure 5 Overview of the relation between different vertical references.

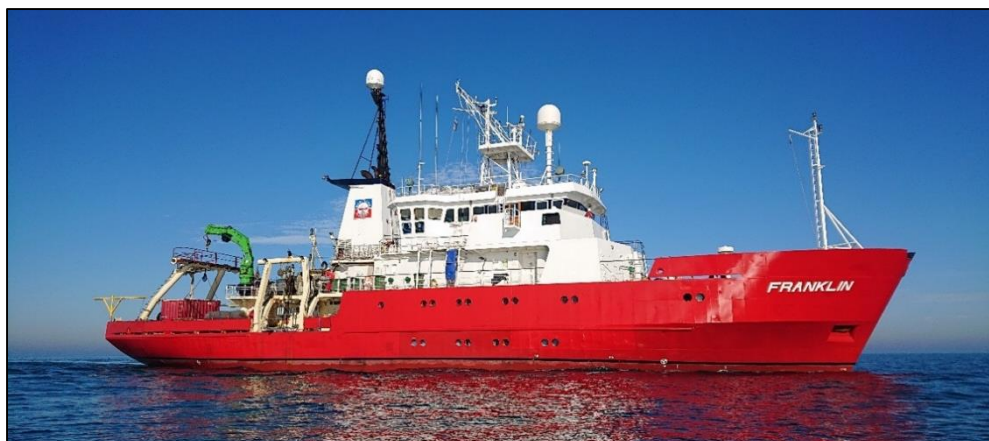
Figure 6 M/V Franklin.

The offshore geophysical survey operation was conducted by the survey vessel M/V Franklin (Figure 6). The vessel equipment is shown in Table 15.

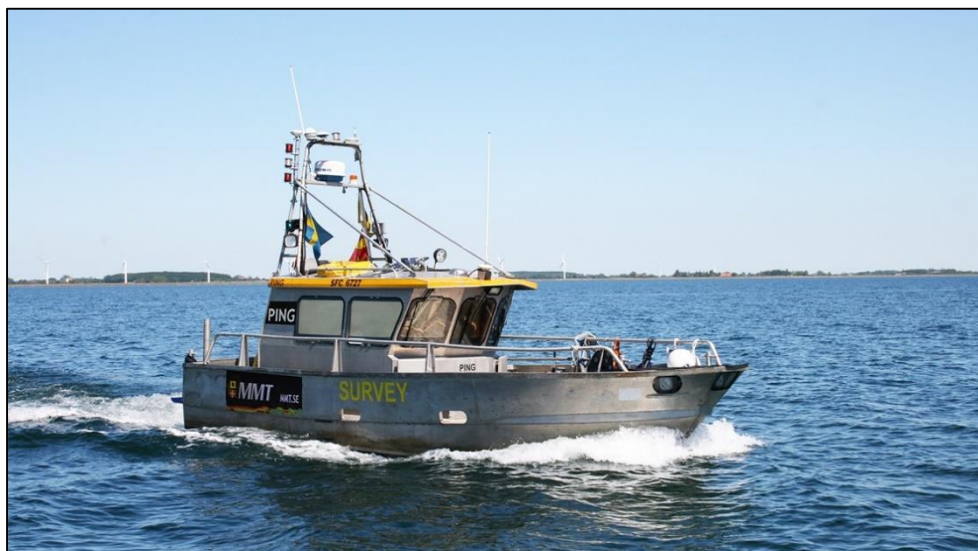
Figure 7 M/V Ping.

The nearshore geophysical survey operation was conducted by the survey vessel Ping (Figure 7). The vessel equipment is shown in Table 16.

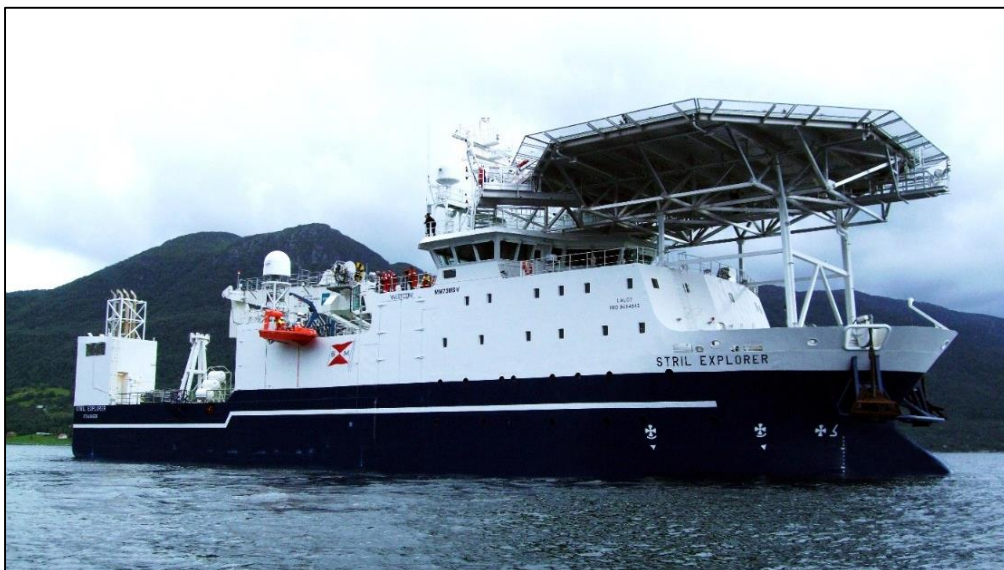
Figure 8 M/V Stril Explorer.

The offshore geotechnical survey operation was conducted by the survey vessel M/V Stril Explorer (Figure 8). The vessel equipment is shown in Table 17.

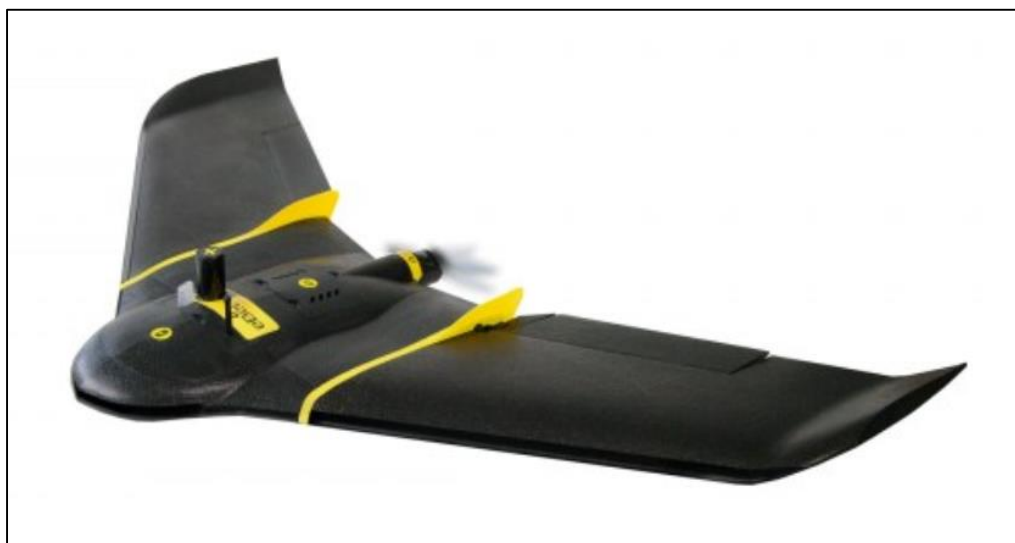
*Figure 9 UAS SenseFly eBee.*

The two landfall topographic surveys were sub-contracted and were conducted using an UAS (Figure 8). The equipment is shown in Table 17.

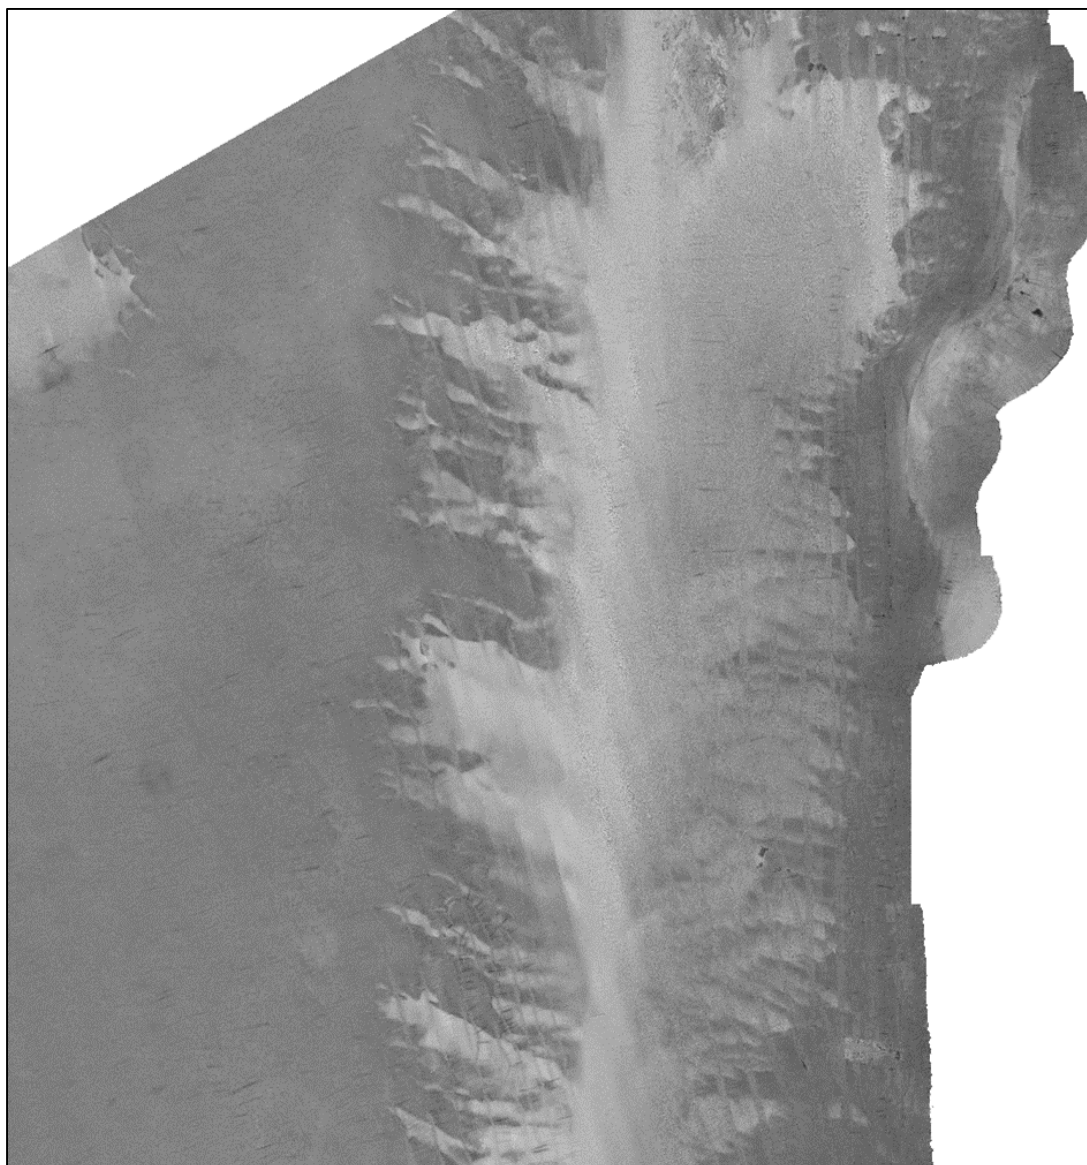
*Figure 12 Example backscatter mosaic Tile R2\_445\_6257\_MBES\_BS\_100CM.  
Image is presented north-up. Areas with high acoustic reflectivity show up as lighter shades of grey.*

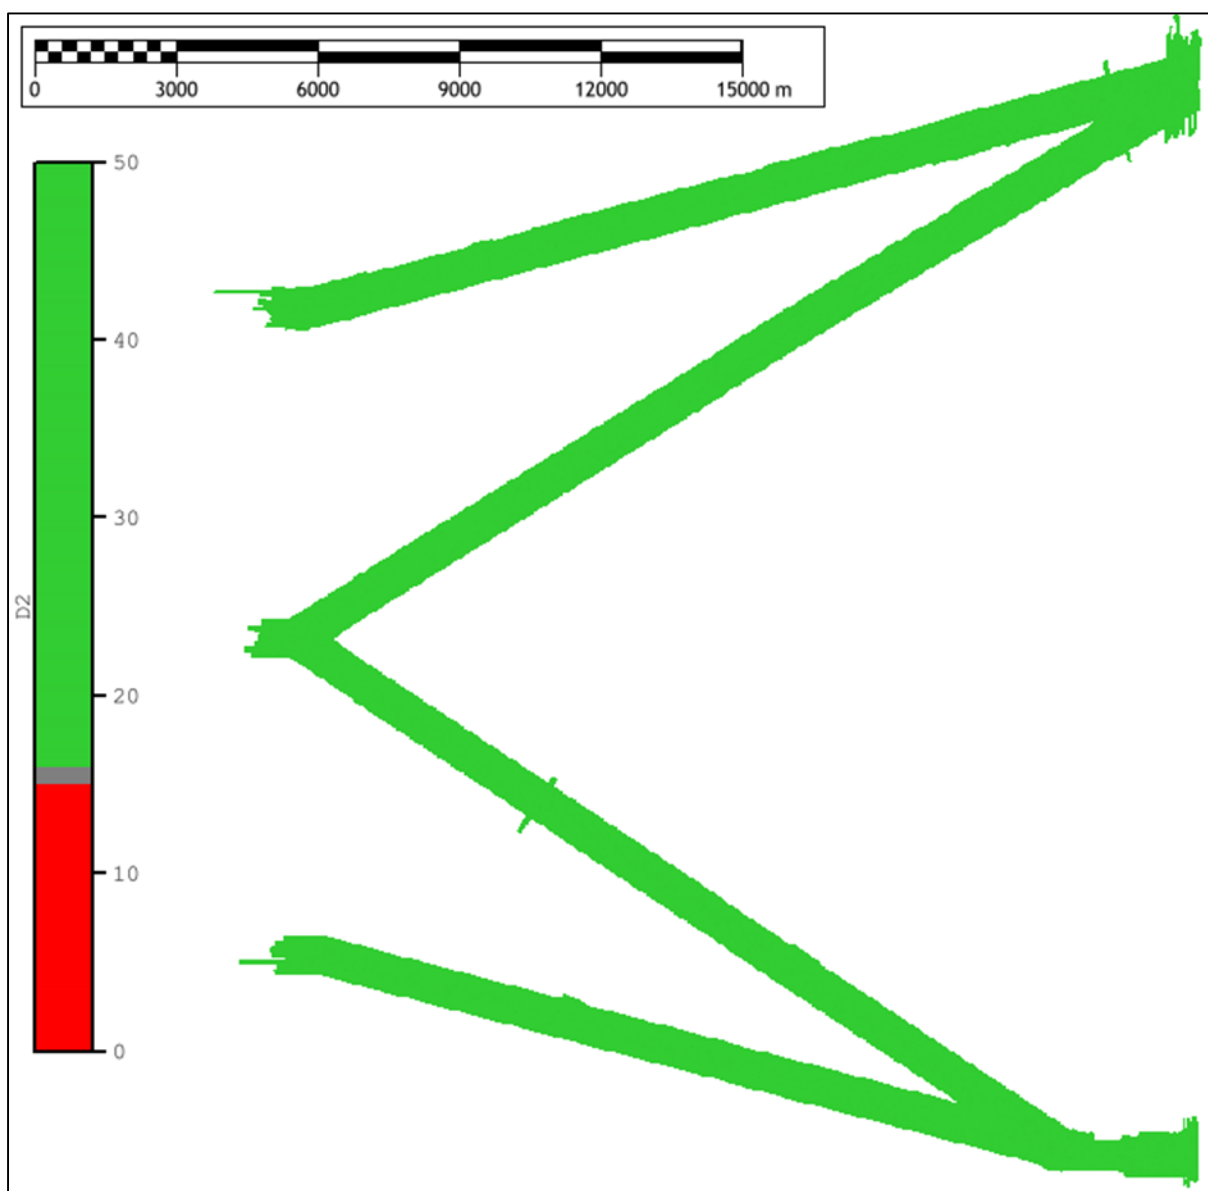
The horizontal and vertical uncertainty of the soundings data were, for the vast majority of the survey area, within the 0.5 m threshold as specified by the client. Sounding density across the routes generally conformed to the revised specification of 16 soundings per 100 cm cell (Figure 20). Density and gap checking was performed on gridded surfaces in Caris HIPS during survey operations for MV Franklin. Some data gaps exist in the final dataset, these correspond to areas that did not meet the infill threshold criteria (i.e. 4 or more missing 1 m cells that shared a long side) and areas that were flagged as rejected during office data cleaning after both vessels had left the survey area.

Figure 20 Overview of the sounding density surface for Lot 2.

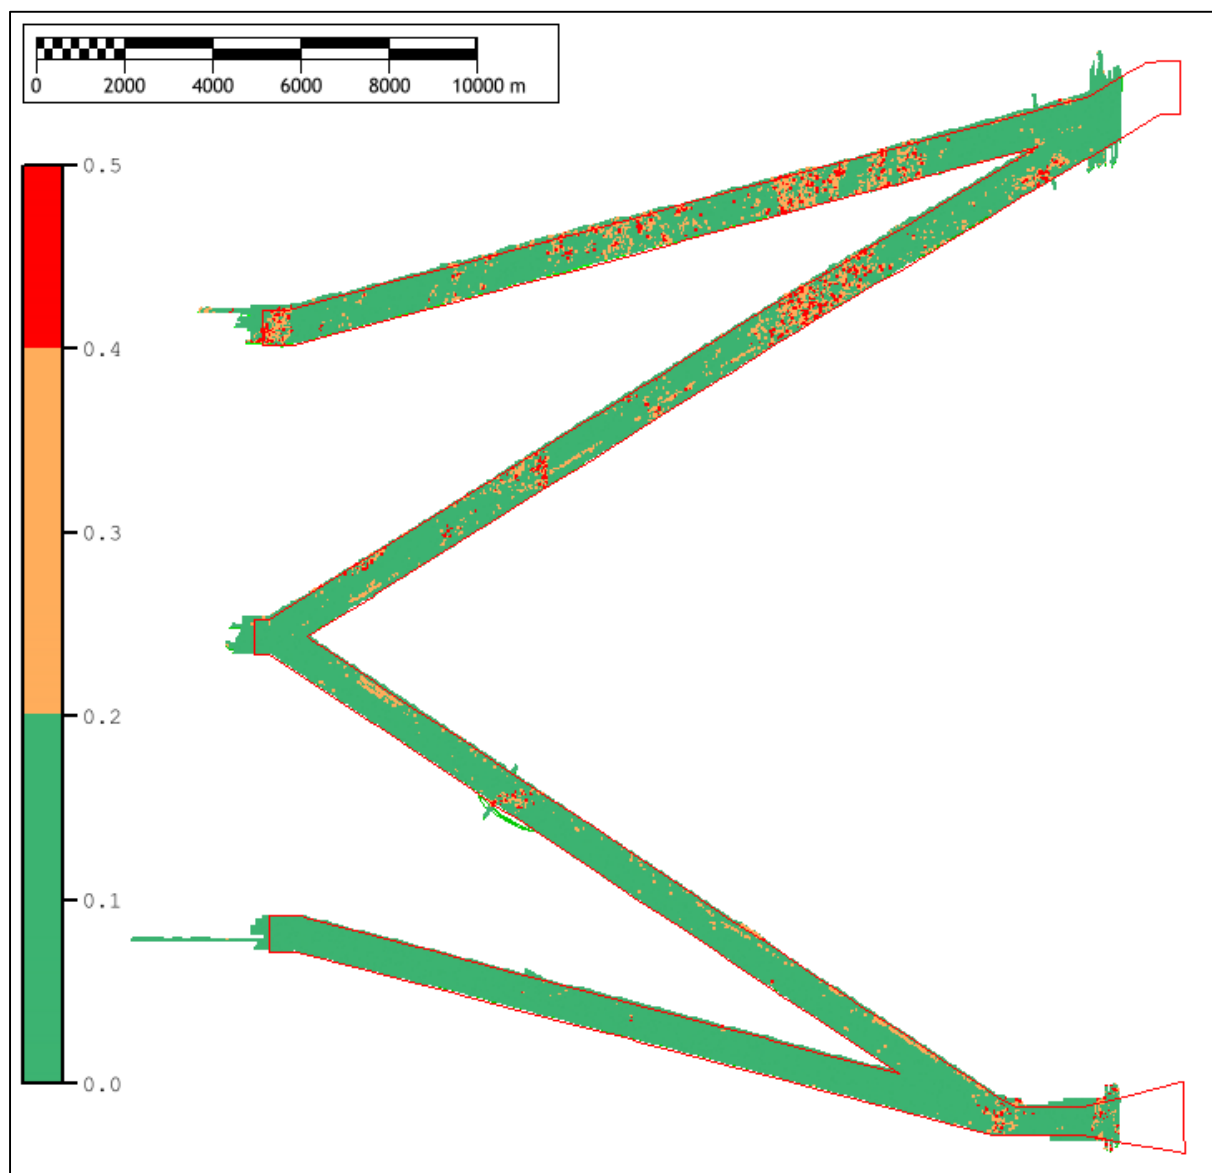
Figure 21 shows an overview of the Lot 2 Standard Deviation surface for MV Franklin, which presents regions as having low, medium and high standard deviations in green, orange and red, respectively. Regions where there are numerous boulders are present on all routes but more prevalent on routes 2 and 3. These show up as clusters of orange and red points. These features are not indicative of poor quality data but represent areas that have a greater vertical spread of soundings within a cell relating to the natural roughness of the seabed. Linear artefacts that follow the survey line direction are visible in the standard deviation surface which are the result of minor systematic errors within the data. Such errors relate to small misalignments in vertical position of the vessel and typical differences in sound velocity. An example of such an error can be seen in Figure 22.

Figure 21 Overview of the Standard Deviation surface for Lot 2.

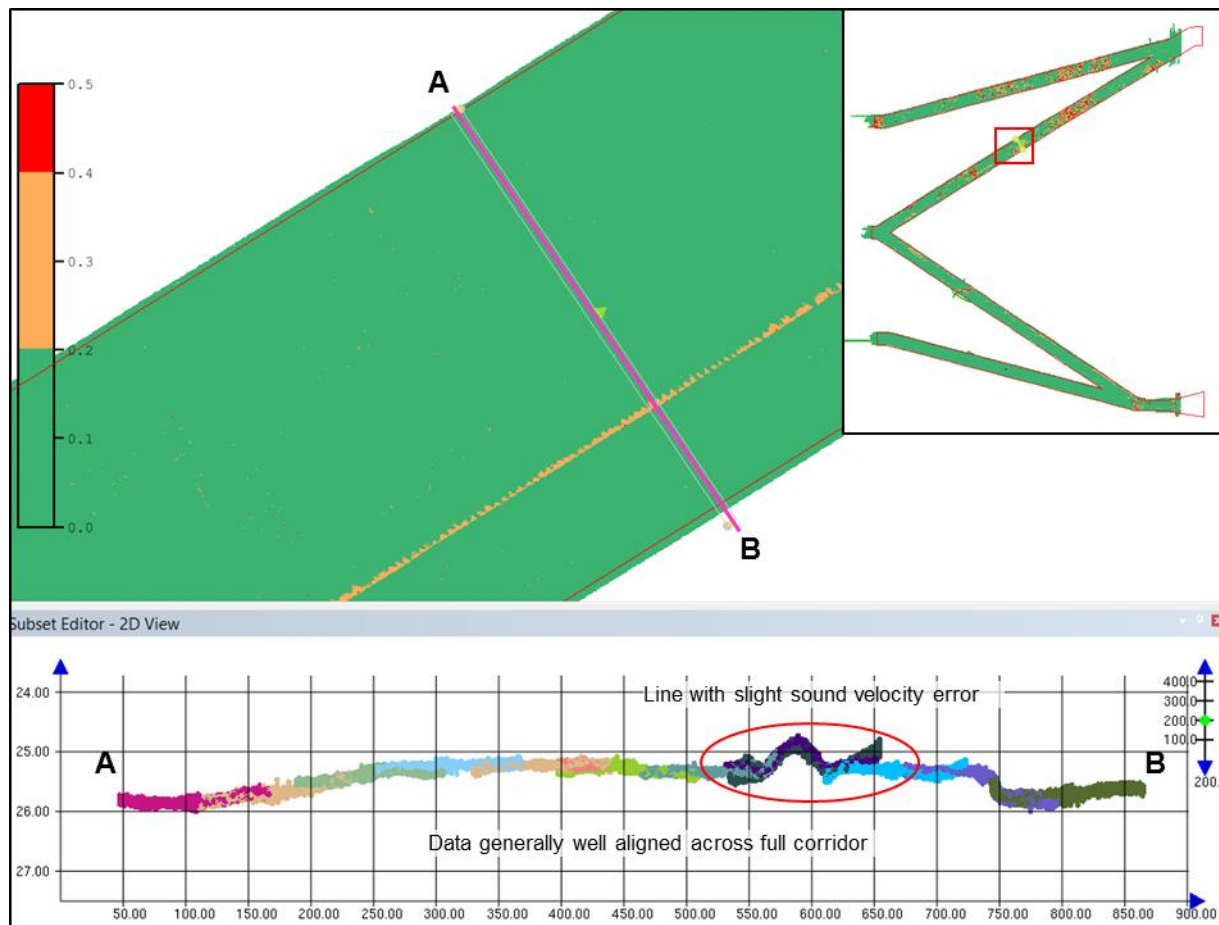
Figure 22 Example of good and poor data along Route 3.  
 Depth convention in Caris HIPS is positive down; vertical exaggeration of cross section is x200. Pink line marks position of cross section.

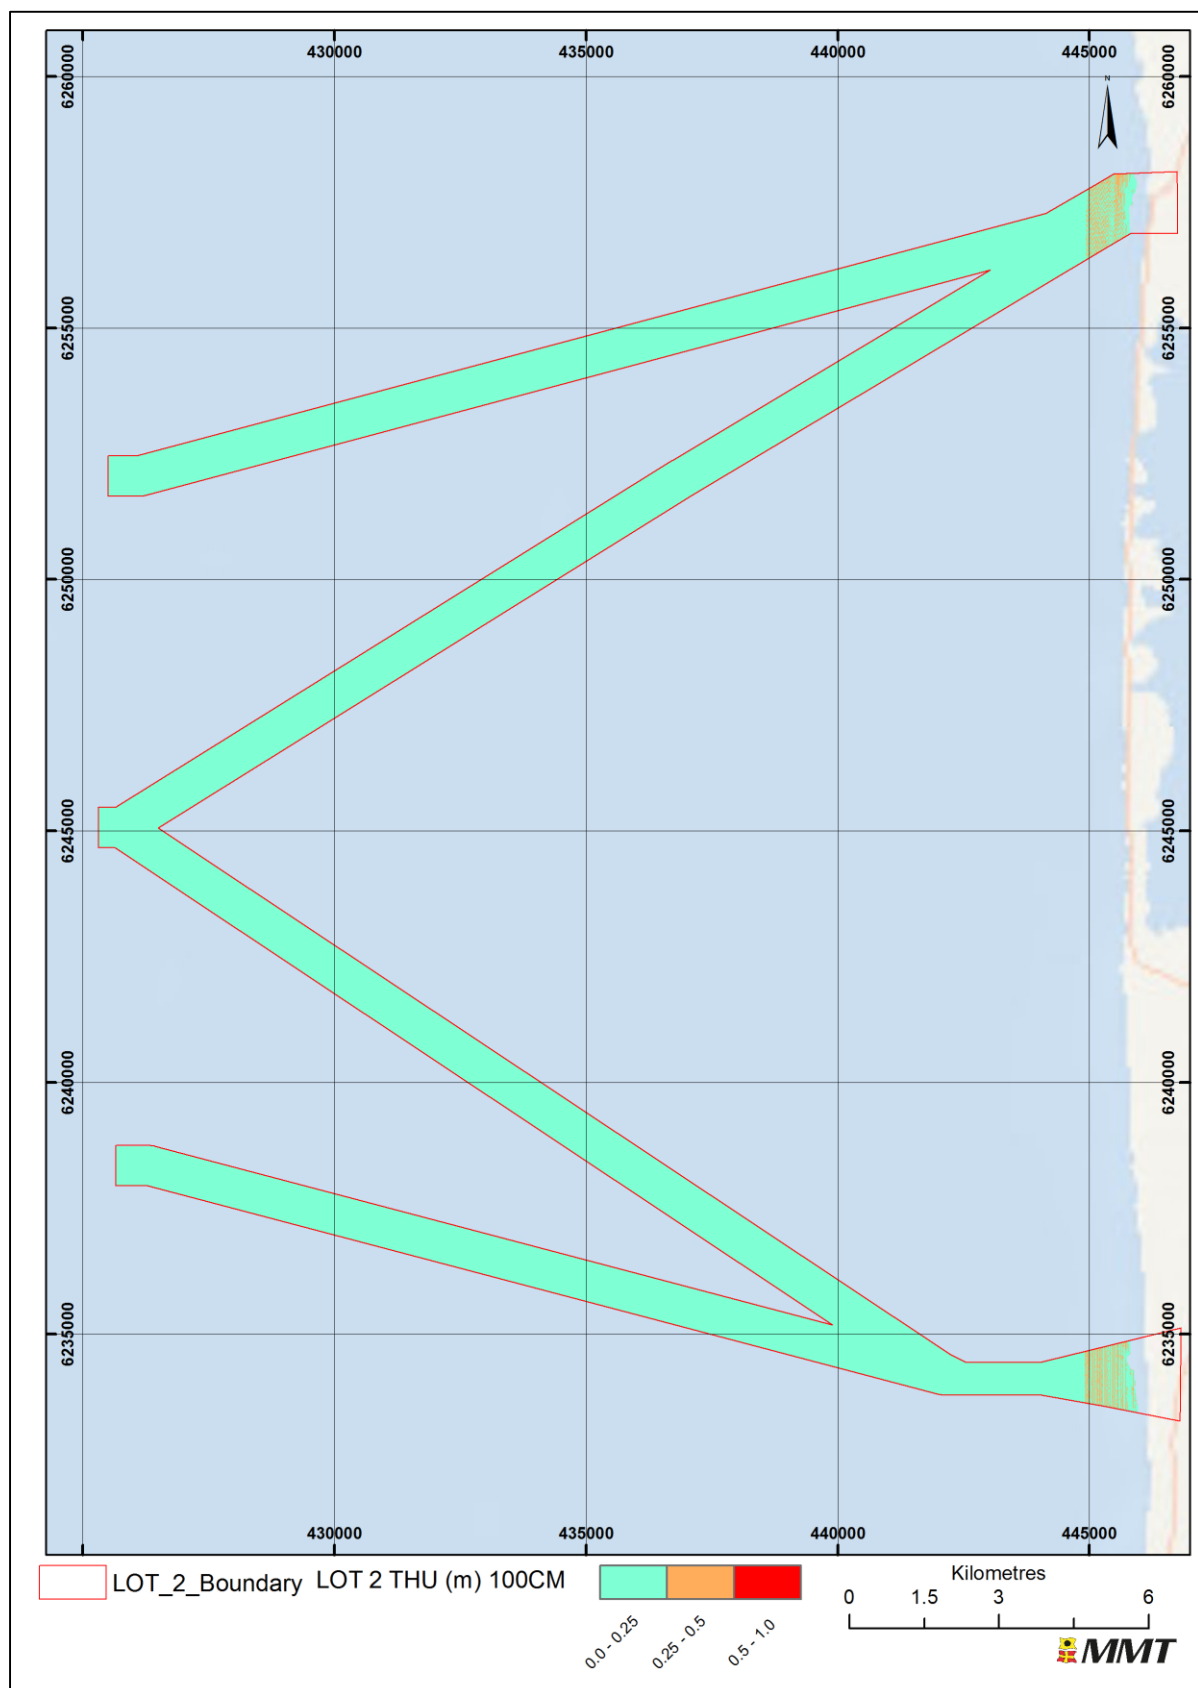
An overview of the THU results is shown in Figure 25. The range of values has been restricted to show areas with low THU as blue-green, medium THU as orange and higher THU as red. The overview shows that the values associated with the MV Ping data are relatively higher than those generated by MV Franklin, however all are within the 0.5 m threshold for positional uncertainty. The differences arise as the datasets from MV Franklin and MV Ping are not directly equivalent. Different MBES equipment was used and the data was processed using different software packages (following the same workflow principles). Most importantly though the sizes of the vessels is very different with the smaller vessel, MV Ping, being subjected to larger ranges of motion during the survey of the more dynamic nearshore areas of Route 2 and 5. Faster changes in position resulting from wave motion could lead to elevated uncertainty values for the MV Ping dataset. A close up view of the Route 5 nearshore region is shown in Figure 26. The same pattern is observed in the Route 2 nearshore area.

Figure 25 Overview of the Total Horizontal Uncertainty (THU) surface for Lot 2.

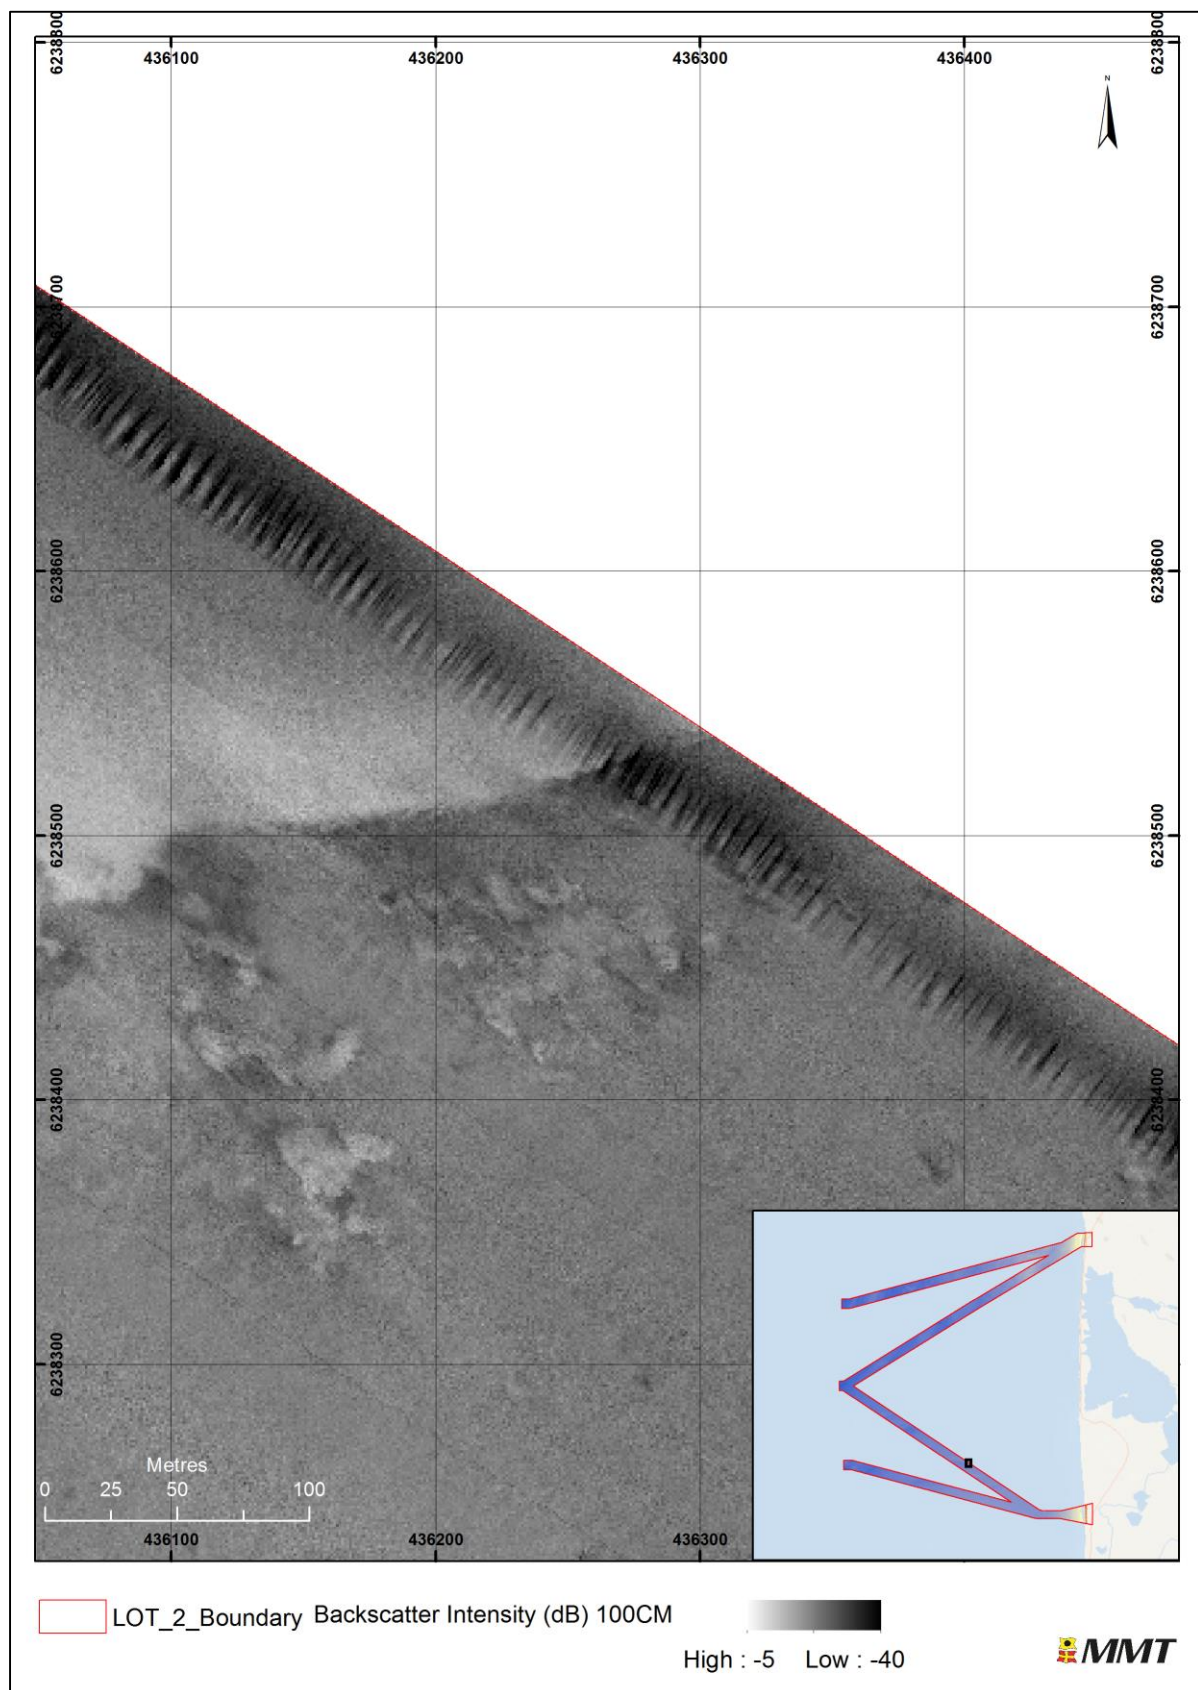
Figure 29 shows an artefact that is derived from excessive motion in the MV Franklin mosaic. This oscillation between light and dark tones occurs where FMGT fails to determine the fluctuations of backscatter intensity as vessel motion and this becomes presented as differences in sediment properties.

Figure 29 Motion artefact in MV Franklin backscatter mosaic in Route 4.

The presence of these artefacts is visually distracting but does not affect the results of the seabed interpretation. Experienced marine geologists are able to see beyond the artefacts and use multiple layers of data (bathymetry, bathymetric hillshade, gradients and side-scan-sonar mosaics) to determine whether these variations arise from real features of the seabed.

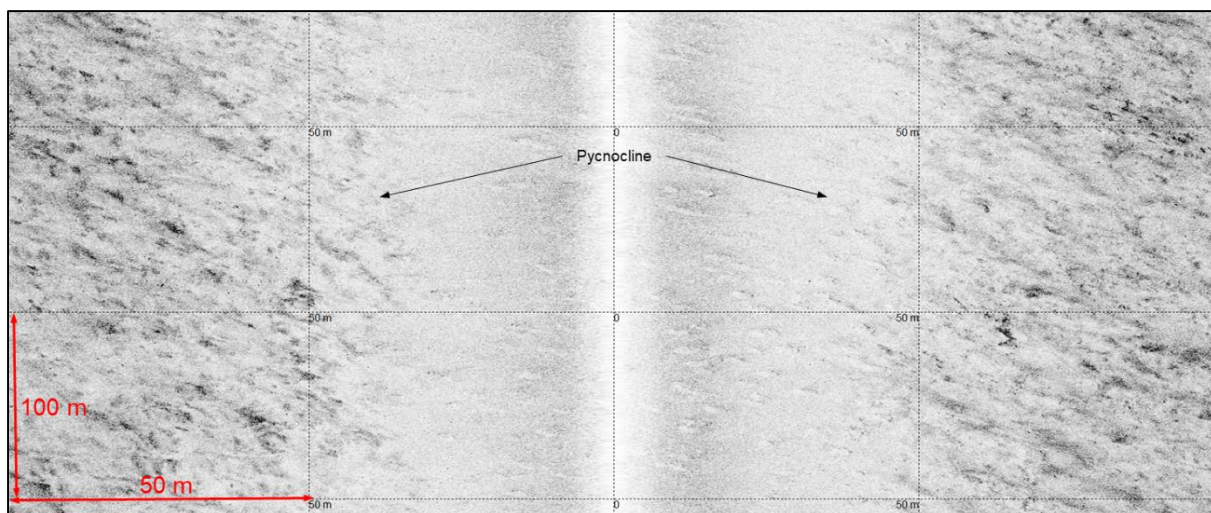
The SSS data quality varied and very much depended on the prevailing weather conditions and a strong pycnocline that was observed on all routes, affecting the data in the outer ranges; in some sections up to 40% of the data was affected (Figure 31). This noise varies along the routes and in most cases it was possible to cover the areas of poor data with adjacent lines, achieving full coverage. However, some areas have small sections where coverage was marginal and in such cases (particularly on the outer 30 m to the corridor boundary), these have been correlated against the MBES and Backscatter data to support the interpretation and description of the routes.

Figure 31 Pycnocline as observed on Route 3 at ~KP15.

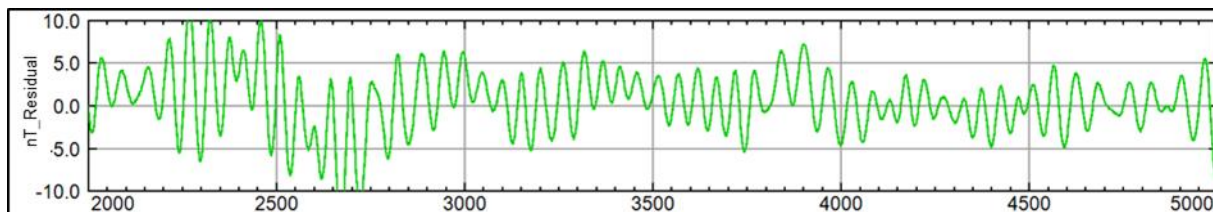
The MAG data quality was generally good. Background noise level varies from +/- 2 nT to +/- 10 nT (Figure 34). Some files had increased noise levels due to poor weather conditions or electrical interference, these were rejected and rerun where deemed appropriate. Another main issue of rejected files was the failure of the online logging system (QINSy) and equipment malfunction, such as loss of USBL tracking. In general, the areas affected by these issues, did not extend for more than 4000 m of the whole line plan for Lot 2, approximately 0.4% of the original line plan.

Figure 34 Example of background noise oscillation, on Route 2.

Infills were acquired in all sections where noise levels where too high. Altitude was generally equal or below 8 m and no infills were generally required. When the increase in altitude was momentary and not significantly above 8 m no infills were made. The decision to run infills was made onboard the vessel together with the client representative onboard.

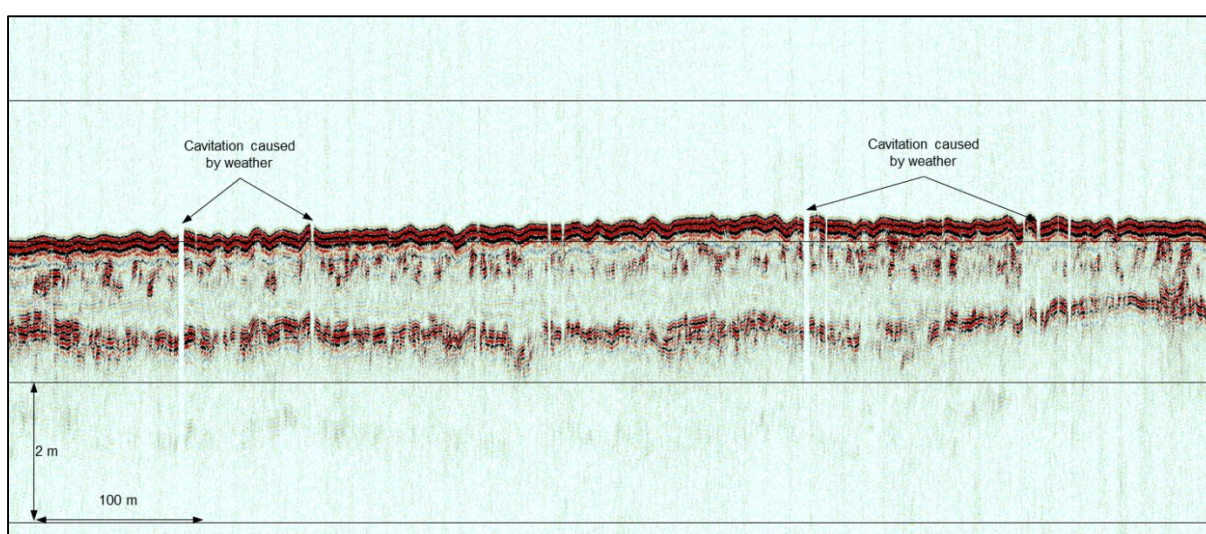
Figure 37 Cavitation caused by weather. Route 3 at ~KP19.

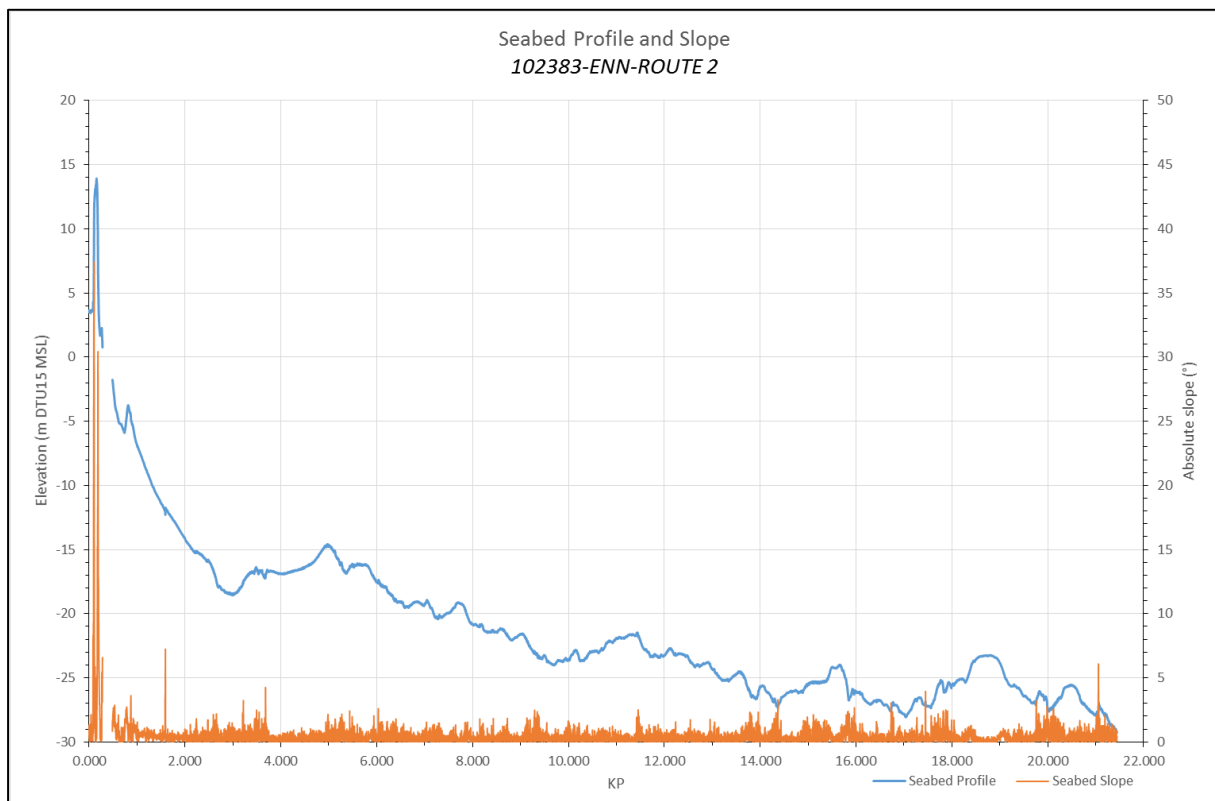
Figure 43 Route 2 longitudinal profile and slope.  
 Elevation is in metres (with bathymetric depths negative below MSL datum) and slope is in degrees (absolute value for visualisation). Vertical exaggeration x 250.

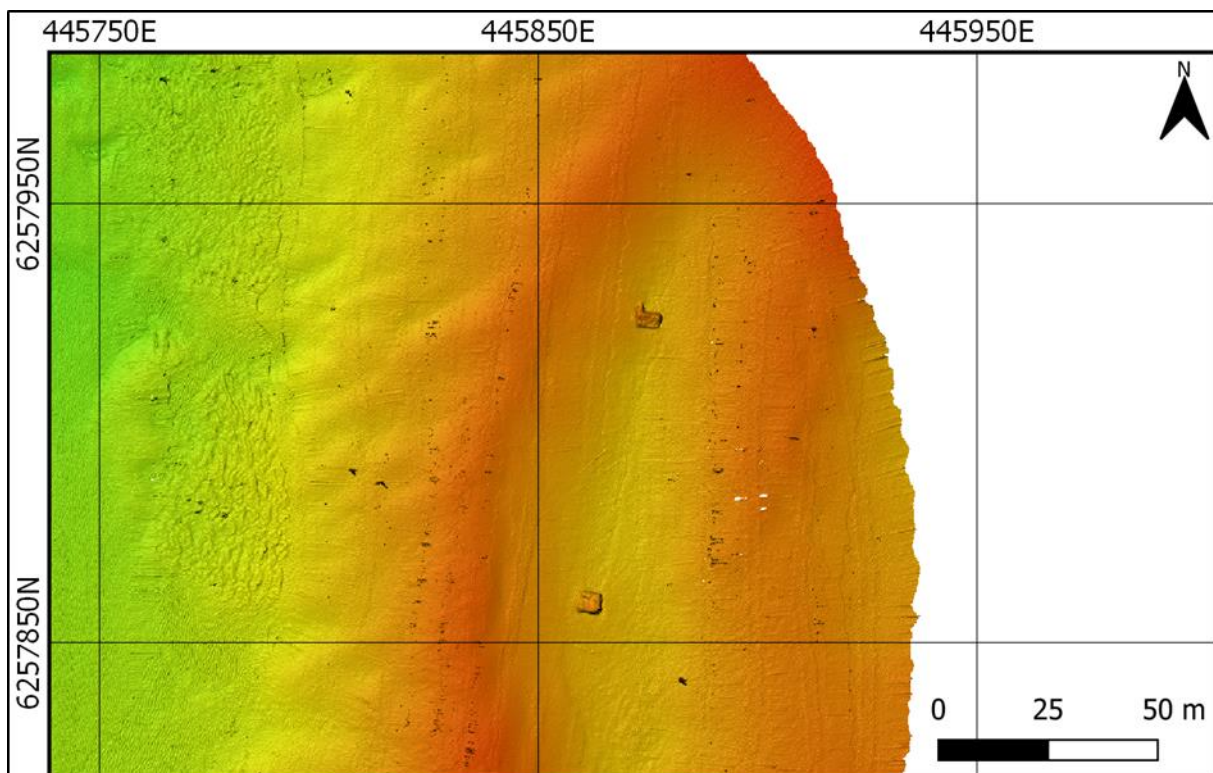
Figure 51 MBES image at KP 0.371 and KP 0.386  
 Military bunkers sitting between two sandbanks.

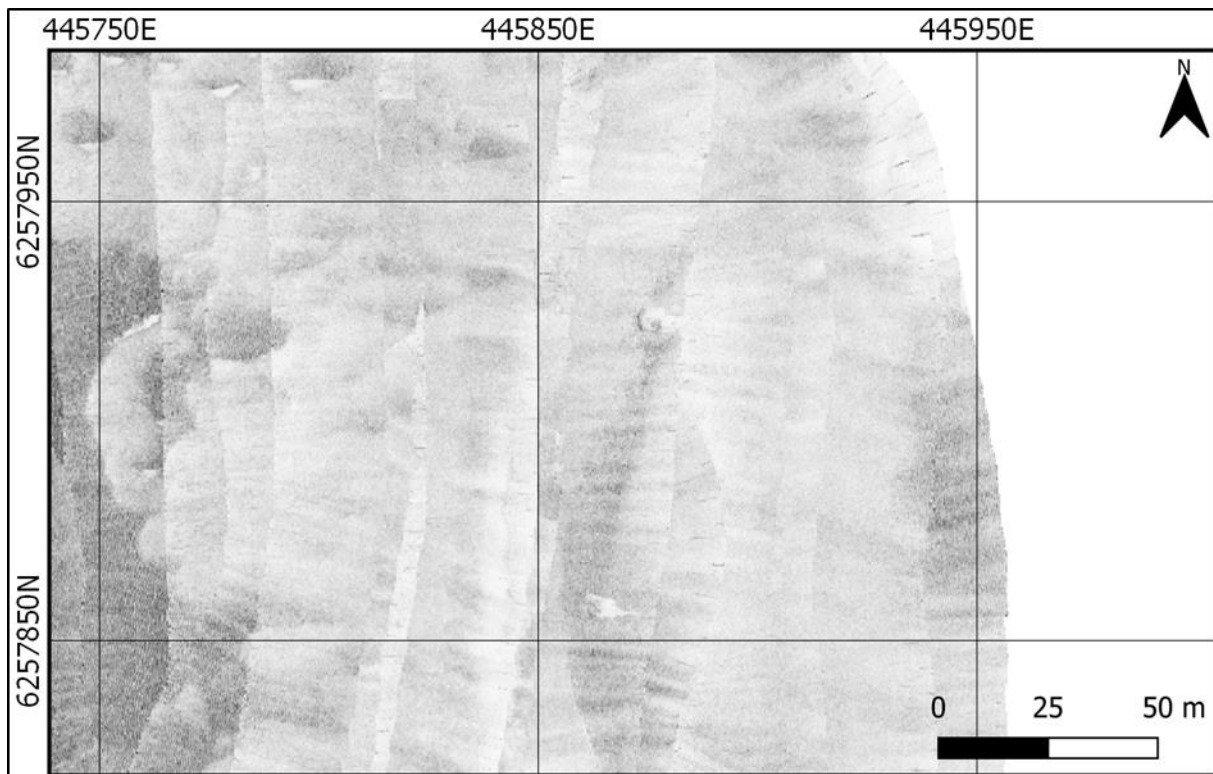
Figure 52 Side scan sonar image at KP 0.371 and KP 0.386  
Military bunkers over SAND sediments and in-between Gravelly SAND to Sandy GRAVEL banks.

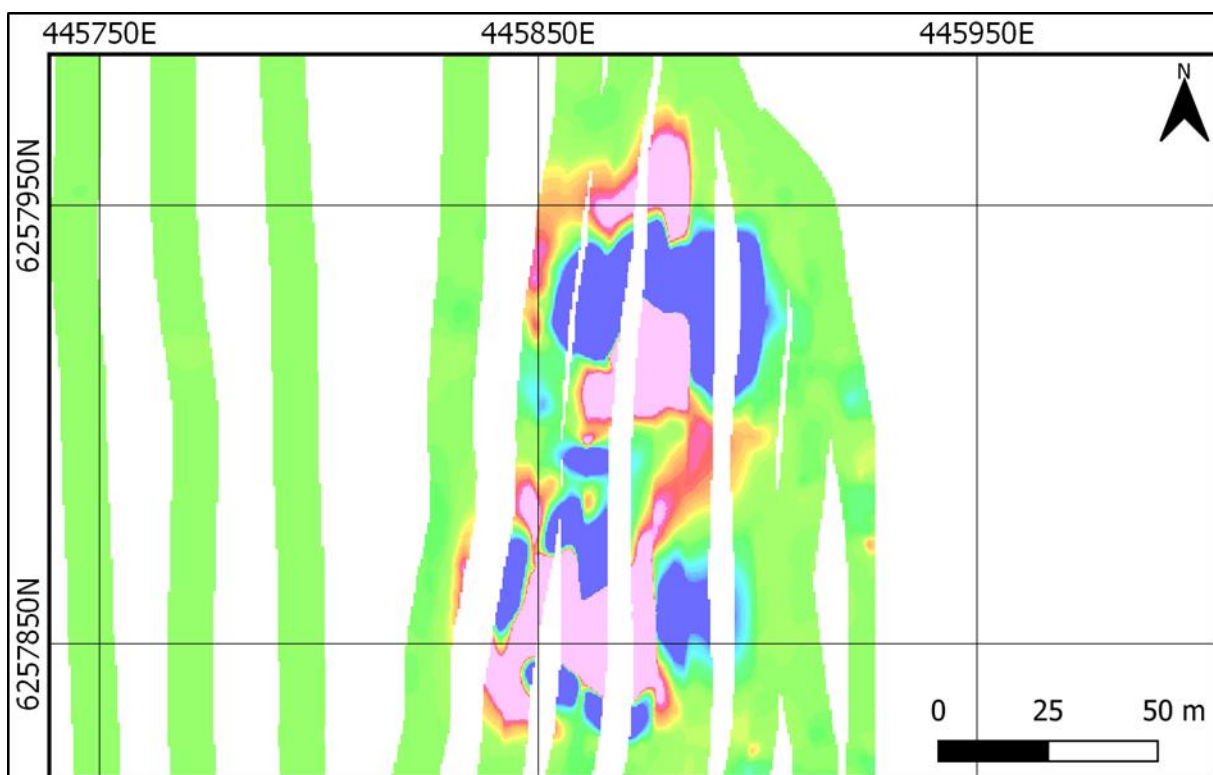
Figure 53 MAG grid KP 0.371 and KP 0.386  
Magnetic response (max 11871.8 nT) for military bunkers at KP 0.371 and KP 0.386.

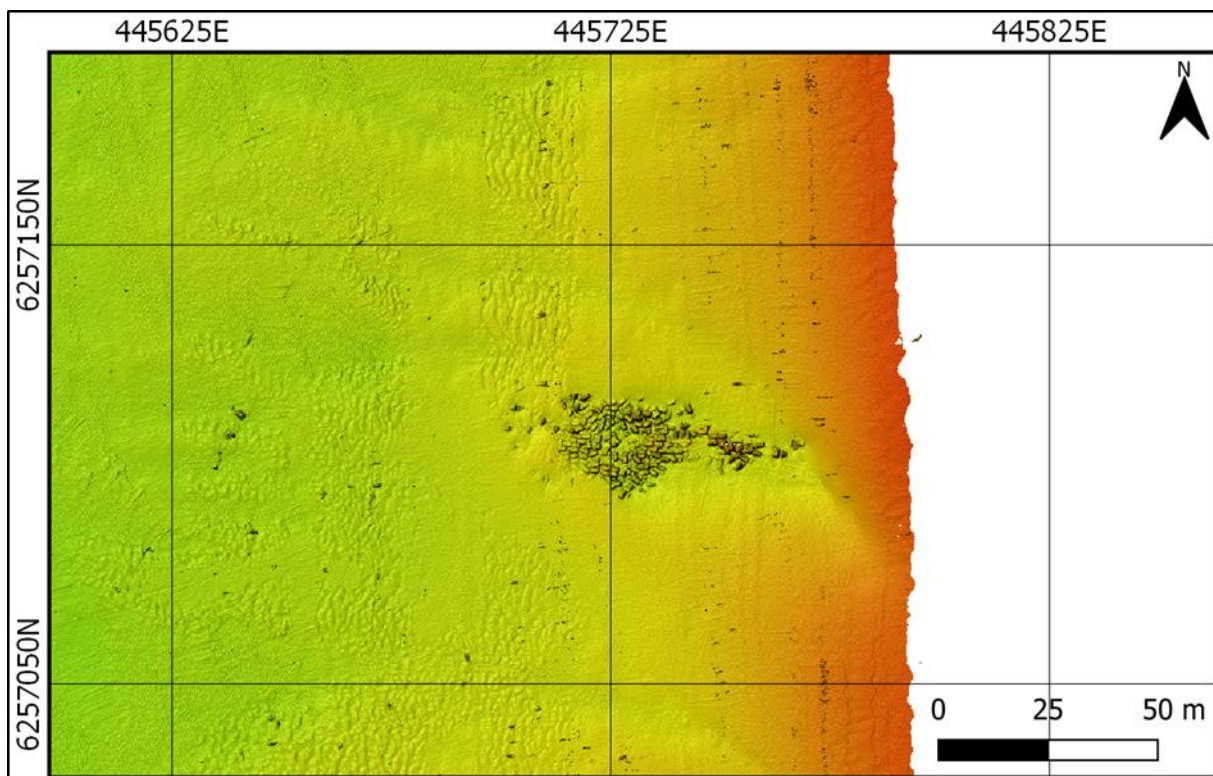
Figure 54 MBES image at KP 0.541 (DCC -177.9)  
Coastal defence blocks.

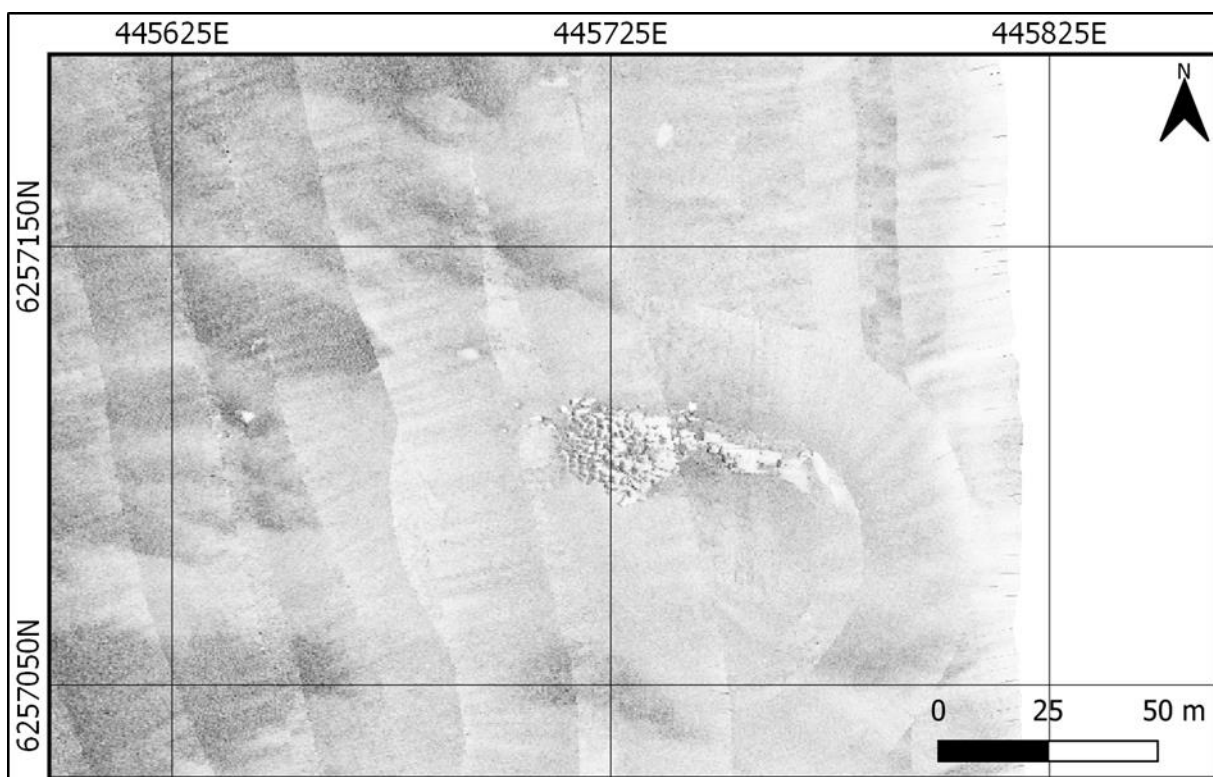
Figure 55 Side scan sonar image at KP 0.541 (DCC -177.9)  
Coastal defence blocks over SAND sediments.

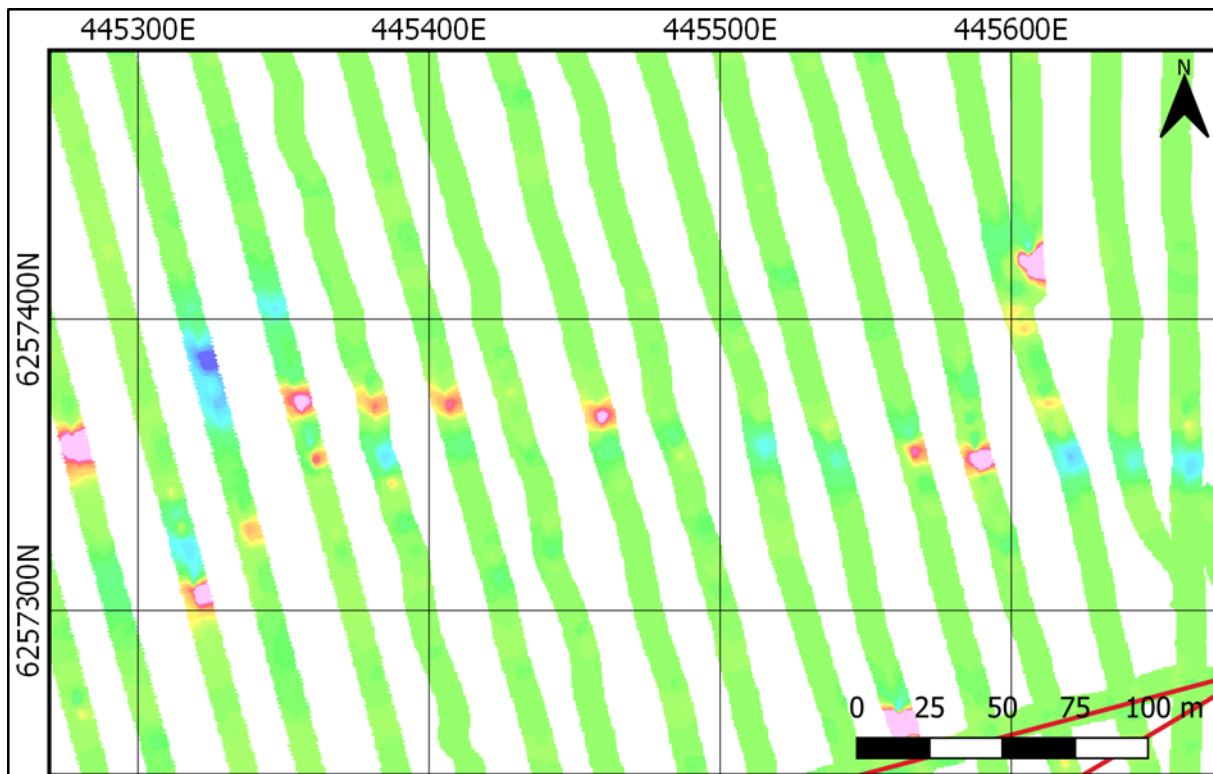
Figure 56 MAG grid from KP 0.622 (DCC 87.6) to KP 0.951 (DCC 177.6)  
 Possible linear feature.
