# GEOPHYSICAL SURVEY REPORT

103282-ENN-MMT-SUR-REP-SURVLOT2  
REVISION B | FOR USE  
MAY 2020

### THOR OFFSHORE WIND FARM EXPORT CABLE ROUTE INVESTIGATIONS LOT 2

DANISH NORTH SEA  
AUGUST-DECEMBER 2019

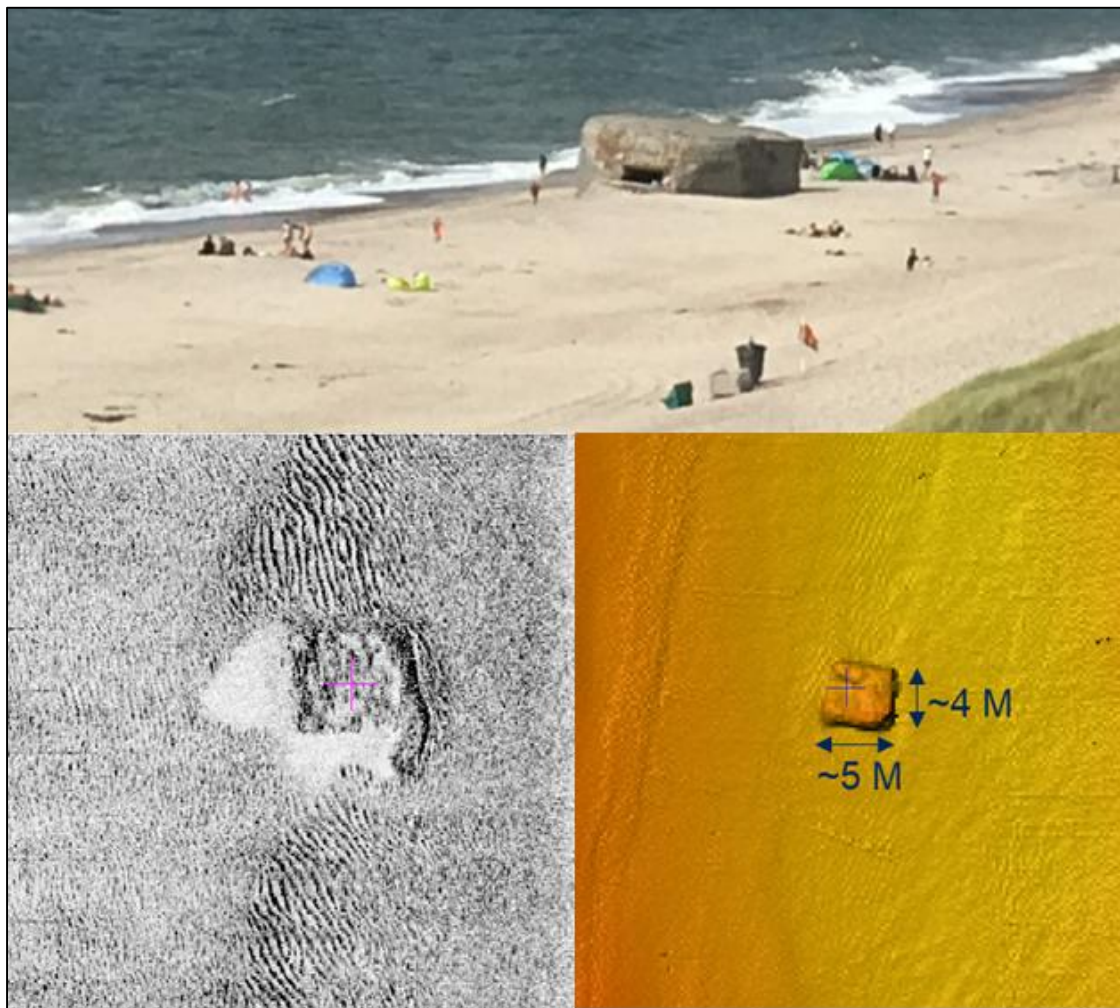
Figure 66 Photograph, SSS and MBES image of a military bunker along Route 2 coastline.

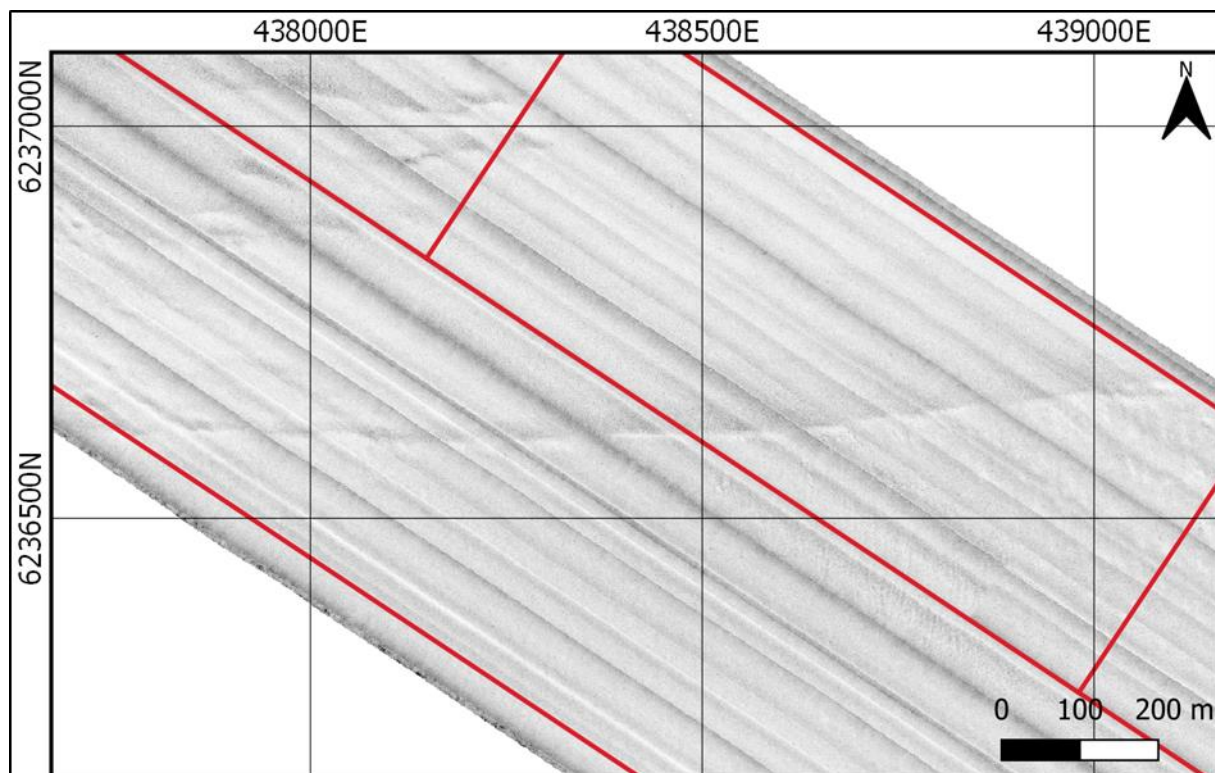
Figure 94 Side scan sonar image illustrating a sandwave crossing survey corridor at KP 8.588.

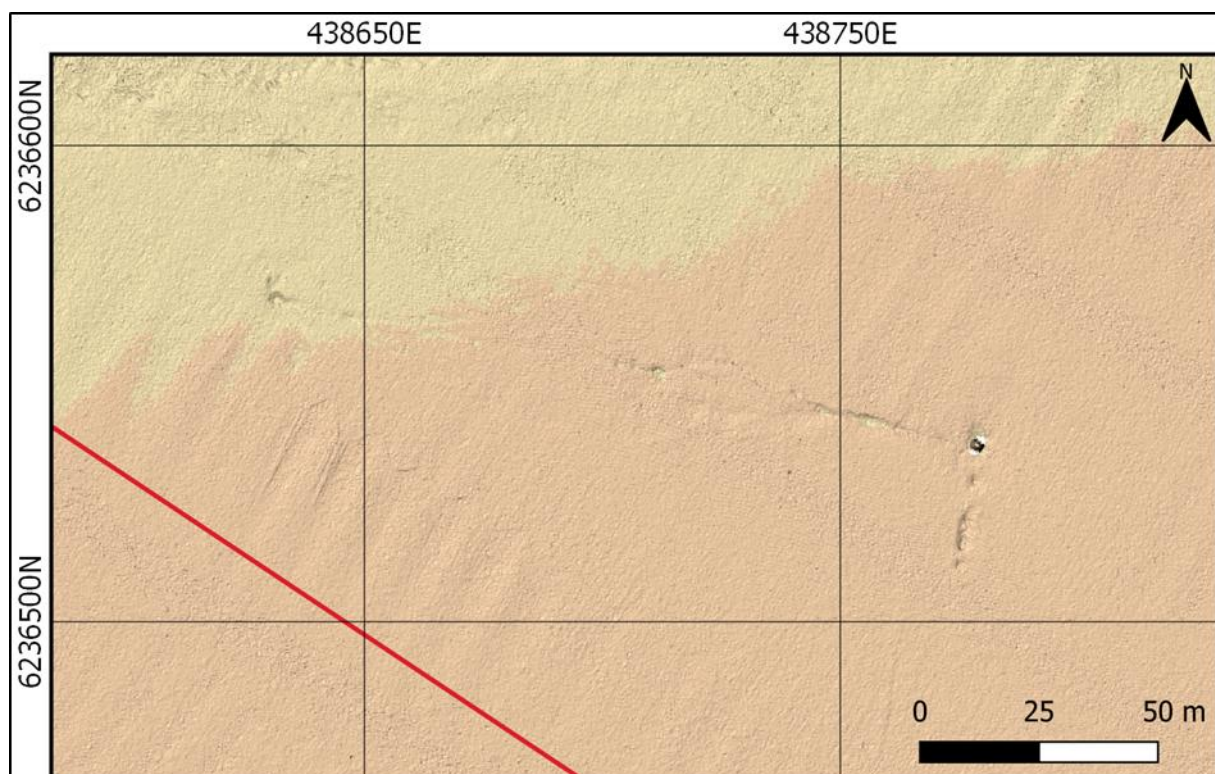
Figure 95 MBES image KP 8.311 (DCC 104.55)  
 Possible fishing gear with the rope still attached

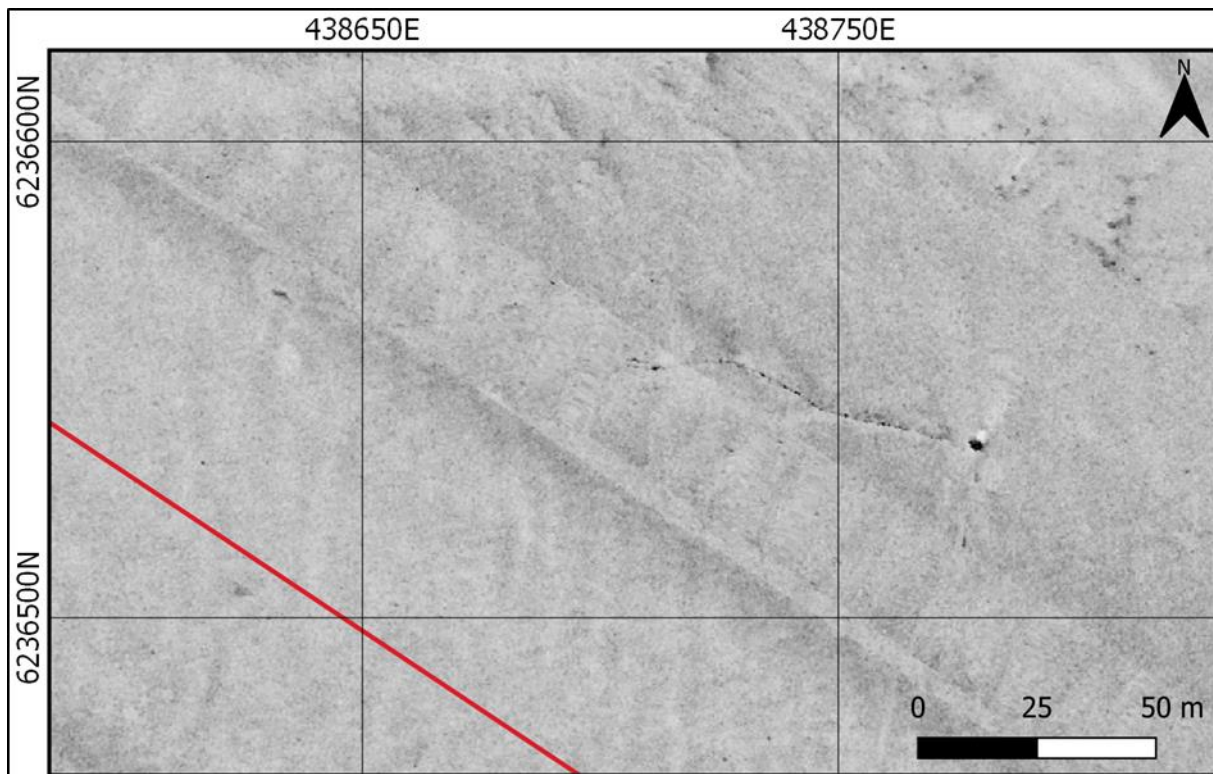
Figure 96 Side scan sonar image KP 8.311, (DCC 104.55)  
 Possible fishing gear with the rope still attached on SAND.
