# THOR OFFSHORE WIND FARM MARITIME TRAFFIC AND SAFETY OF NAVIGATION

Project name **THOR offshore wind farm environmental investigations**  
Project no. **1100040575**  
Recipient **Margot Møller Nielsen, Signe Dons (Energinet)**  
Document no **1100040575-816011983-48**  
Version **3.0**  
Date **24/02/2021**  
Prepared by **MRTH, TOKJ**  
Checked by **FMR**  
Approved by **CFJ**  
Description **Maritime Traffic and Safety of Navigation**

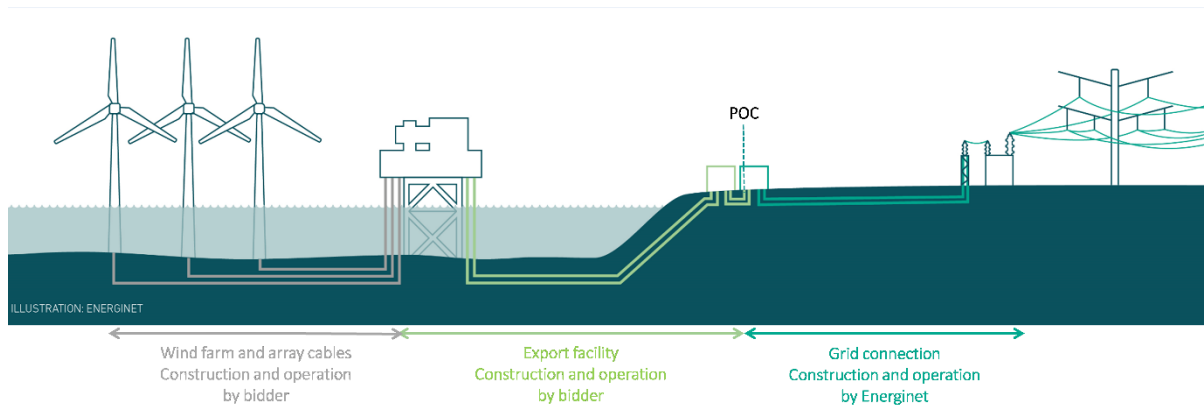
**Figure 1-2. Sketch of the cabling of the Thor OWF.**

From Figure 1-2, it can be seen which parts need to be established in the construction and operation of Thor OWF.

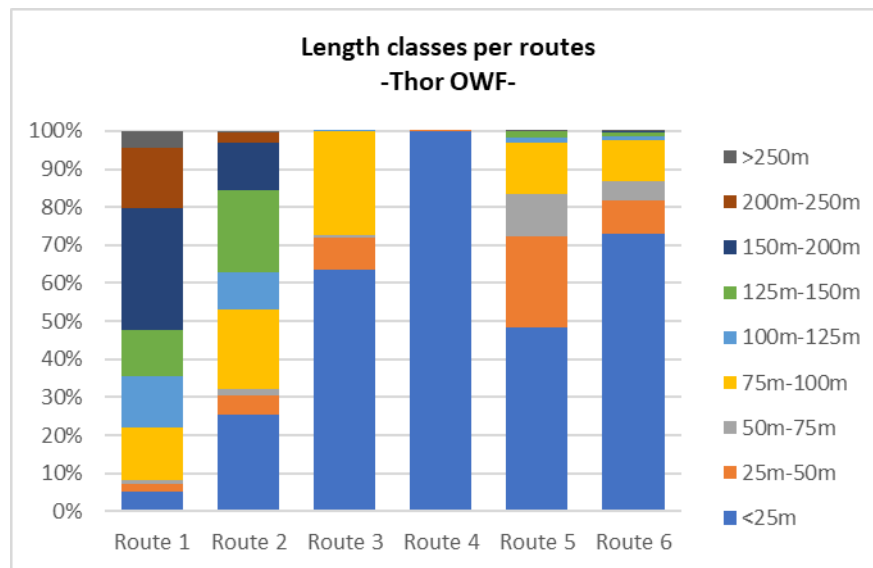
**Figure 2-2 Shows the size of the ships on the given routes based on ship sizes given in AIS data from 1<sup>st</sup> of January to 31<sup>st</sup> of December 2019.**

As mentioned above, it is clear from Figure 2-2 that the traffic going around Jutland ("Route 1") consists of the larger ships. This leads to the heaviest traffic going by this route, while the smaller ships are seen on the other routes going to and from the local harbours.

**Route 1:** As shown in Figure 2-2, “Route 1” primarily accounts for larger ships. It can be seen that more than 50% of the ships are 150 m or more, while more than 75% are longer than 100 m, based on AIS-data from 2019. Around 90% of the ships on this route are cargo ships and tankers accordingly to Figure 2-3, which fits with the size of the ships using this route. It is clear from Table 2-2 that “Route 1” carries most of the traffic in the area, with around 17,800 ships per year using the route placed on both directions.

**Route 2:** From Figure 2-2 it is seen that the size of the ships are evenly distributed with roughly 50% being under 100 m. Around 55% of the ships are cargo ships and tankers and 20% being fishing vessels according to Figure 2-3, with numbers based on AIS-data from 2019. From Table 2-2 can it be seen that close to 4,700 ships per year use the route.

**Route 3:** The route going from Hvide Sande and towards the northwest. As seen in Figure 2-2, this route mainly carry ships shorter than 100 m, where more than 60% are fishing vessels cf. Figure 2-3. “Route 3” is used by close to 2,900 ships per year, based on AIS-data from 2019.

**Route 4:** This route is used by ships going to and from Thorsminde harbour. Nearly all the ships using Route 4 are under 25m, with most of them being fishing vessels or under the category “other” cf. Figure 2-2 and Figure 2-3, based on AIS-data from 2019. From Table 2-2 can it be seen that around 2,900 use this route per year.

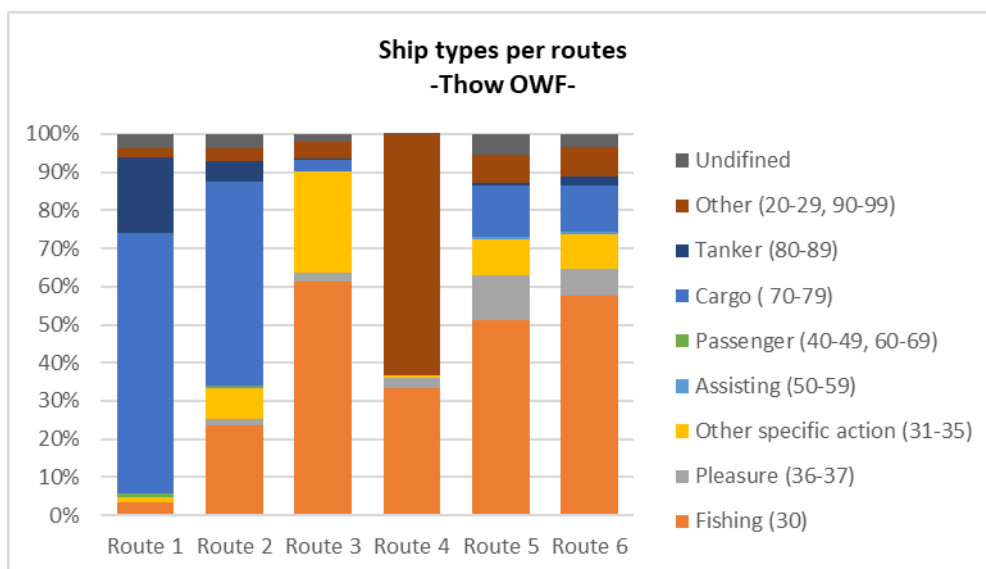
**Figure 2-3 Shows type of the ships on the given route based on ship type given in AIS data from 1<sup>st</sup> of January to 31<sup>st</sup> of December 2019.**

As it can be seen on Figure 2-3, there is a number of ships on Route 4 in the category “others”. Almost all of these registrations are the same dredger going in and out of Thorsminde harbour. Also, a rescue vessel is registered going in and out Thorsminde harbour 94 times.

The type of ships on the routes also confirms that the heavy traffic uses "Route 1" and "Route 2", as it can be seen on Figure 2-3 that these two routes contain mostly cargo ships and tankers.

As seen in Figure 2-3 there are not many pleasure boats using the 6 different routes. It appears that there are most pleasure boats on "Route 5" and "Route 6". The density map in Figure 2-5, shows that the pleasure boats primarily keeps to the shore or goes from/towards Thyborøn from southwest though the investigation area.

From Figure 2-3 and Figure 2-5 it can be concluded that the amount of pleasure boats in the investigation area is minimal compared to the amount of other traffic (heavy traffic and fishing vessels). However, not all pleasure boats are represented in the AIS data, and additional pleasure boats may be present in the area. It is expected that most of these smaller pleasure boats navigate relatively close to the coastline.

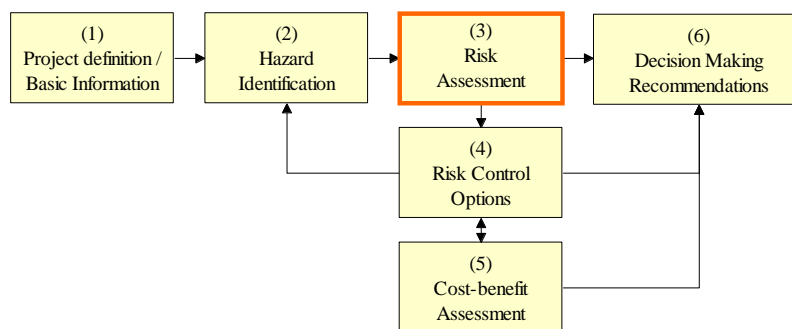
**Figure 4-1. Schematic illustration in steps leading up to a risk assessment and decisions taken based on the risk assessment.**

IMO's guidance for Formal Safety Assessment sets a framework for risk assessment. Relevant elements are described in Figure 4-1 showing how a project definition and a hazard identification leads up to performing the risk assessment.

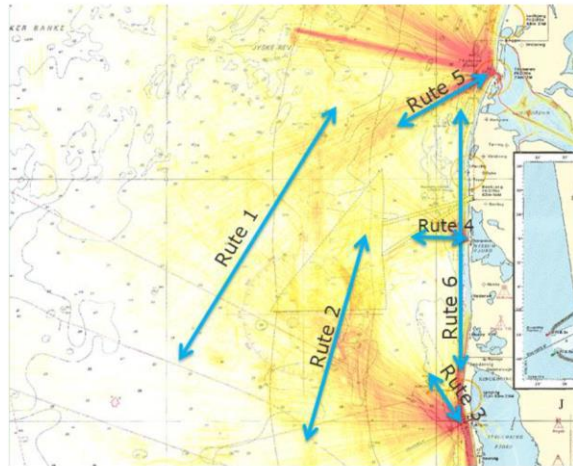
## DENSITETSKORT OVER FISKERE

- Fiskere følger ikke nogen bestemt rute ud fra de 3 havne (Hvide Sande, Thorsminde og Thyborøn)
- Størst antal fiskere syd og nord for området
