INSPECTION AND REMOVAL REPORT - ARTIFICIAL ISLAND PROJECT SITE

104087-ENN-MMT-SUR-REP-WPD-UXO REVISION A | FOR USE OCTOBER 2022

NORTH SEA OWF AND ENERGY ISLAND

UXO INSPECTION AND DISPOSAL SURVEY (WPD) FOR OFFSHORE WIND FARMS AND ENERGY ISLAND

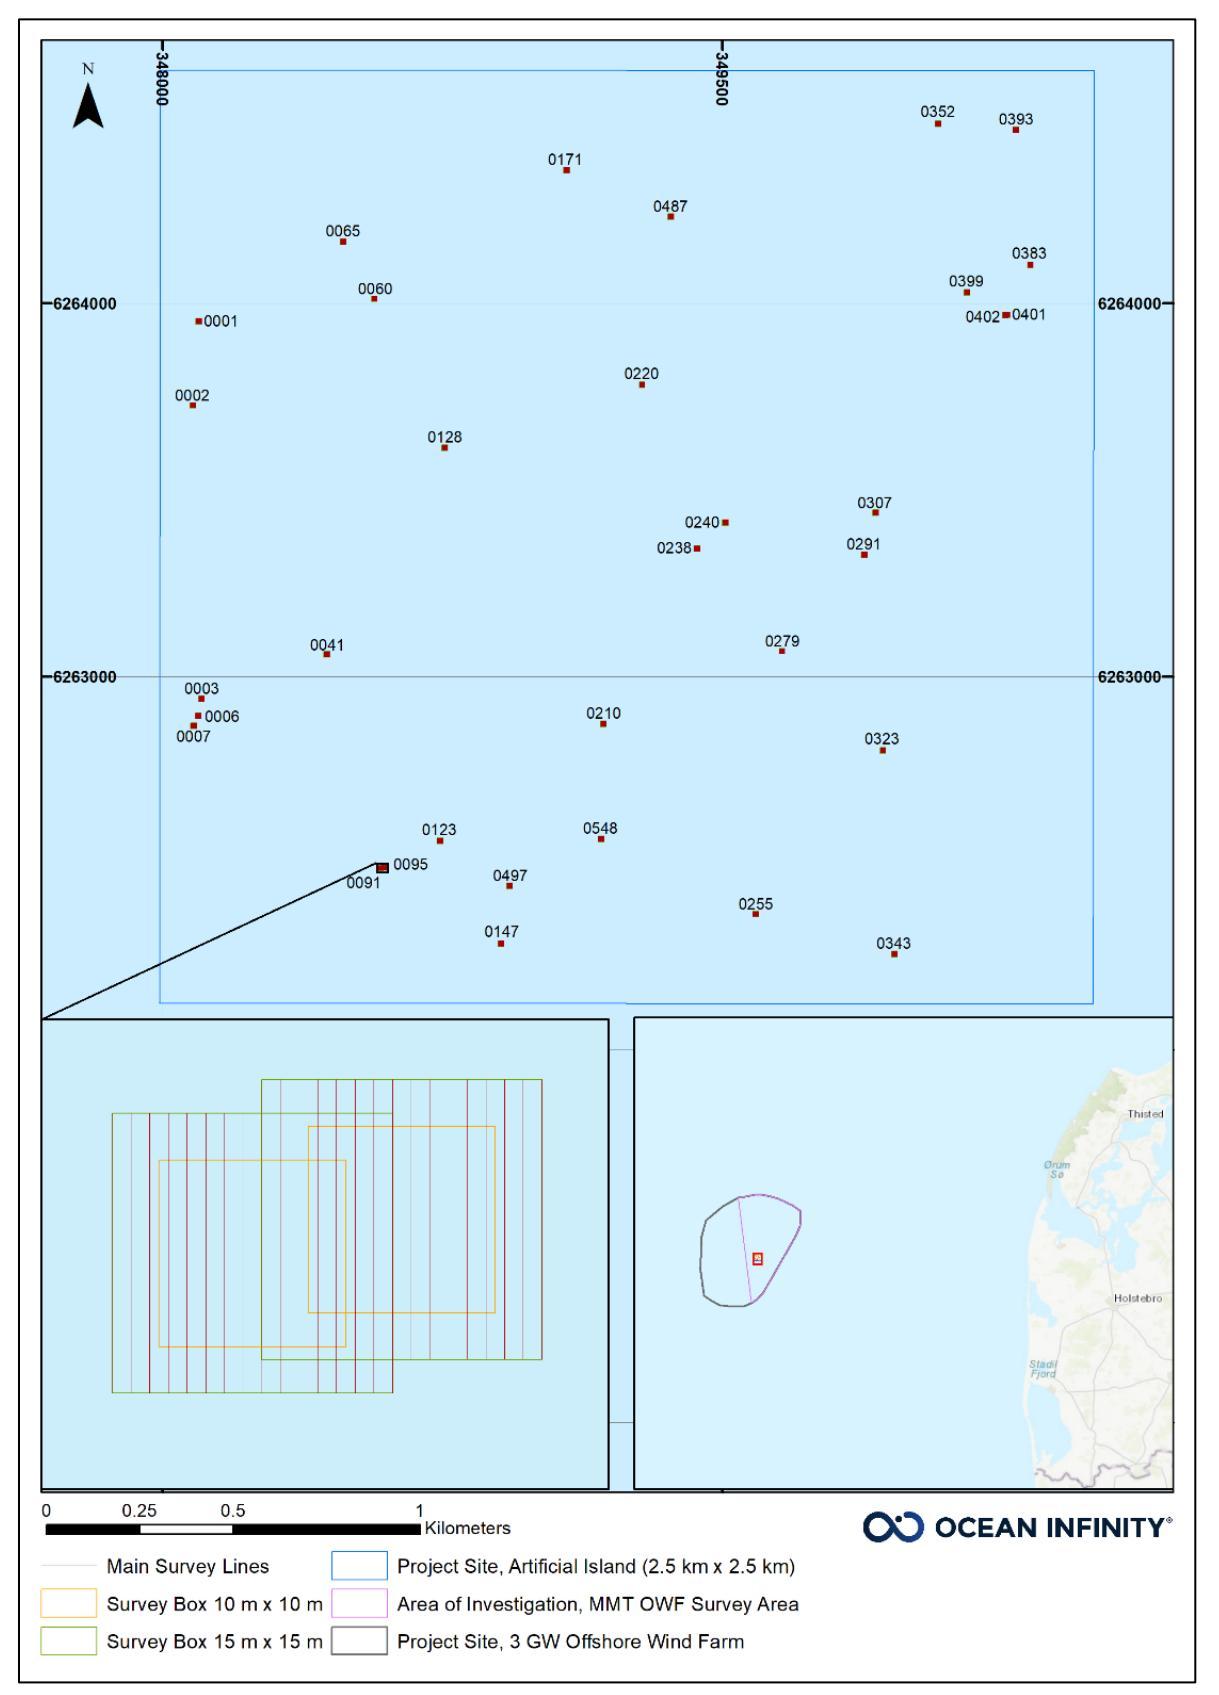
Figure 2 Line plan – Target investigation survey lines in the Artificial Island Project Site.

Survey lines at each UXO inspection location within the Artificial Island Project Site were oriented N-S and performed with the TSS and MBES. An example is shown in Figure 2 below.

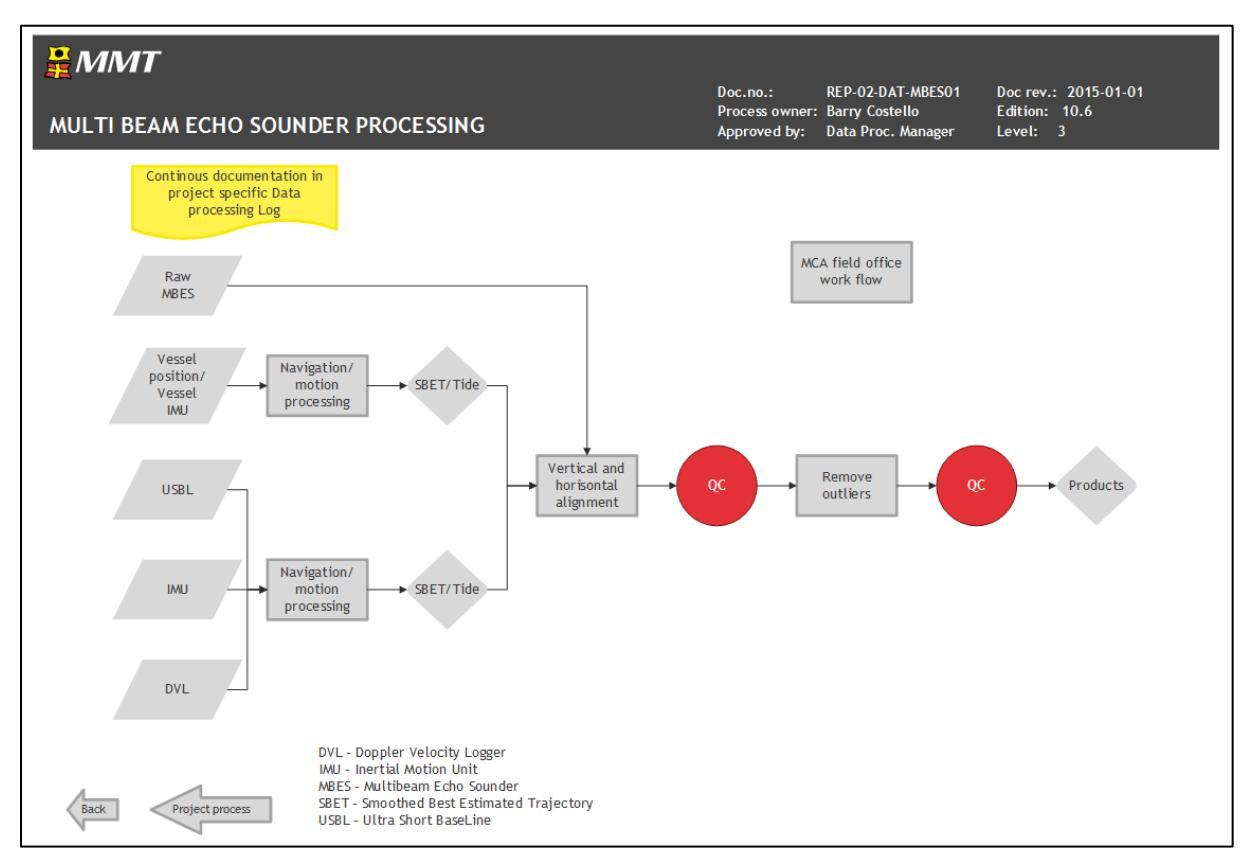
Figure 5 Workflow MBES processing.

The work flow diagram for MBES processing is shown in Figure 5.

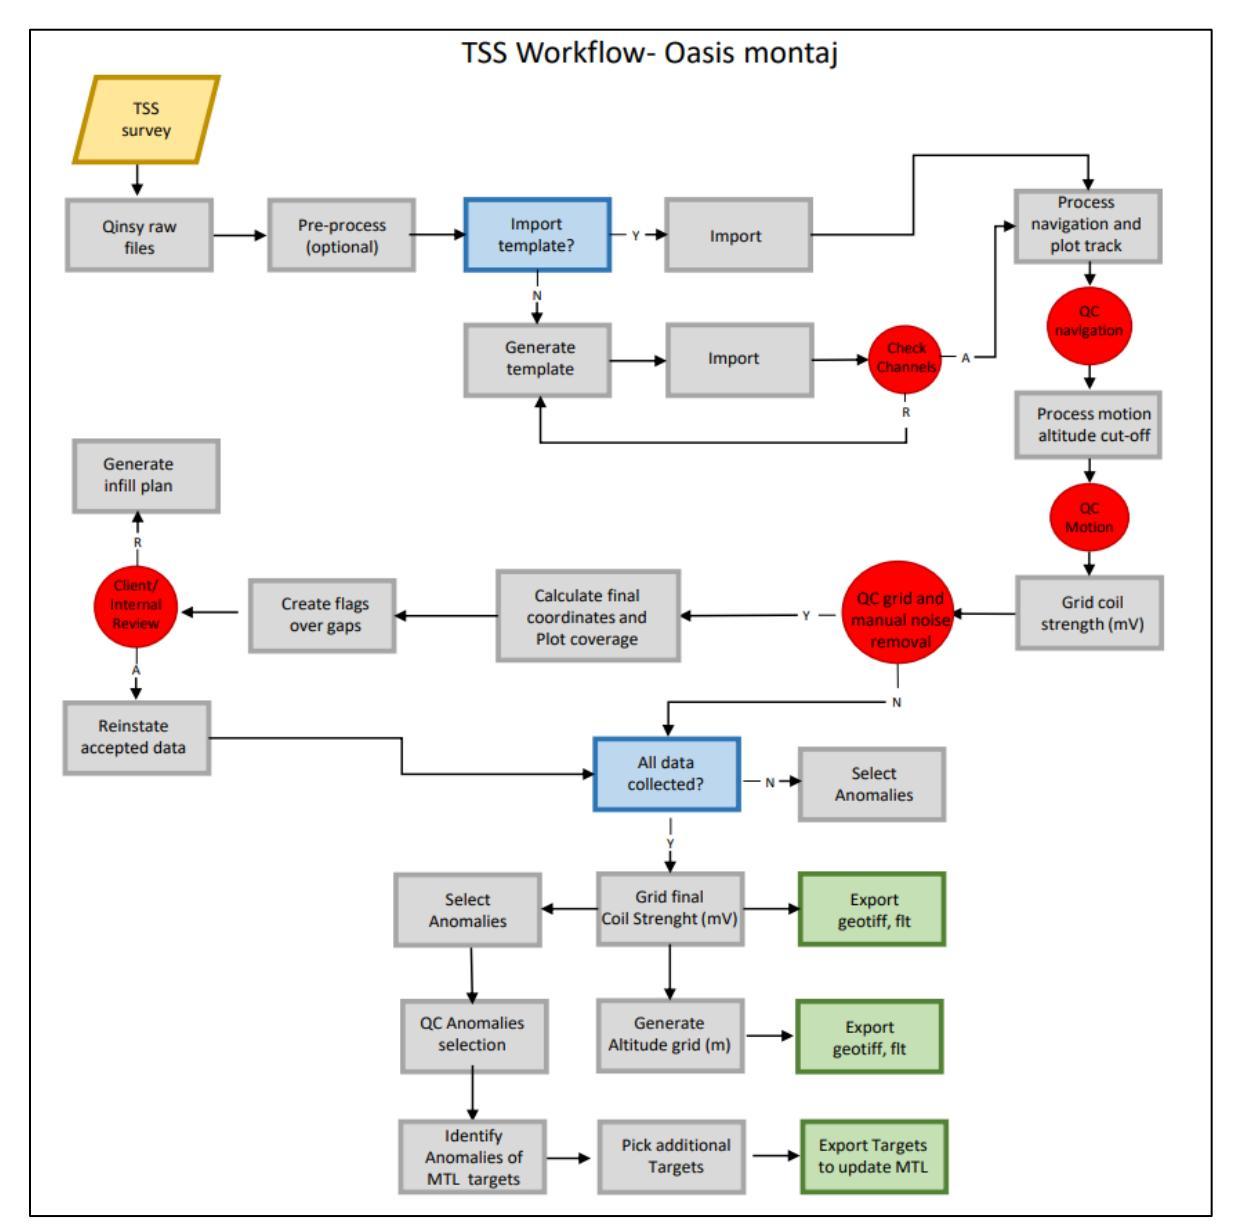
Figure 6 MMT specific workflow for processing TSS data.

The work flow diagram for TSS processing is shown in Figure 6.

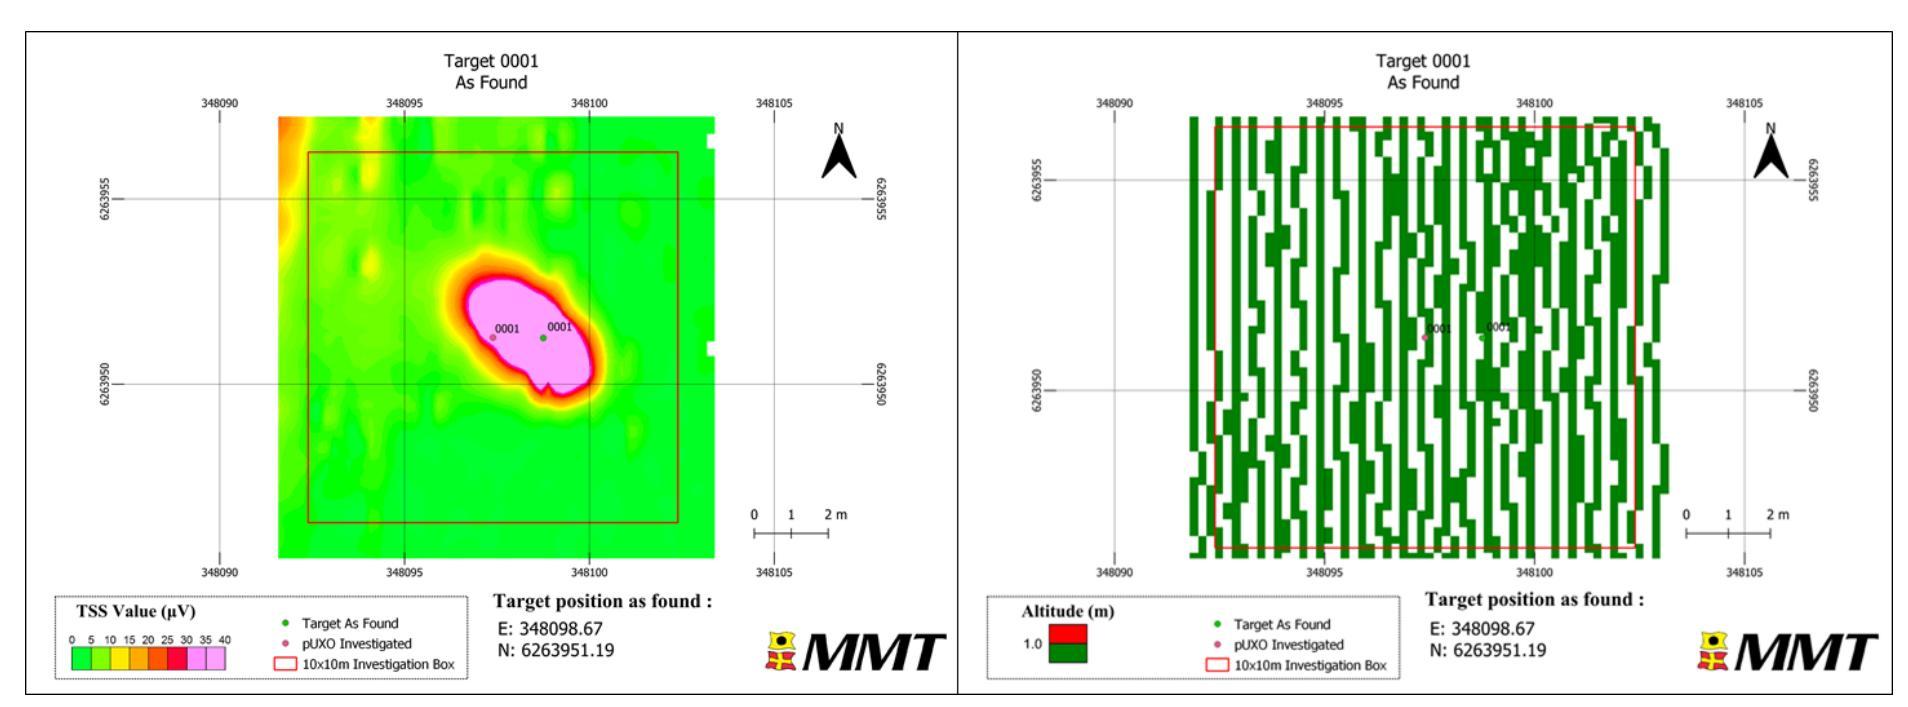
Figure 7 Example of As Found grids created with the project specific requirements and exported as GeoTiffs.

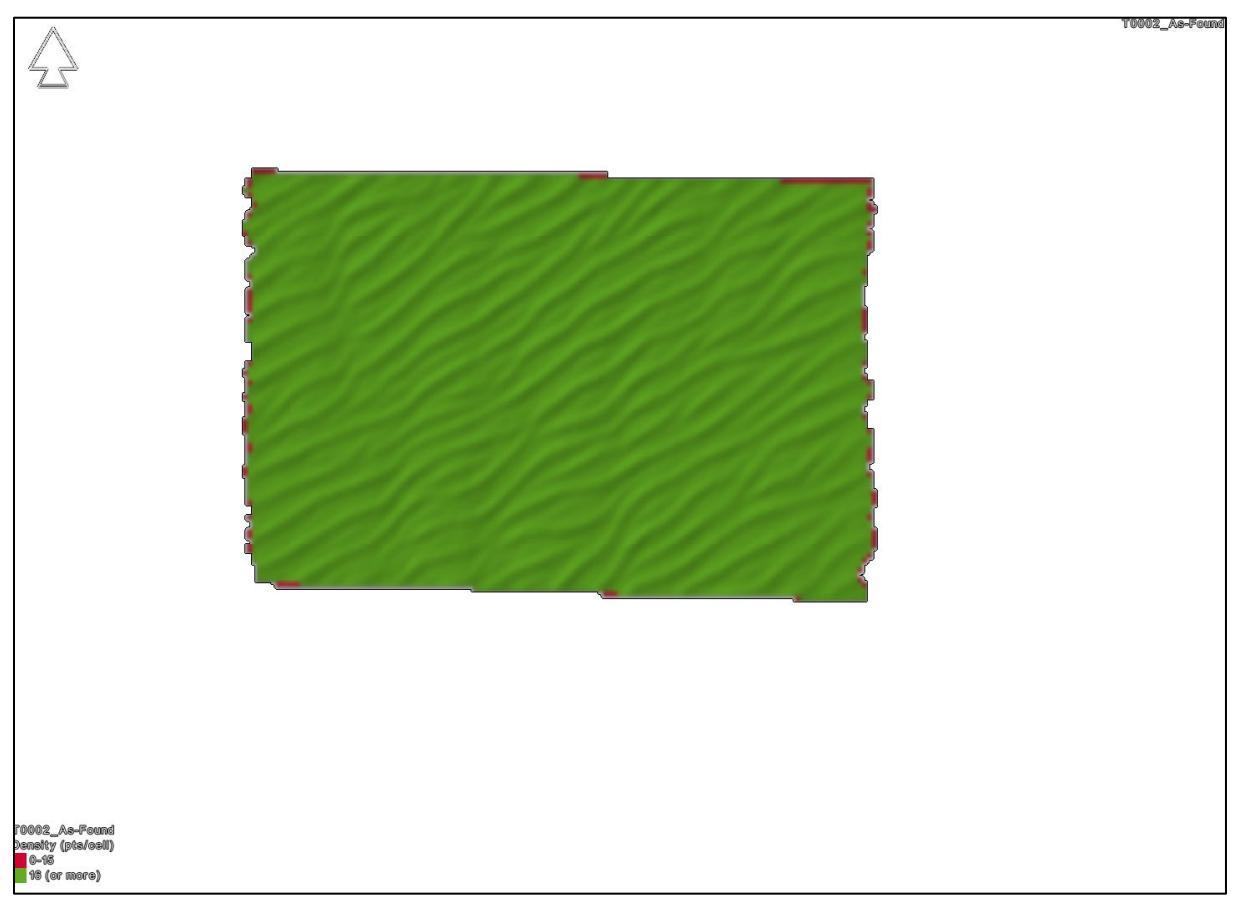
The processed MBES bathymetry data meets the required specifications. Checks were made during acquisition and in post-processing to ensure that sounding density conformed to the 16 soundings per 1.0 m cell criteria (Figure 8). The high ping frequency used for MBES acquisition meant that the data density achieved far exceeded the required density with some cells having hundreds of soundings. The figure below shows that DTM grids with 0.2m gridding met the specifications set for 1.0 m gridding.

Figure 8 Artificial Island project site sounding density per 0.2 m cell.

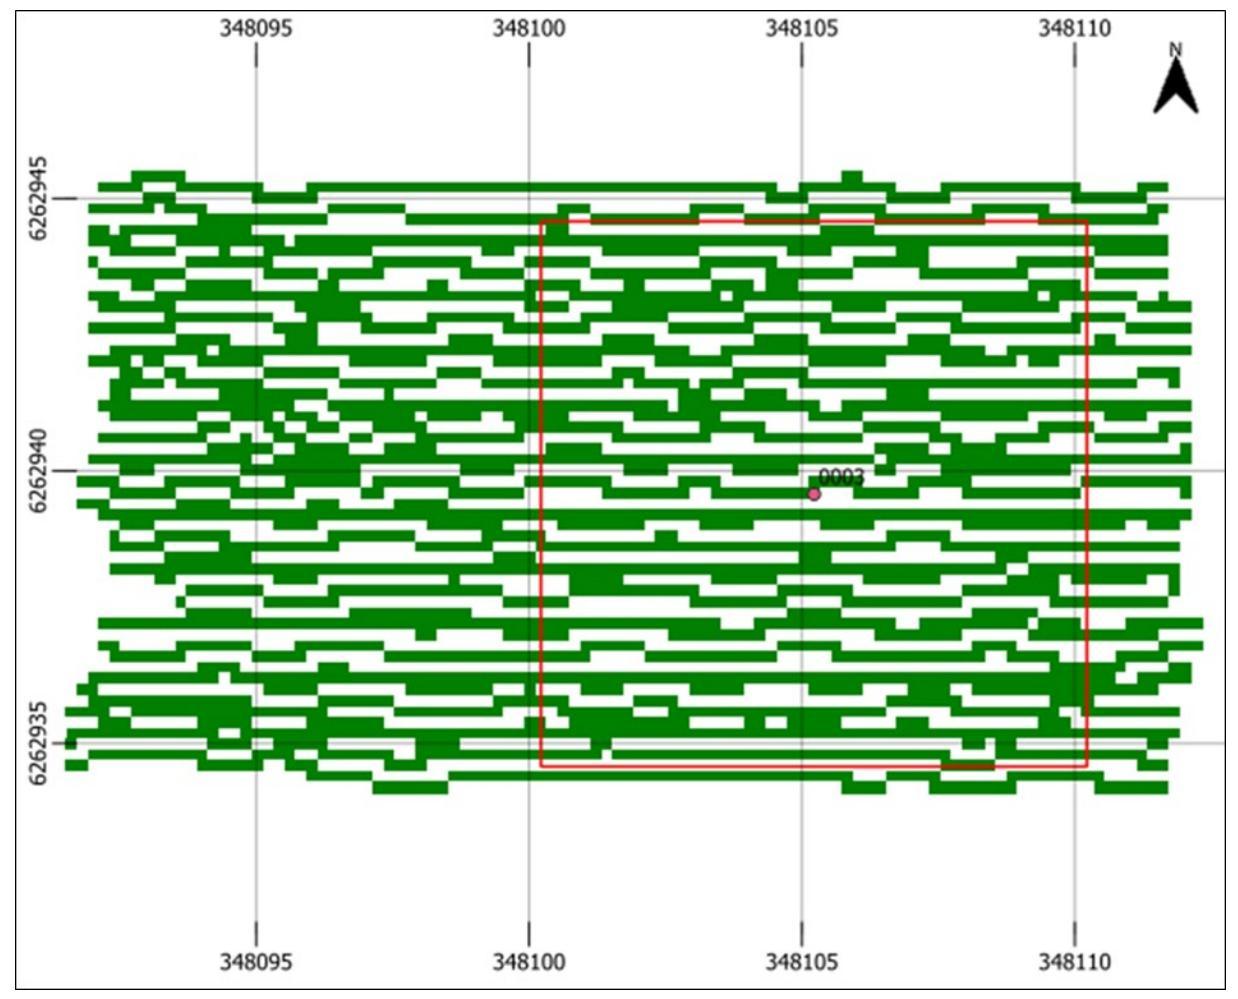
An example of the TSS data density can be seen below in Figure 9.

Figure 9 Sample separation grid for target 0003 As-Found. For a cell to be green it needs to be less than 20 cm from the last cell. So even if a lot of these cells would be red, the density requirement would still be meet.

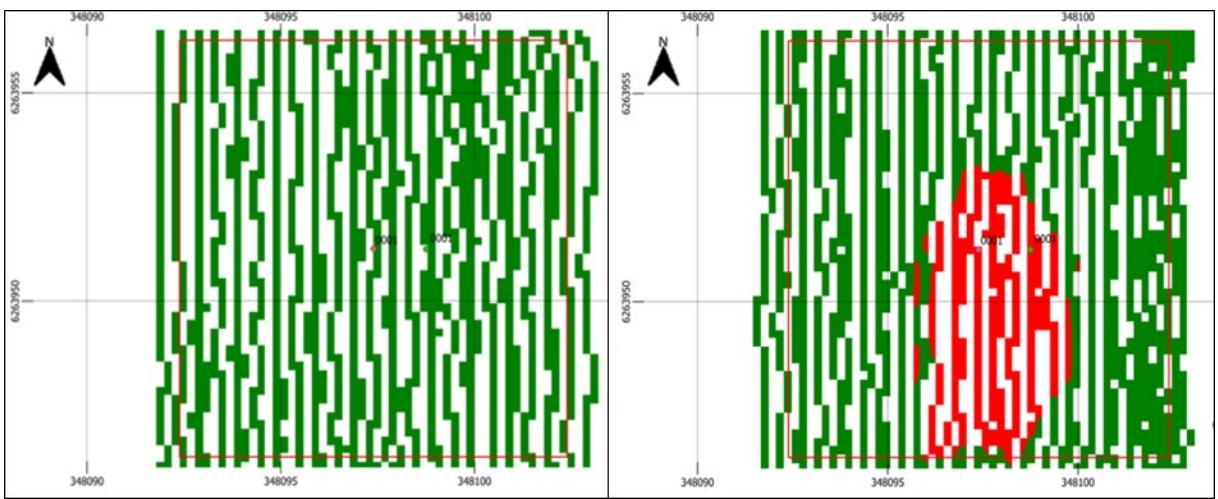
The altitude requirement of staying below 1.0 m was meet for all As-Found surveys but was not for all As-Left surveys because of the depression in the seabed caused by dredging. The WROV is unable to keep the altitude below 1.0 m without the risk of damaging the equipment. These areas were accepted by the on-board Clients Reps (see Figure 10).

Figure 10 Target 0001 As-Found altitude grid on the left and As-Left altitude grid on the right. Green means altitude above the seabed is below 1.0 m and red means it is above 1.0 m.

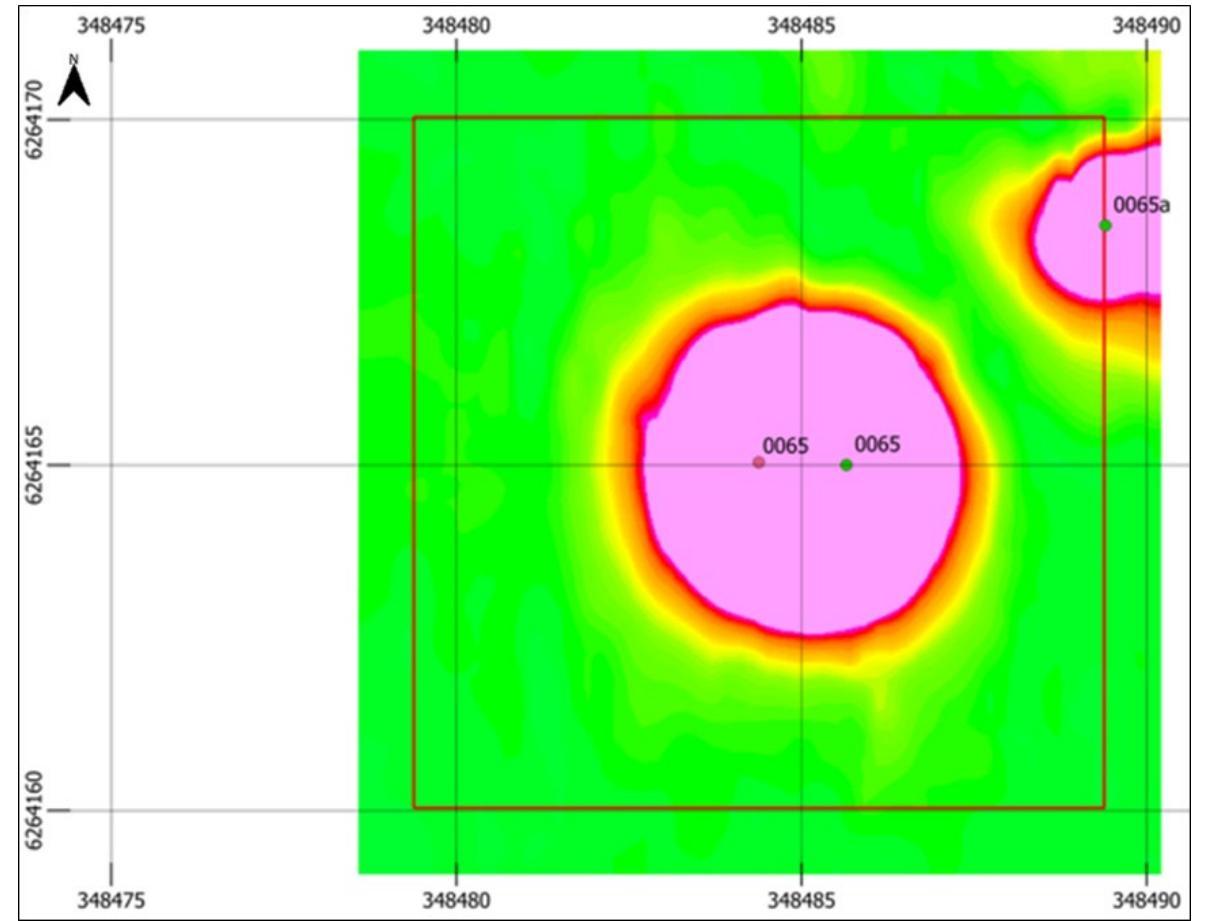
In Figure 11, a magnetic grid of target 0065 is presented showing the low noise levels: green is 0 μ V, yellow is 10 μ V and pink is 40 μ V or higher. The average noise level was between 0 - 6 μ V.

Figure 11 Target 0065 μ V grid shows a circular shaped anomaly with a smaller anomaly close by. The main anomaly has a peak value of 6315 μ V and the smaller one has 155 μ V. Observe the lighter green area in the north part of the grid, its where the data is noisiest.

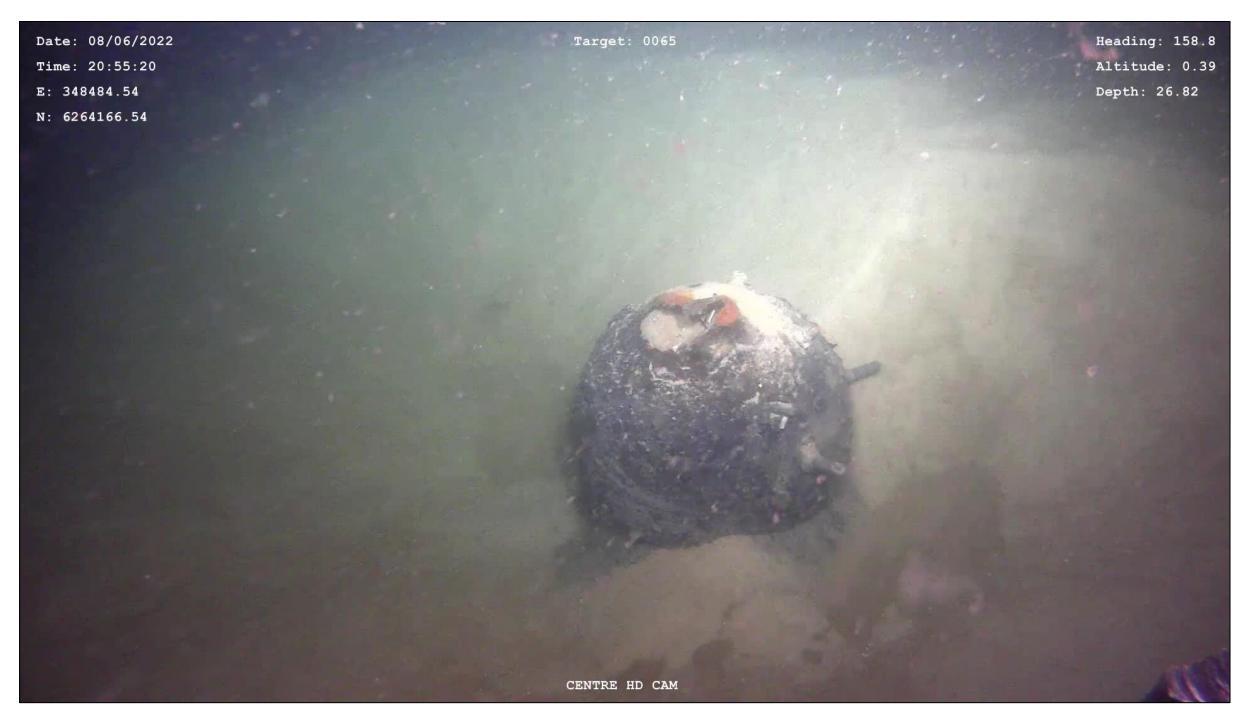
Figure 12 to Figure 15 are showing the before and after disposal completion by the Danish Navy EOD specialists of targets 0065 and 0255. Detailed information about these targets is presented in Appendix A| Target Investigation Report (TIR).

Figure 12 Target 0065 as found after dredging/excavation.

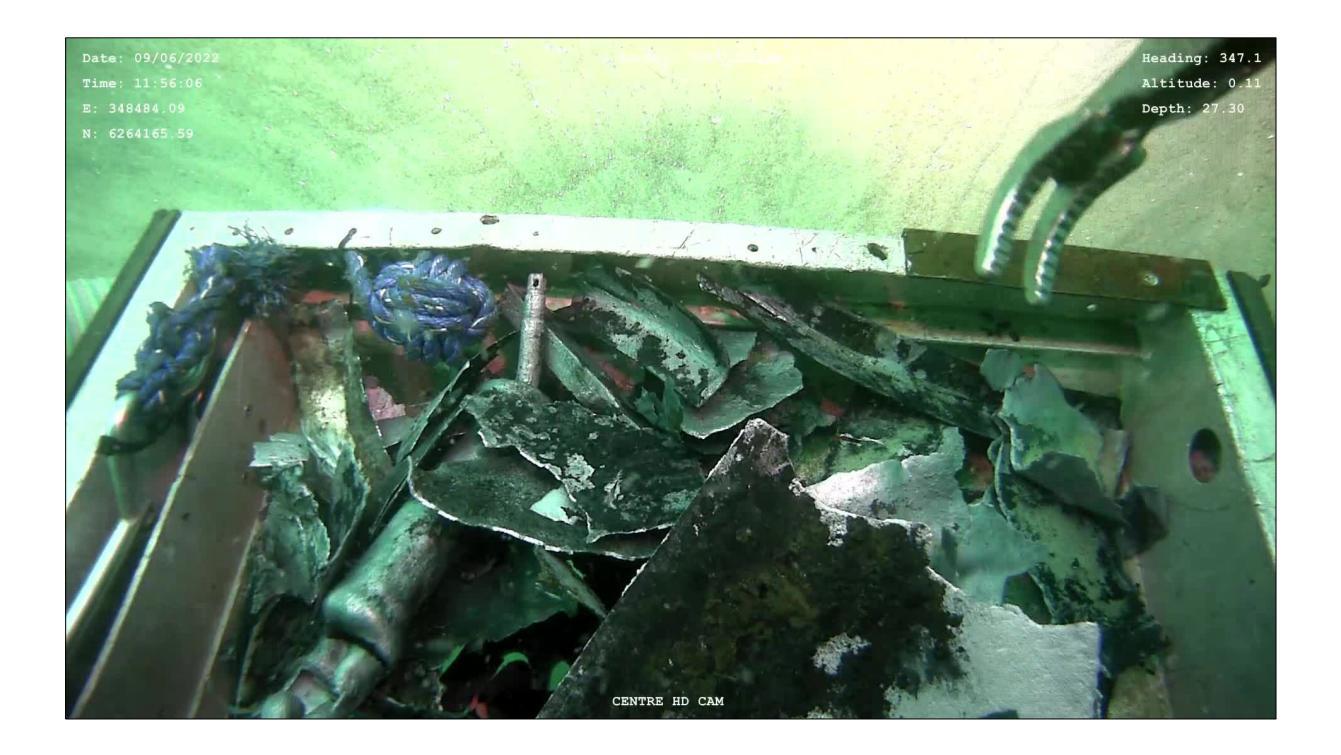
Figure 13 Target 0065 after disposal by the Danish Navy EOD specialists.

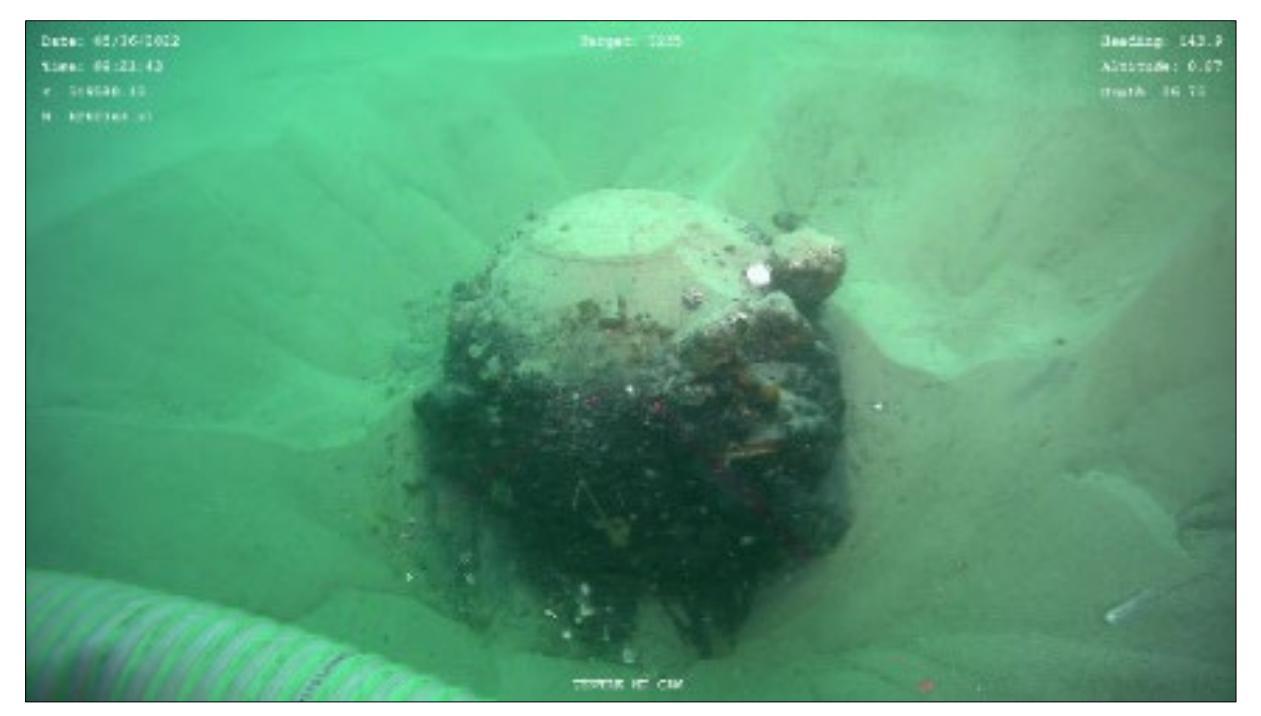
Figure 14 Target 0255 as found after dredging/excavation.

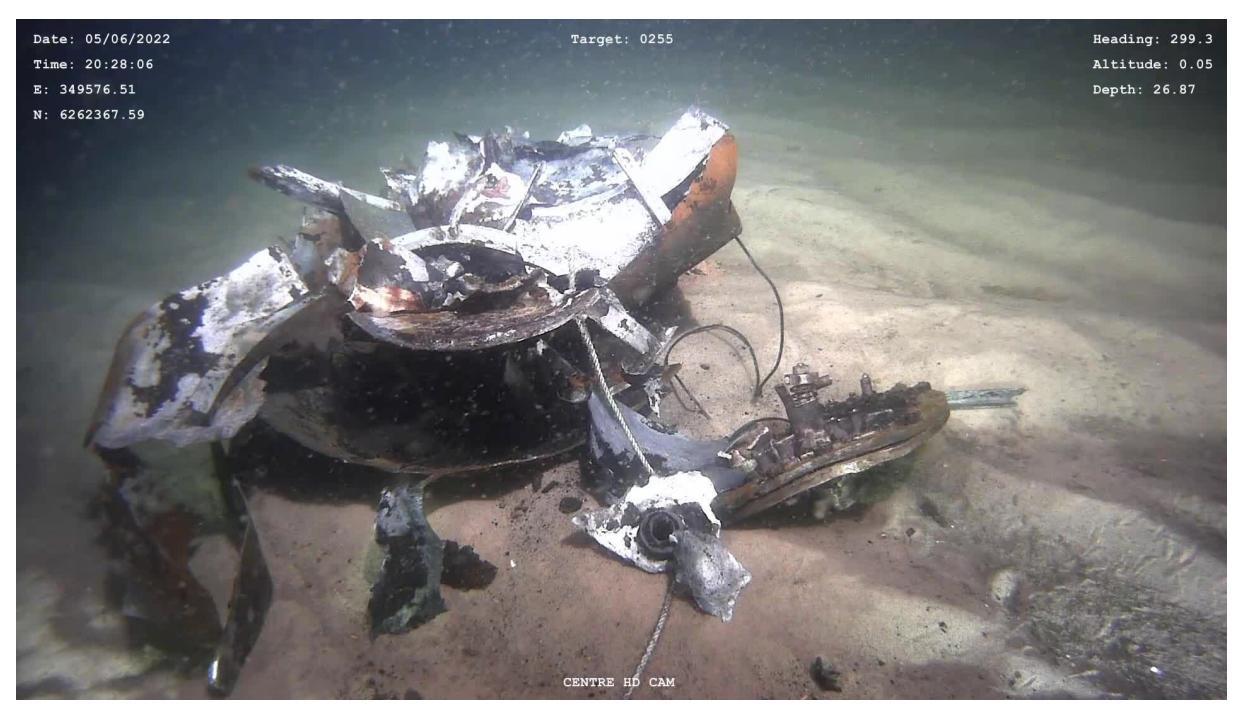
Figure 15 Target 0255 after disposal by the Danish Navy EOD specialists.

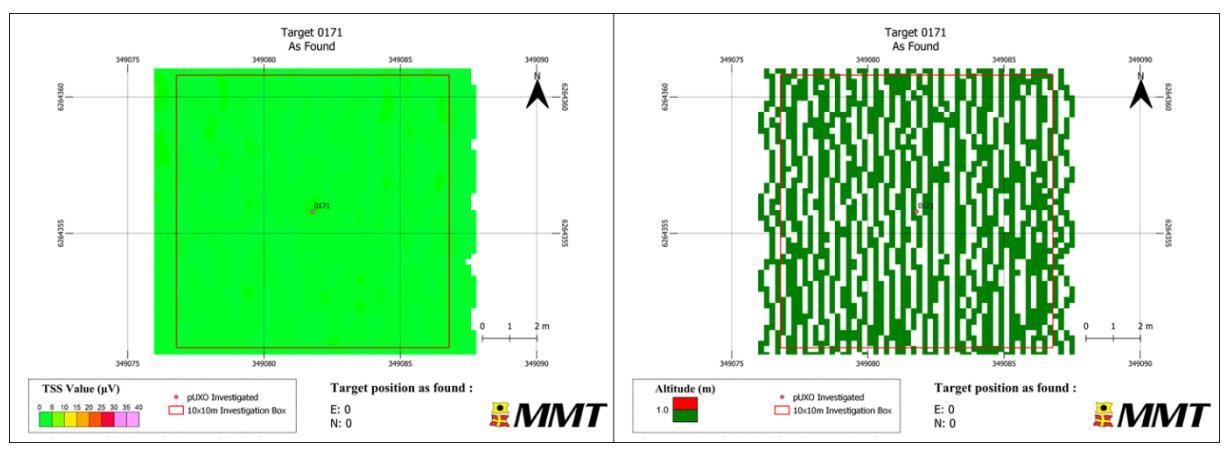
Only one of the 33 targets was not identified on the first 10 m x 10 m TSS As-Found survey, target 0171 (Figure 16). According to the project specific procedure, when a target is not found by the first TSS survey inside the 10 m x10 m target box, a second TSS As-Found survey must be performed inside the 15 m x 15 m target box (Figure 17). Both TSS As-Found surveys showed no anomalies detection.

Figure 16 TSS As-Found magnetic grid on the left side and TSS As-Found altitude grid on the right side performed within the 10 m x 10 m target box.

Since no TSS hits were found on target 0171 in 10 m x 10 m and 15 m x 15 m target boxes during both TSS As-Found surveys, Client Rep on-board approved that nothing was found at the location and no further action required.

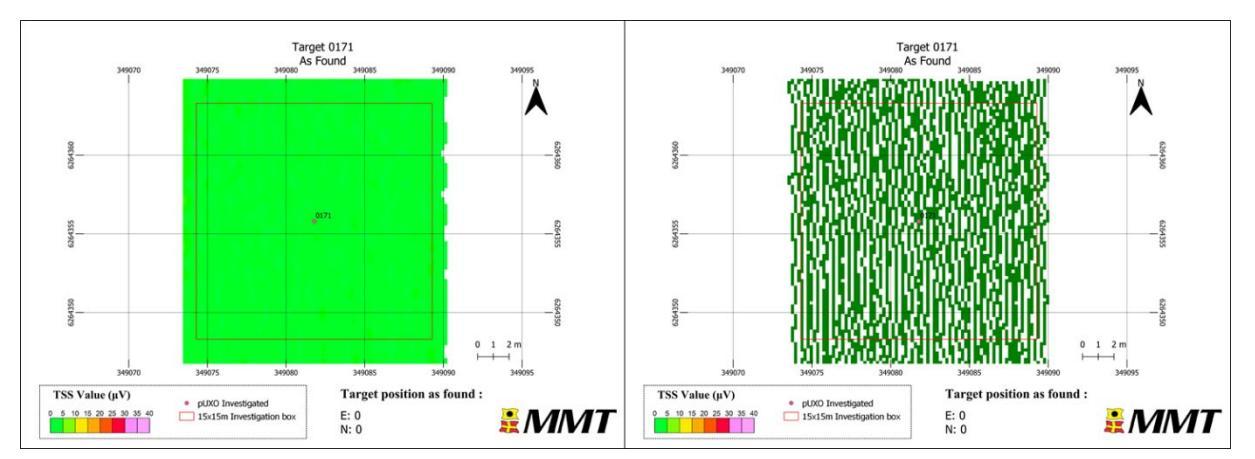
A TSS check with WROV tether was performed to verify if equipment was working correctly and it was verified there were no issues with the coils (a magnetic signature was detected by all coils).

Figure 17 TSS As-Found magnetic grid on the left side and TSS As-Found altitude grid on the right side performed within the 15 m x 15 m target box.
