UXO DESK STUDY

OFFSHORE WIND FARM BORNHOLM I WEST

Report:	UXO Desk Study Offshore Wind Farm Bornholm I West
Client:	Energinet Eltransmission A/S
Report no.:	2021.03.214/UP0-343
Date:	23-10-2023
Version:	4.0
Author:	E. van den Berg

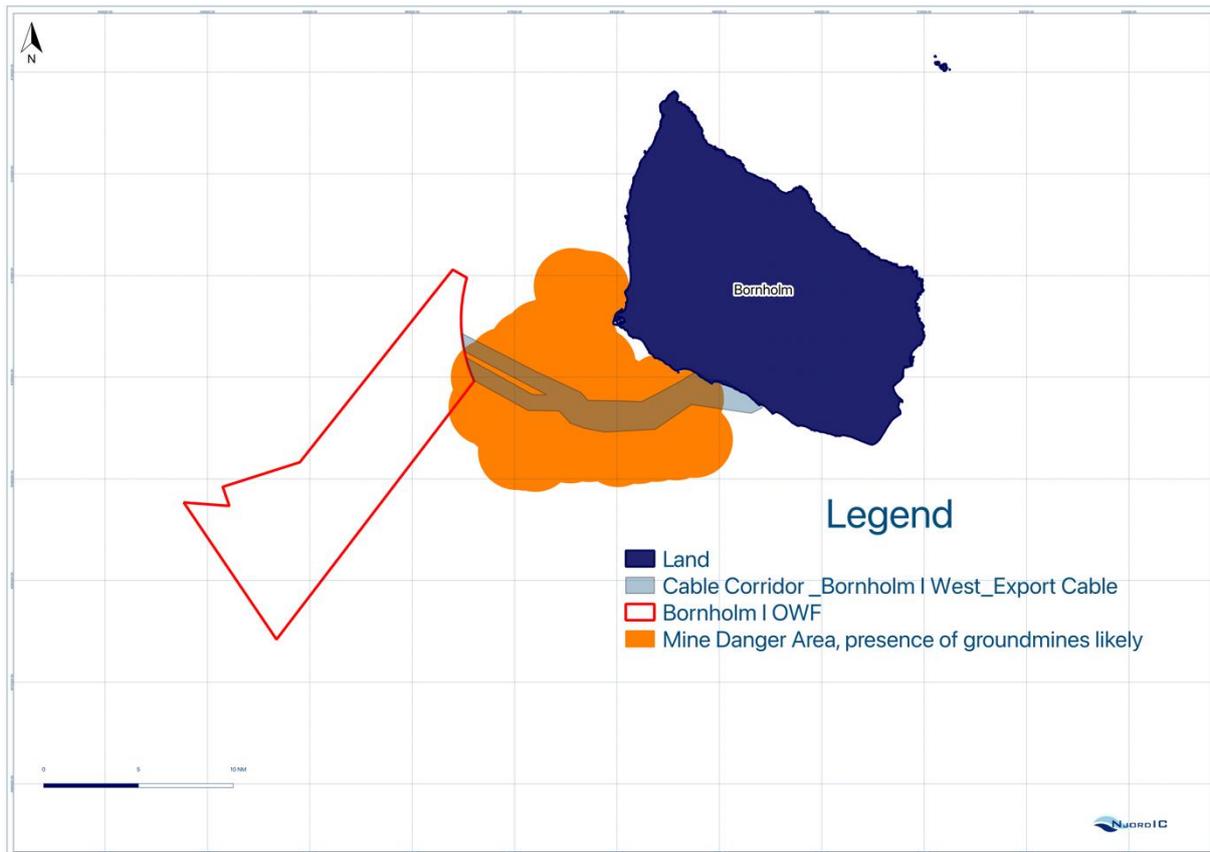
Figure 4: Demarcation of the area Mine Danger Area where the presence of ground mines is likely.

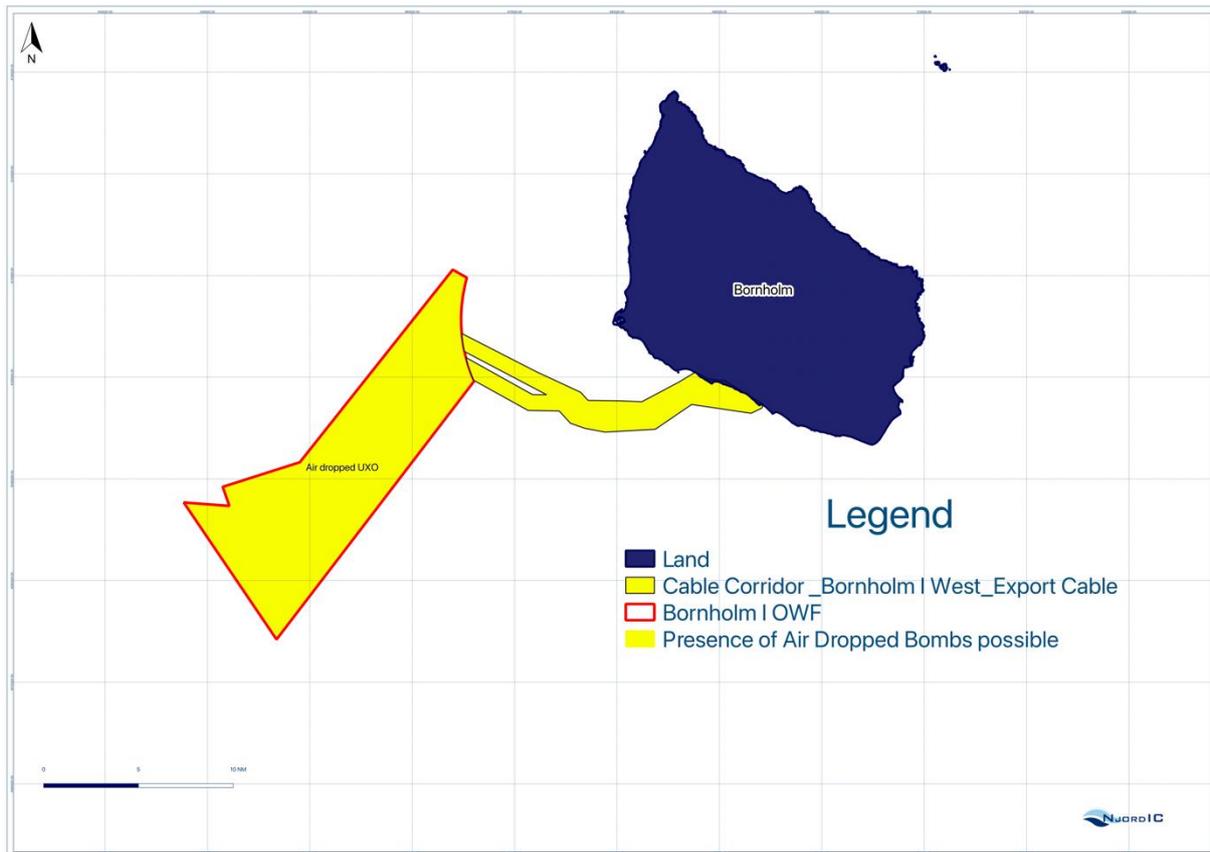
Figure 5: Area within the area of investigation where the presence of jettisoned bombs is possible.

IT is not possible to reliably demarcate the area where bomb jettisons may have occurred. Therefore, the likelihood of presence of jettisoned bombs applies to the entire area of investigation (see Figure 5).

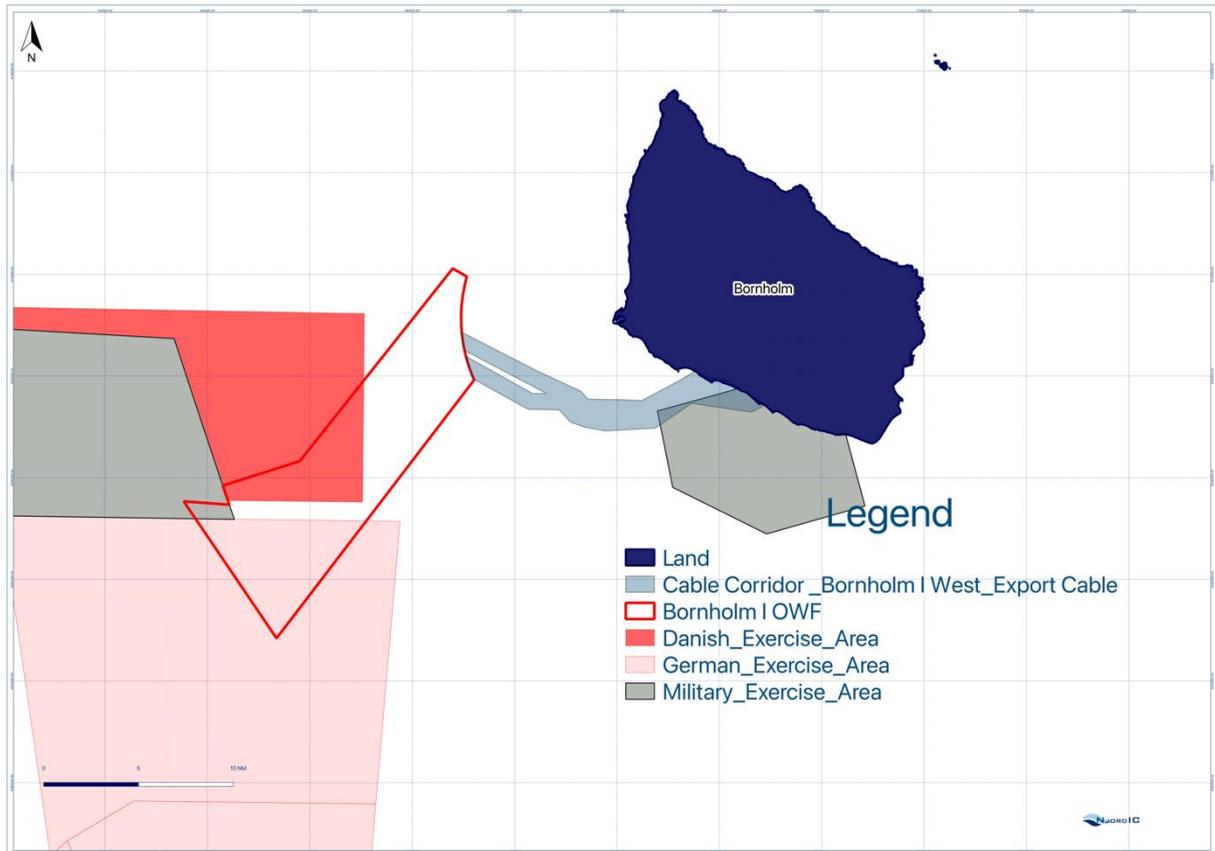
Figure 7: Military training areas.

The likelihood of presence for artillery shells in the area intersecting with the ‘Artillerieschießgebiet Pommersche Bucht’ is assessed to be highly likely, since these UXO were encountered in the neighboring OWFs.

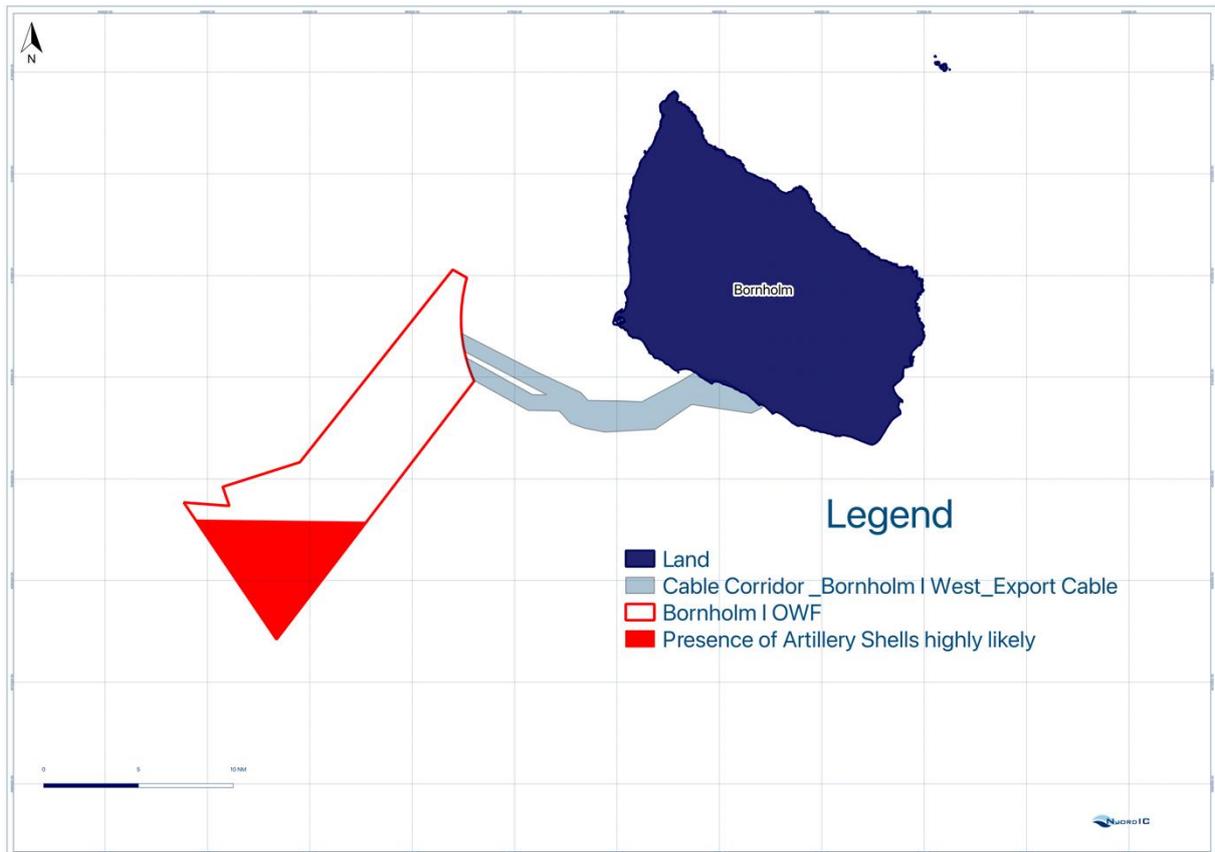
Figure 8: Area within the area of investigation where the presence of artillery shells is highly likely.

The area in which the presence of artillery shells is highly likely is shown in Figure 8.

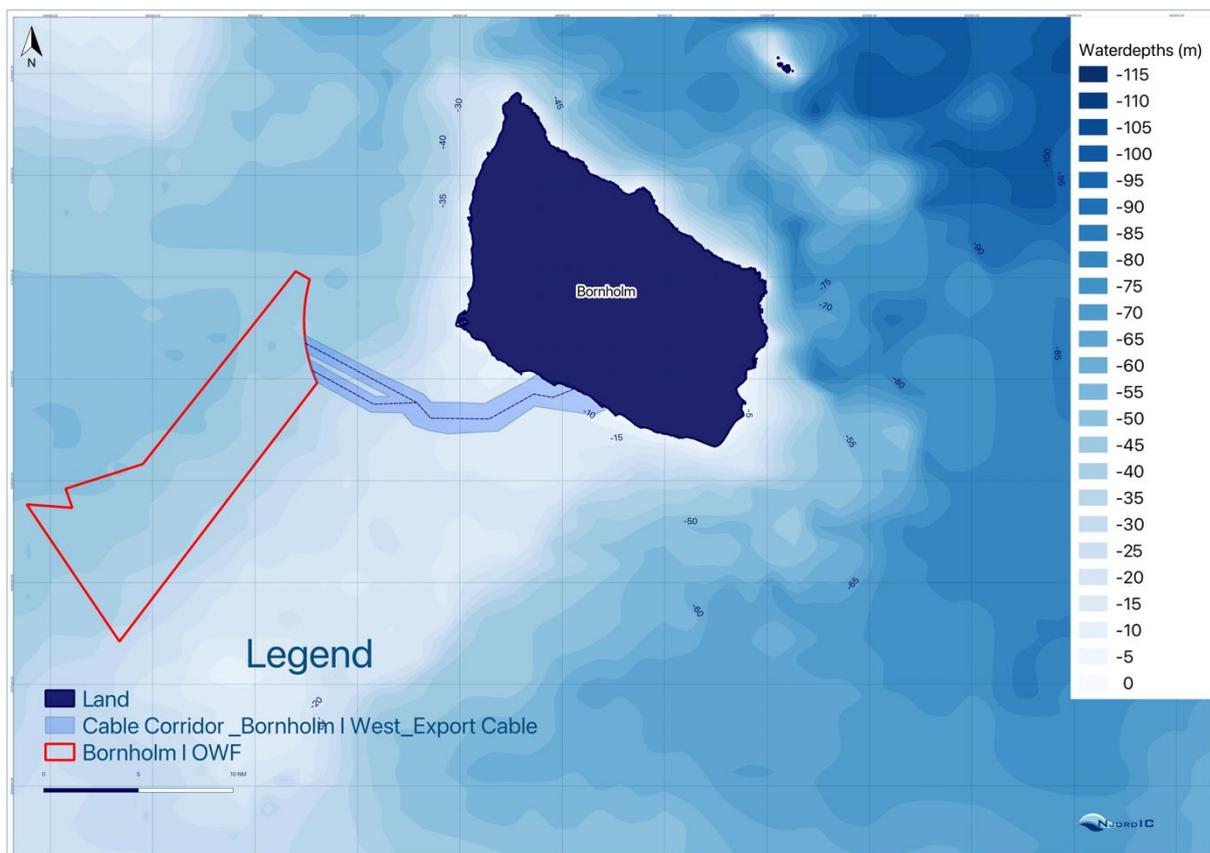
Figure 9: Bathymetry overview. ¹⁰⁰

To the Southwest of Bornholm, a shallow water area with Adler Grund and Rønne Banke separates the Arkona and Bornholm Basins. The Water depths on Rønne Banke is about 20m, and on Adler Grund the shallowest area is about 10 m deep. The maximum water depth in the Bornholm Basin is 92m and the average depth in the Arkona Basin is 48m. In the Bornholm I West OWF site the water depth increases towards the northwest, from approximately 28m to 47m (see paragraph 3.3.1).

An overview of the bathymetry is shown in Figure 9.

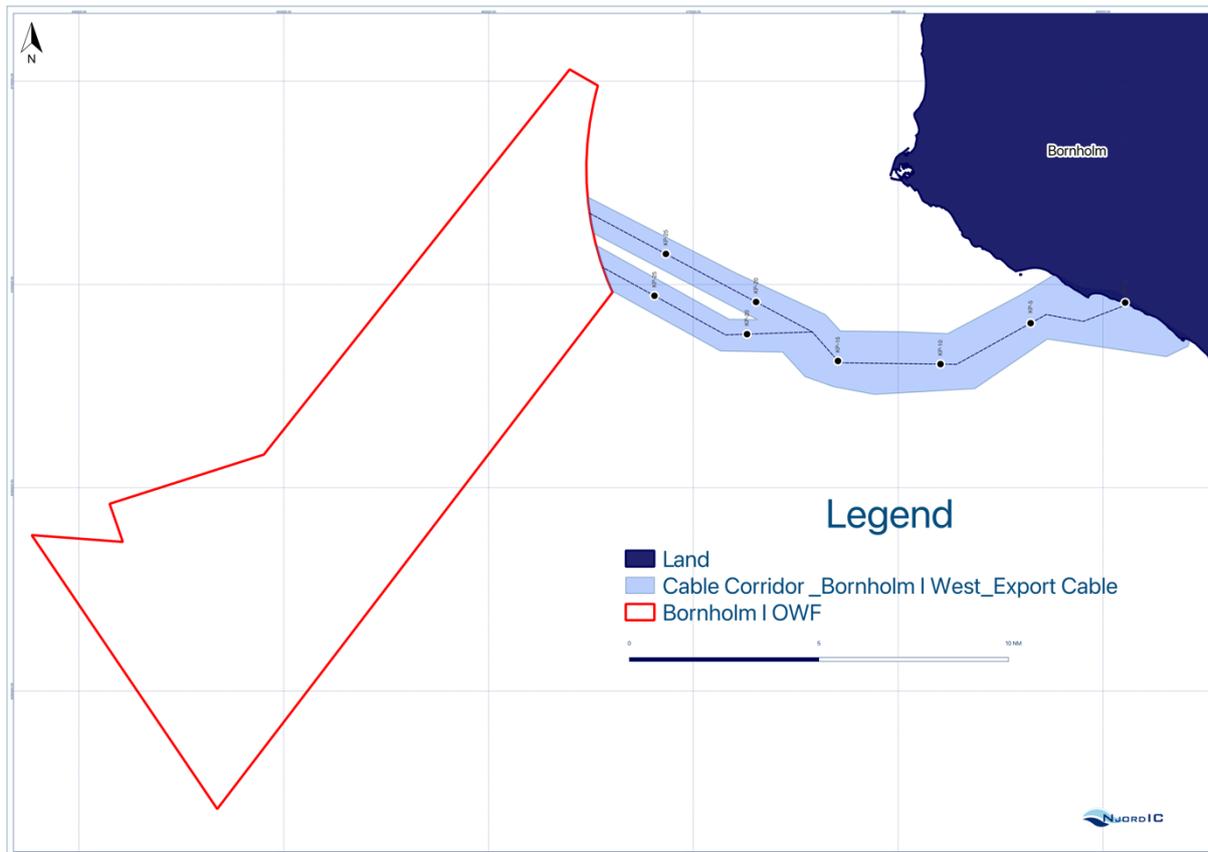
Figure 10: Overview of the Bornholm I West export cable routes. ¹⁰¹

In this section the site-specific information for the export cable route is presented. The export cable route comprises part of the cable route Bornholm-Sjælland (KP 0.000 – KP 16.607), and the export cable routes 1A (KP 16.607 – KP 28.995) and 1B (KP 16.607 – KP 27.560).

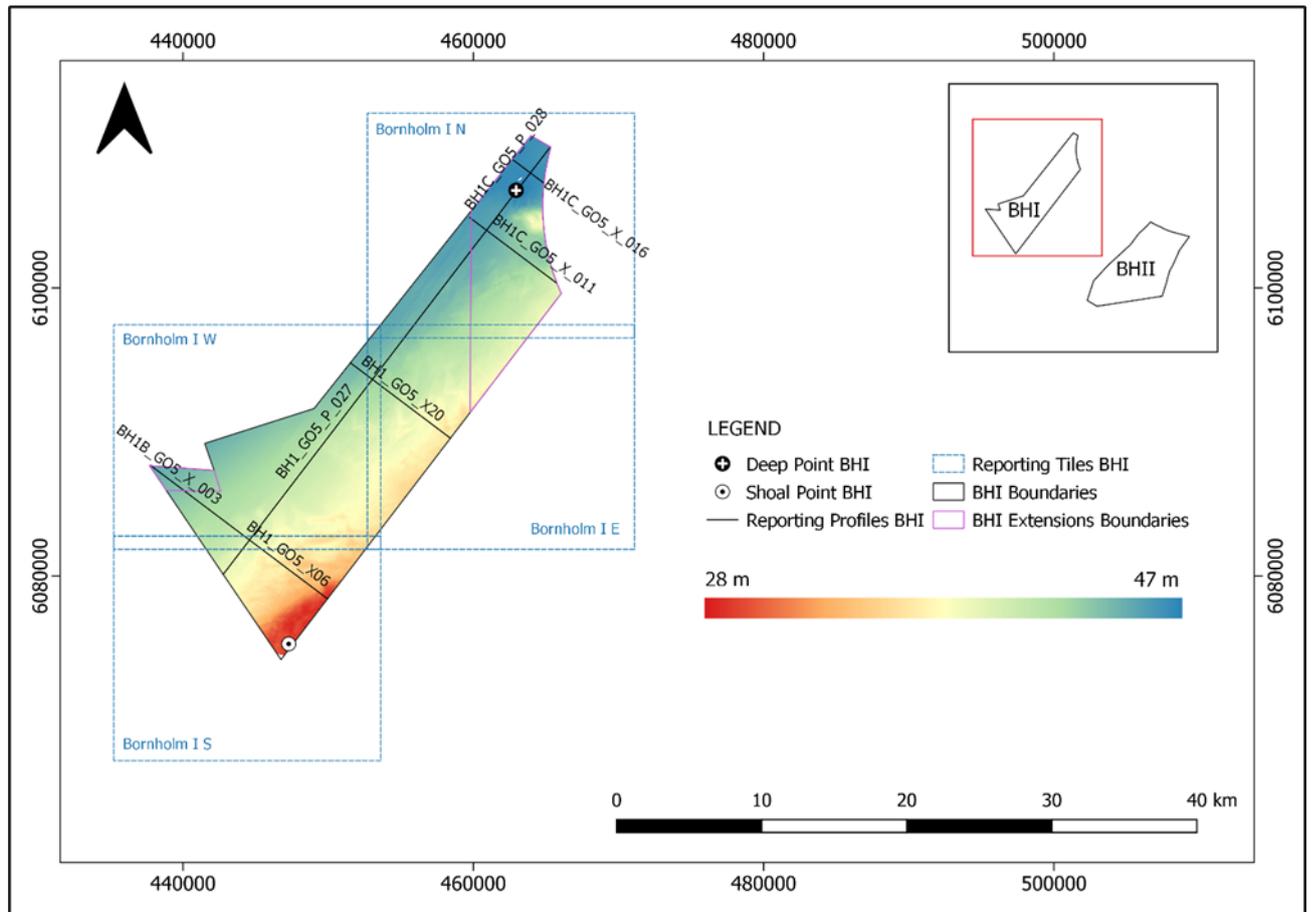
Figure 11: Bathymetry overview. ¹⁰⁷

The water depth varies moderately across the Bornholm I West OWF site. The minimum surveyed depth is 27.83m at 447296m E, 6075327 m N located in the southern part of the site. The maximum surveyed depth is 47.32 m at 462945 m E, 6106756 m N in the northern extended scope (Bornholm I N). The mean depth across the site is 40.63 m. Figure 11 shows an overview of the bathymetry within Bornholm I West.

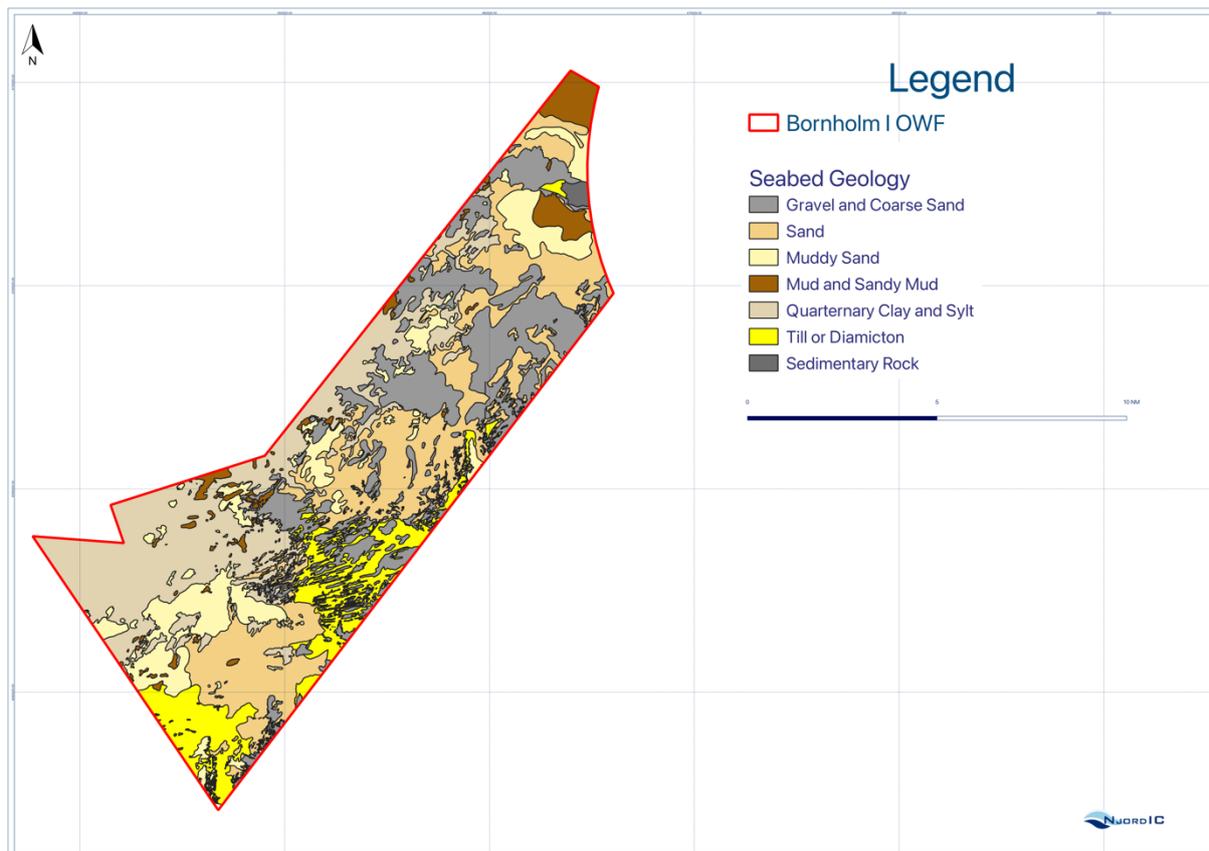
Figure 12: Bornholm I West seabed surface geology classification. ¹⁰⁹

The seabed surface geology is generally characterised by sand and silt. Widespread bands of fine to coarse gravel extend east west while in the eastern section of the site, seabed sediments comprise mainly sand and silt. The western section mainly comprises clay and silt. Alternating bands of fine to coarse gravel and sand and a possible till matrix, extend across from the northern to the eastern part of the site.

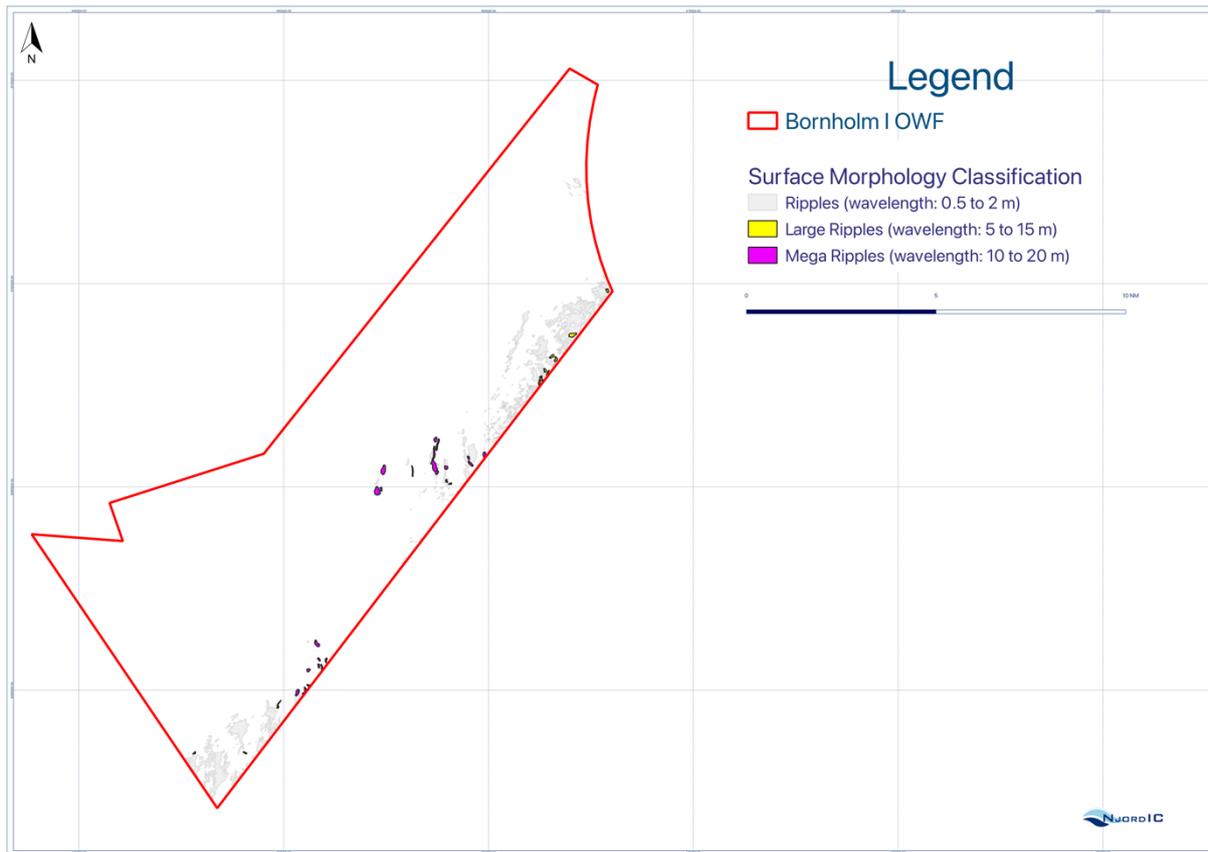
Figure 13: Seabed surface morphology classification¹¹²

¹¹¹ Ripples: wavelength <5m, height <0.01 – 0.1m, large ripples: wavelength of 5m - 15m, height <0.1 - 1m, mega ripples: wavelength 15m - 50m, height 1m – 3m.

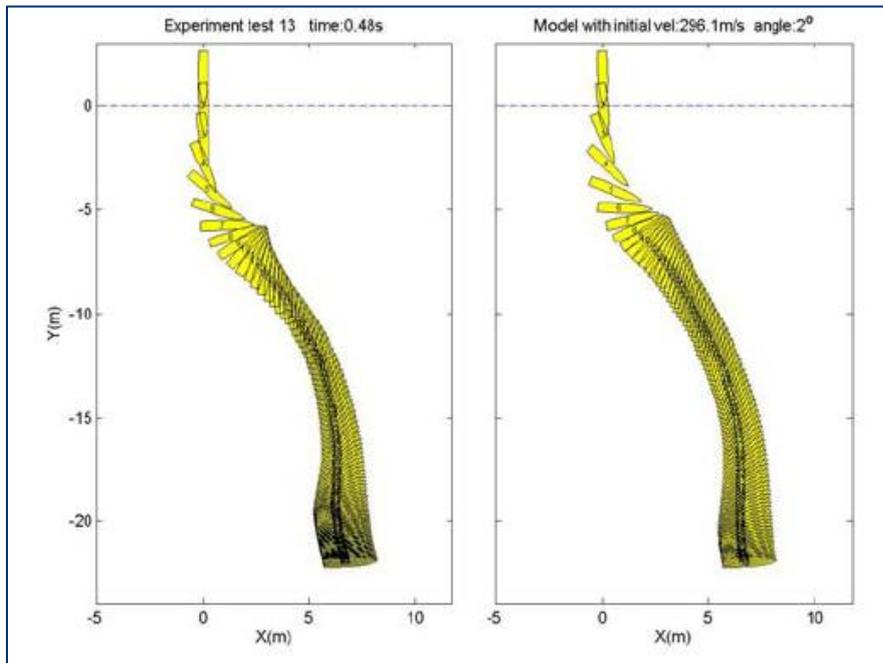
Figure 16: Comparison between modelled and observed Mk84 bomb trajectories. ¹¹⁸

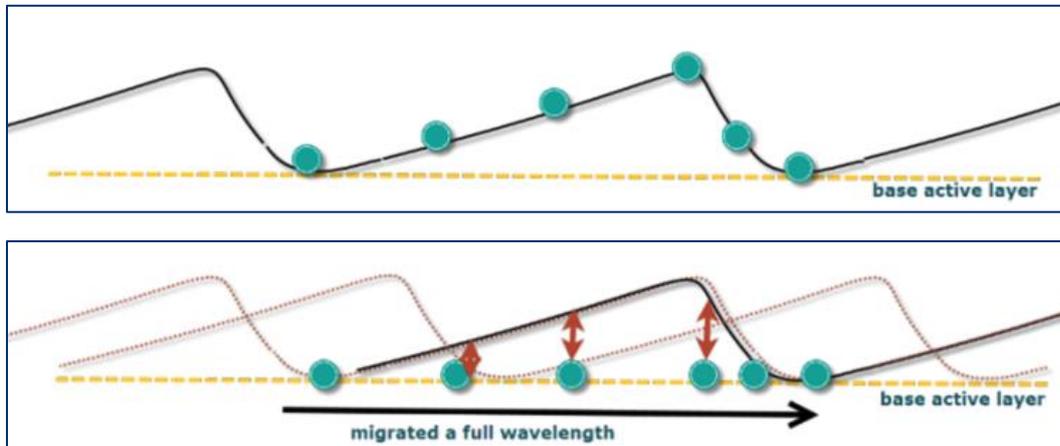
Figure 17: Schematic representation of mobile bedform migration and burial of UXO's to the base of the active layer (cross section of bathymetry).¹²¹

In areas with large ripples, burial because of bedform migration is limited to 1.0m below seabed (at the crests of the large ripples). In areas with mega ripples, the maximum burial depth may be as much as 3.0m below seabed.

A morphodynamical analysis is not available. Therefore, the migration direction and rate of the bedforms is unknown. In assessing the maximum burial depth, it is assumed that since the war, the large and mega ripples have migrated more than a full wavelength, and that all UXO are located on the base of the active layer (see Figure 17). This is a worst-case assumption.

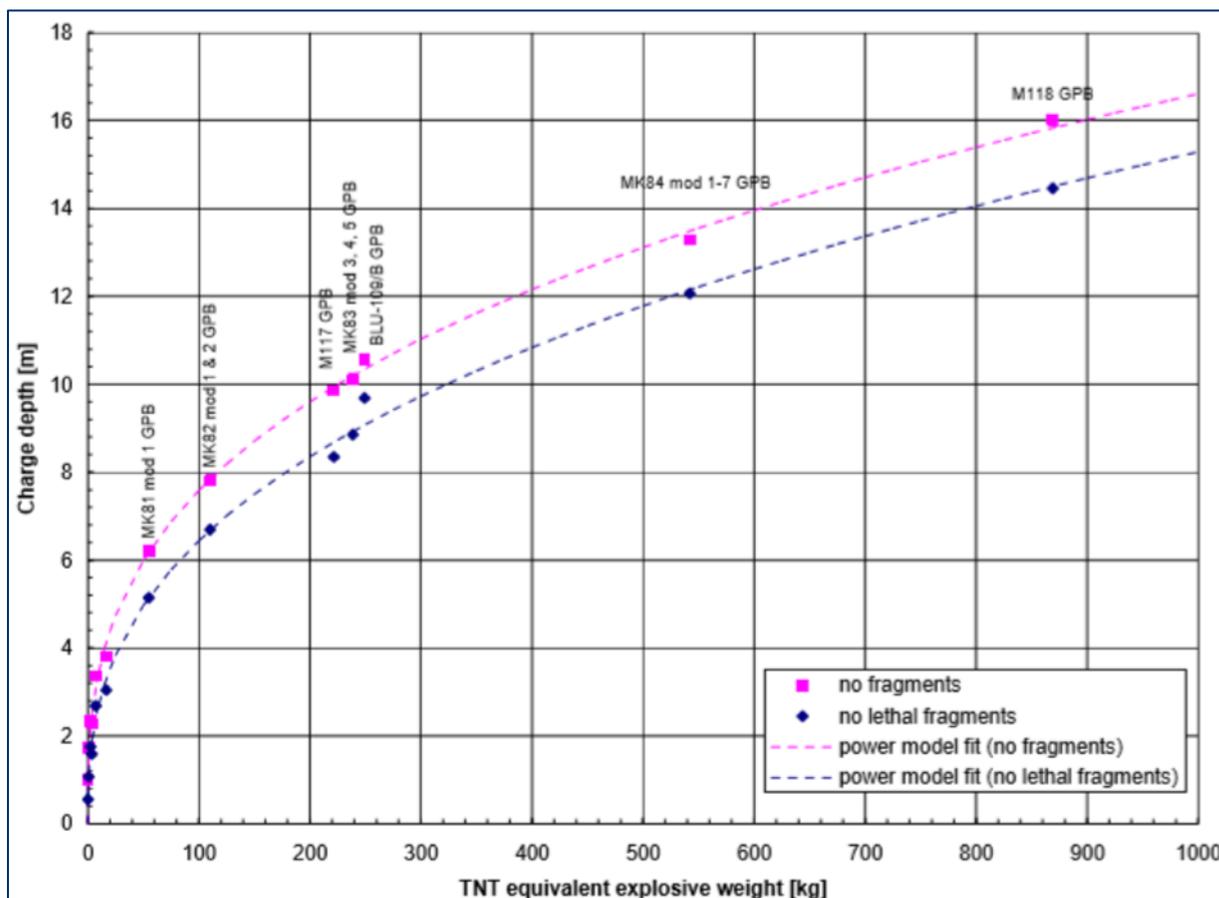
The displayed values are worst-case values based on spear-shaped fragments and a vertical fragment course (perpendicular to the water line). In case of a non-vertical course of the fragments the distance travelled by the fragments through the water column is larger.

Figure 18: Minimal water depths to suppress fragments for 0-1000 kg. ¹⁴⁵

Considering the water depths in Bornholm I West OWF (ranging between 28m to 47m) no risks will occur due to fragmentation in case of a detonation at the seafloor. Only in the shallow parts of the export cable corridors, in water depths under 12.5m, fragmentation may pose a HSE risk.

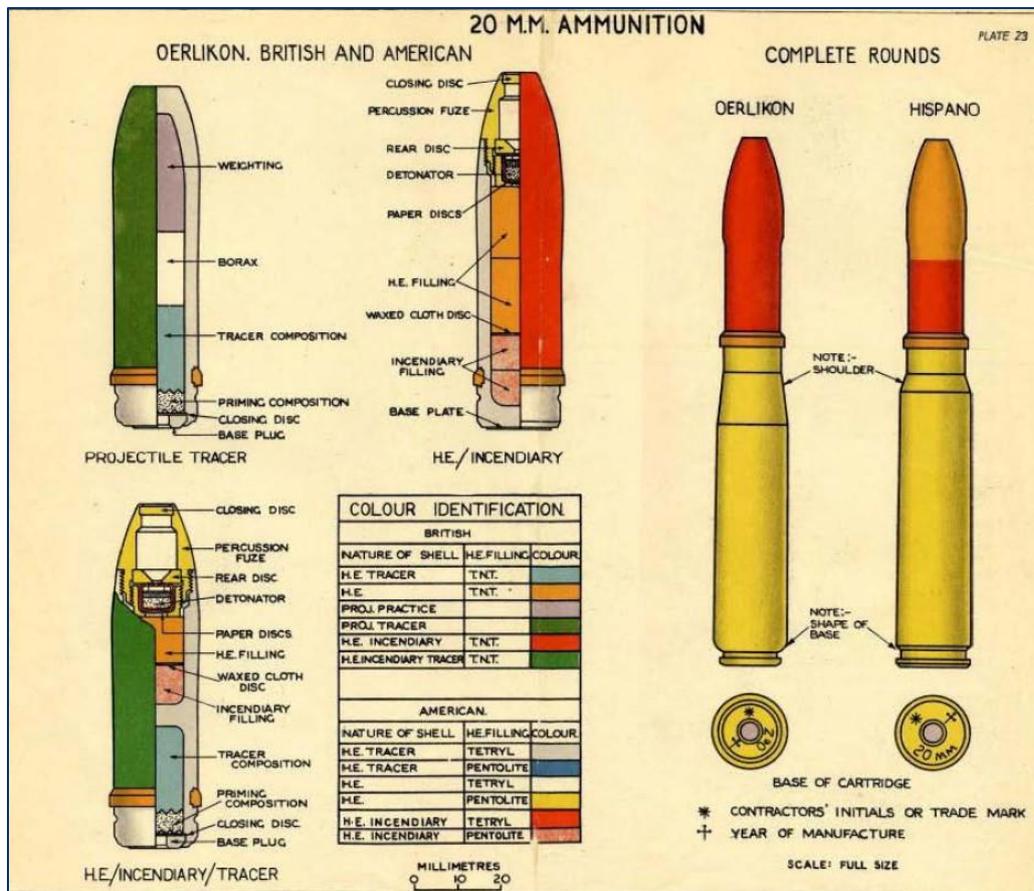
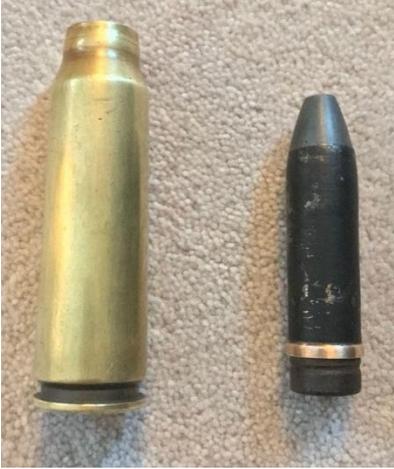
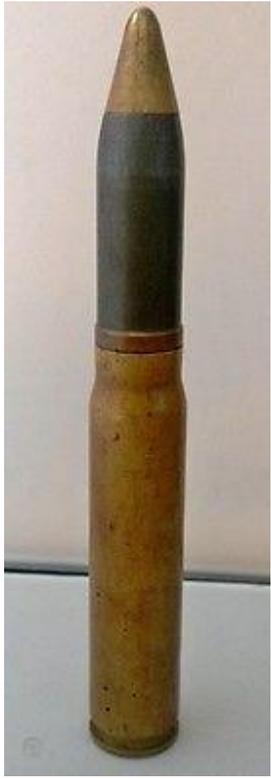
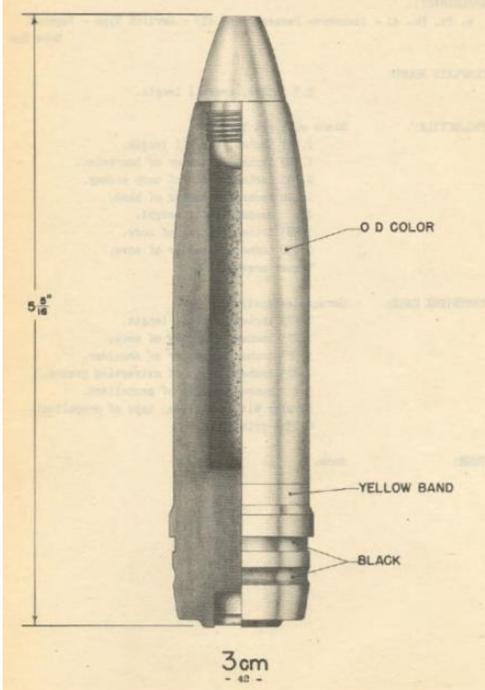
The small calibre UXO projectiles that can potentially be entrapped in the sample are fired from aircraft cannons. They can be of German and British origin. The projectiles are cigar shaped with a diameter of 2 cm/20 mm (German and British) or 3 cm (German) and a length of approximately 8 (2 cm projectile) to 13 cm (3 cm projectile). Below some illustrations of the projectiles are provided for reference as well as some photographs. Since the rounds are fired it is likely that the empty cartridge case and the projectiles may be encountered separately. The projectiles can be armour piercing, high-explosive or incendiary and may pose a threat to personnel.

<p>20 mm cartridge case (left) and projectile (right)</p>	<p>20 mm round</p>	<p>3 cm projectile</p>

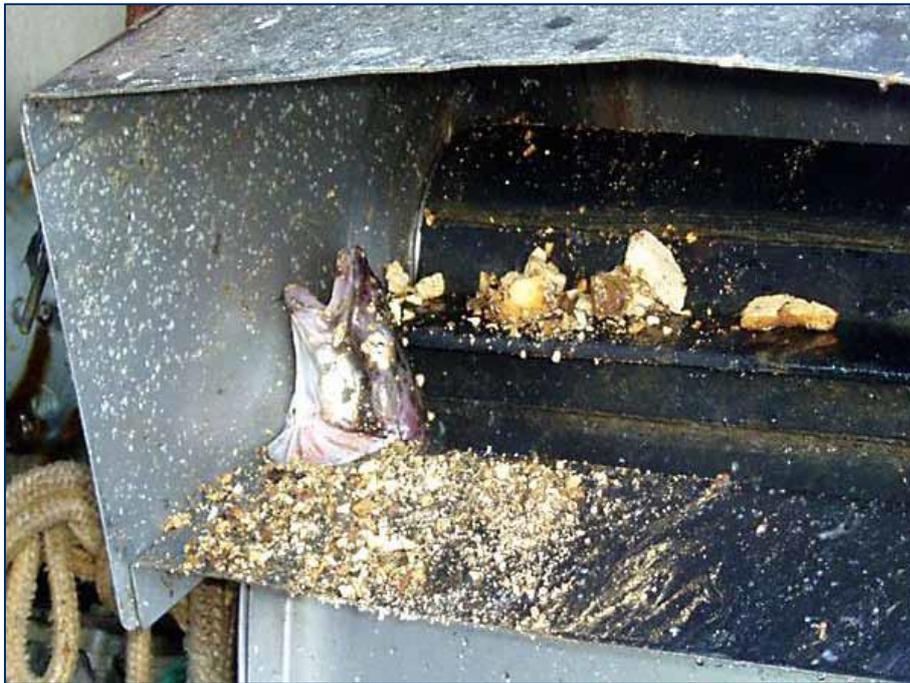
Adamsite can also exist underwater in solidified lumps with a slightly redder colour than sulphur mustard.

Figure 19: Small lumps of sulphur mustard in the fish conveyor belt on board a fishing vessel.¹⁷¹
