# UXO DESK STUDY

## OFFSHORE WIND FARM BORNHOLM II EAST

Report:	UXO Desk Study Offshore Wind Farm Bornholm II East
Client:	Energinet Eltransmission A/S
Report no.:	2021.03.214/UP0-344
Date:	04-02-2022
Version:	3.0
Author:	E. van den Berg

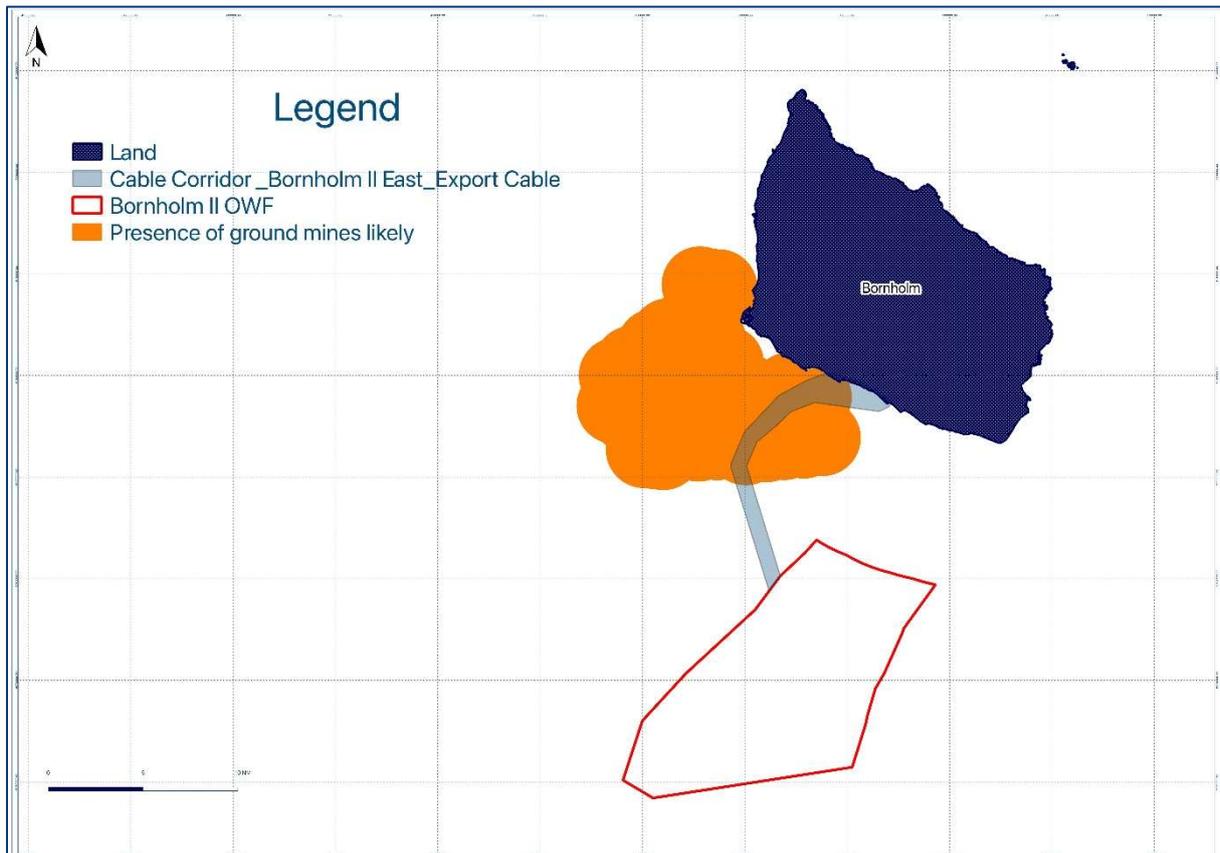
Figure 4: Demarcation of the area Mine Danger Area where the presence of ground mines is likely.

The likelihood for ground mines to remain is limited to the Mine Danger Area (MDA) of the Pollock gardening zone (see Figure 4).

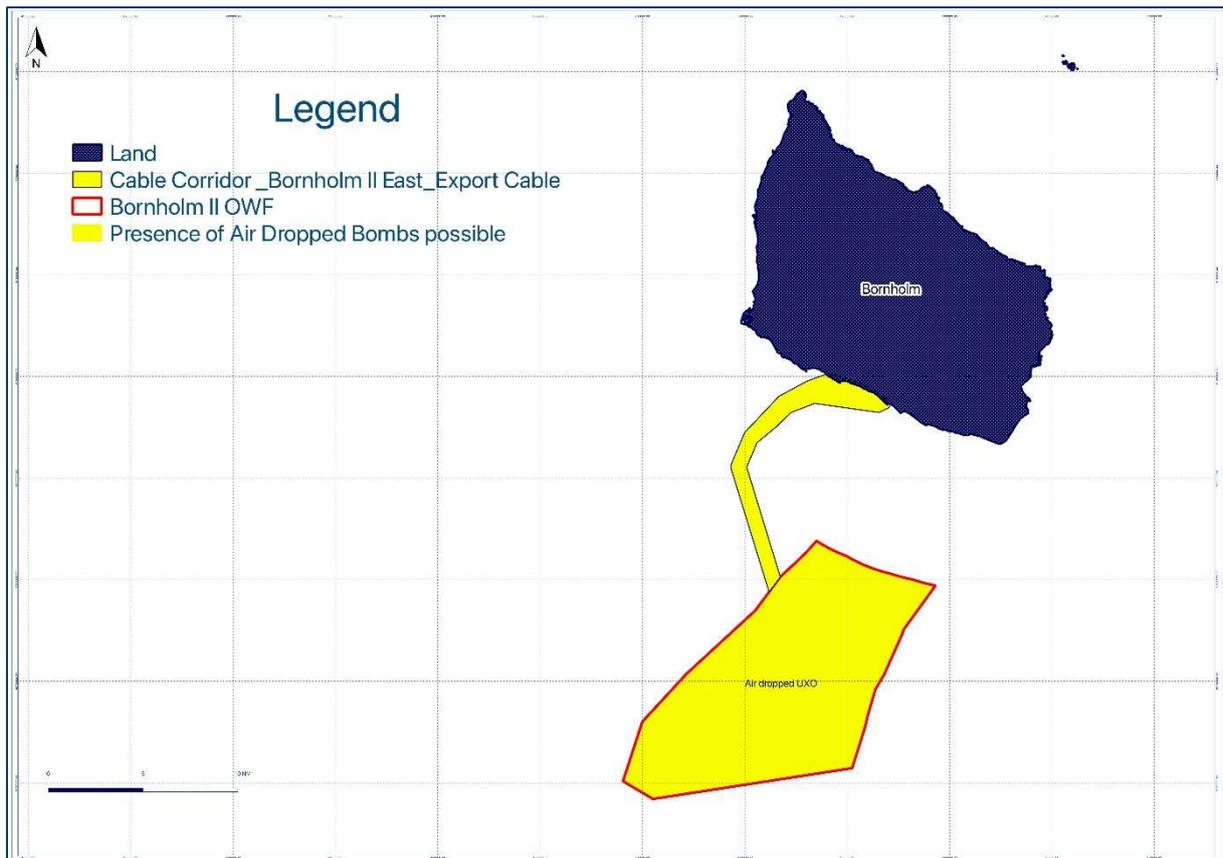
Figure 5: Area within the area of investigation where the presence of jettisoned bombs is possible.

When under attack or damaged by German Night fighters or anti-aircraft artillery, the bombers often jettisoned their bombs to reduce weight and, increase the chance of reaching friendly territory. Bomb loads could be jettisoned in a safe or armed condition. Safe condition means the initiation device fitted within the bombs were not in their armed state. Specific information about the positions of these jettisons is often lacking.

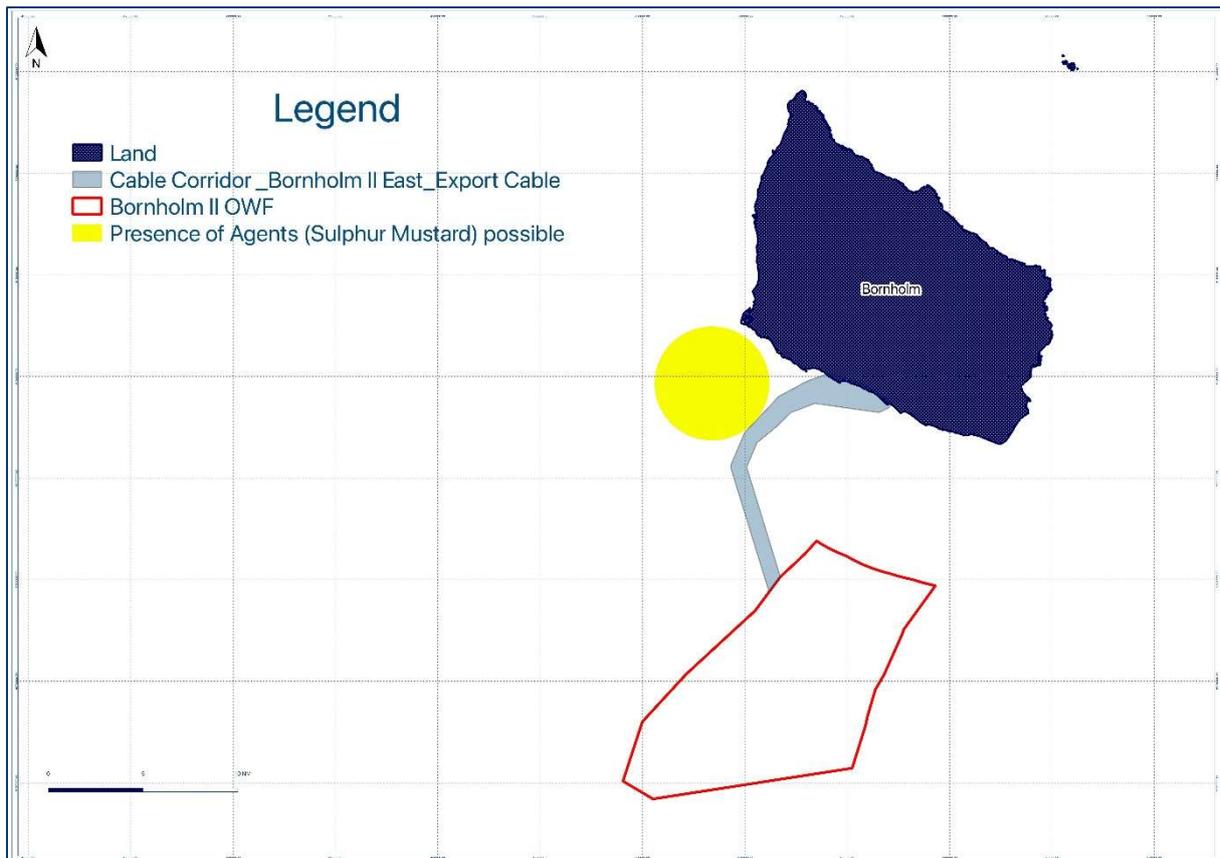
Figure 6: Emergency relocation area for encountered chemical warfare agents.

Chemical warfare materials can be found south-west of Bornholm in an emergency relocation area. This emergency relocation is bordering the Bornholm II East export cable route. The area has been assigned by the Bornholm-located Danish Navy Maritime Surveillance Centre South in the vicinity of the Bornholm dumpsite for the emergency disposal of netted warfare materials too unsafe to be brought and handled ashore. The area has a diameter of 0.5 nautical miles.

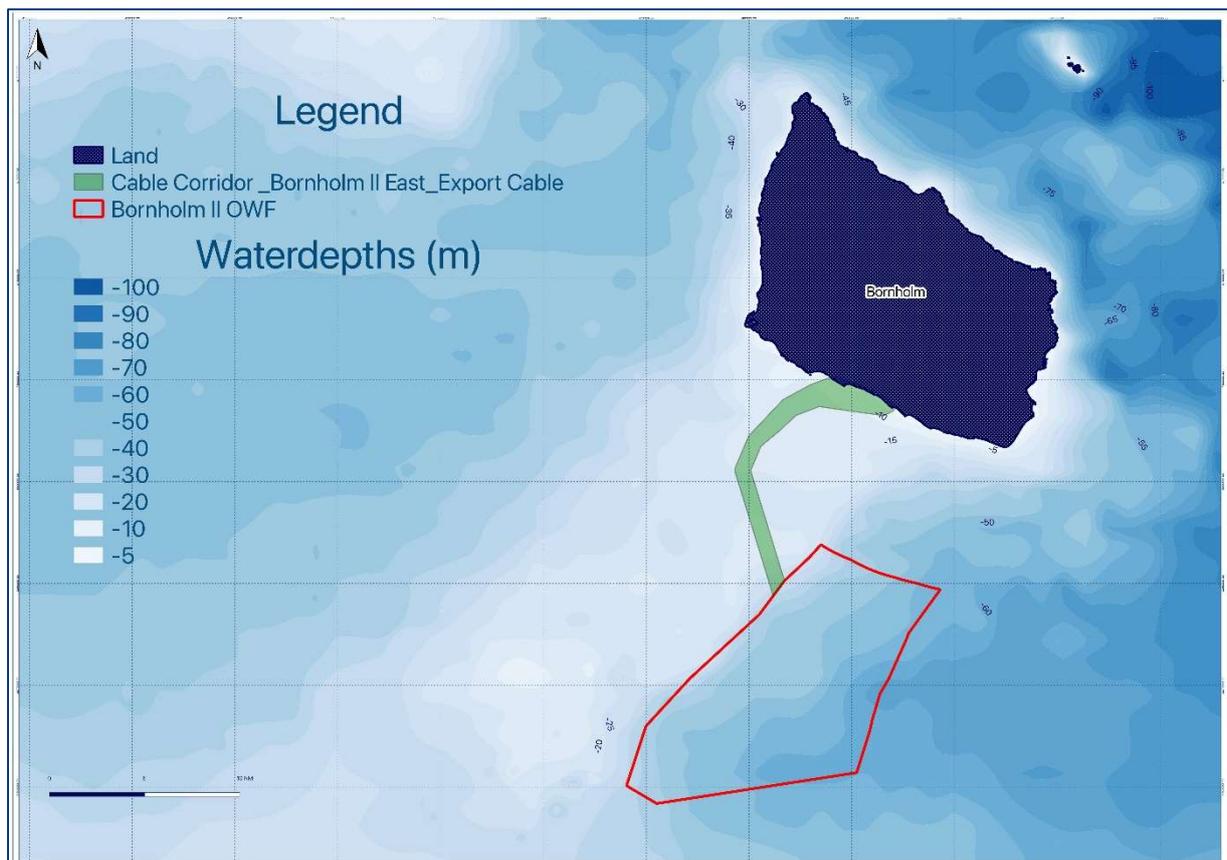
Figure 8: Bathymetry overview. <sup>100</sup>

To the Southwest of Bornholm, a shallow water area with Adler Grund and Rønne Banke separates the Arkona and Bornholm Basins. The Water depths on Rønne Banke is about 20m, and on Adler Grund the shallowest area is about 10m deep. The maximum water depth in the Bornholm Basin is 92m and the average depth in the Arkona Basin is 48m. In the Bornholm II East OWF site the water depth increases towards the south- east from approximately 30m to 50m.

An overview of the bathymetry is shown in Figure 8.

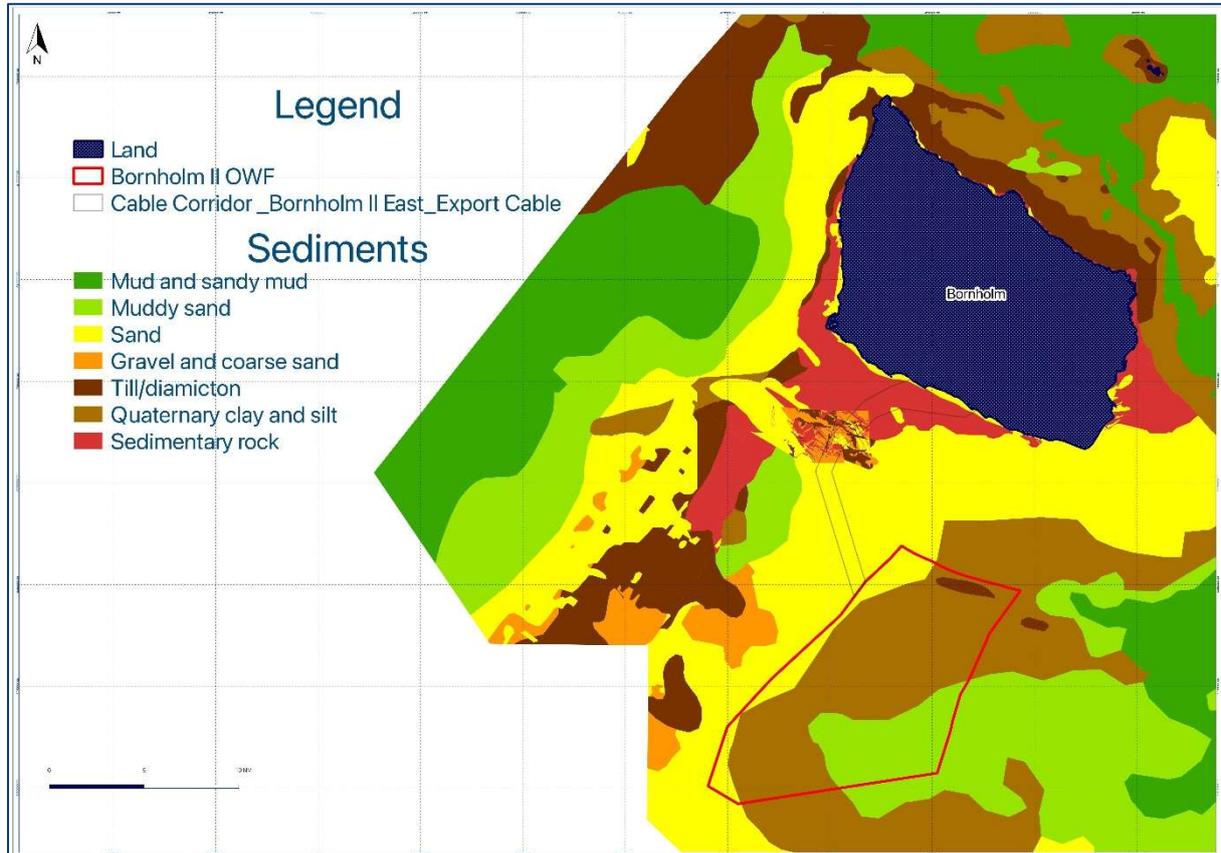
Figure 9: Seabed sidiments overview. <sup>101</sup>

Vibrocore data indicate the presence of marine sand and silt in the south of the site and late glacial glaciolacustrine clay in the northeast. Near landfall of the export cable corridor, sedimentary rock is present (outcropping Mesozoic deposits).

An overview of the seabed sediments is shown in Figure 9.

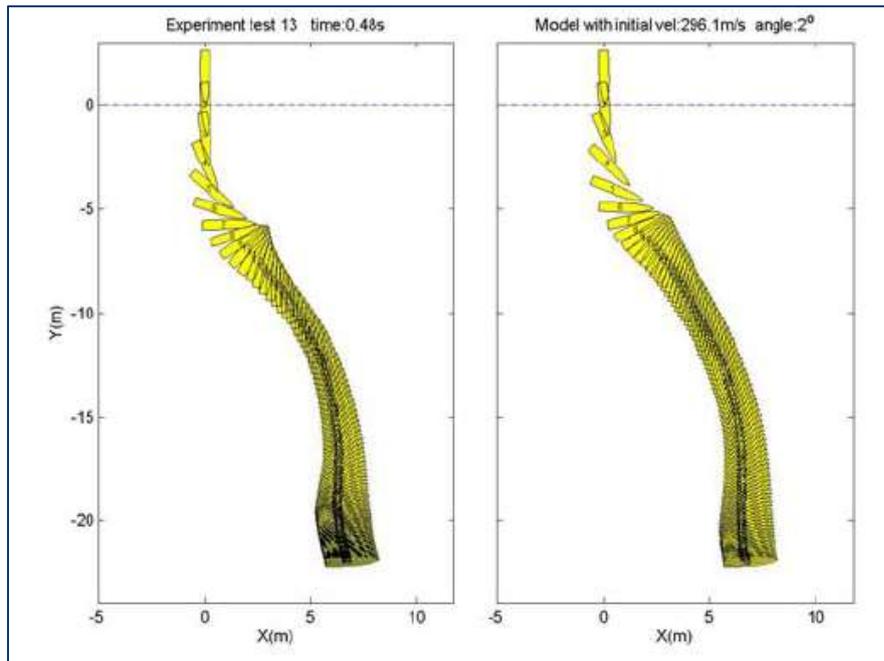
Figure 10: Comparison between modelled and observed Mk84 bomb trajectories.<sup>116</sup>

Experiments on Mk84 bombs in the USA show that the trajectory of a bomb falling into water at an angle of entry of  $\sim 90^\circ$  is rapidly altered by the new medium. The bomb rotates and orientates to near parallel to the seabed by a water depth of around 5-6m. Its burial in sandy soils due to impact will be minimal in water depths over 5m.<sup>115</sup> In muddy soils a bomb/ground mine may get buried because of the weight of the UXO, causing it to slowly sink down in the mud.

Because of the water depths at the OWF site and most of the export cable corridor, burial on impact can be excluded. Potentially, in water depths under 5m, UXO burial on impact is possible. However, at the export cable landfall location, the seabed consists of sedimentary rock (see paragraph 3.2). Based on the seabed conditions in the area with water depths under 5m significant UXO burial can be excluded.

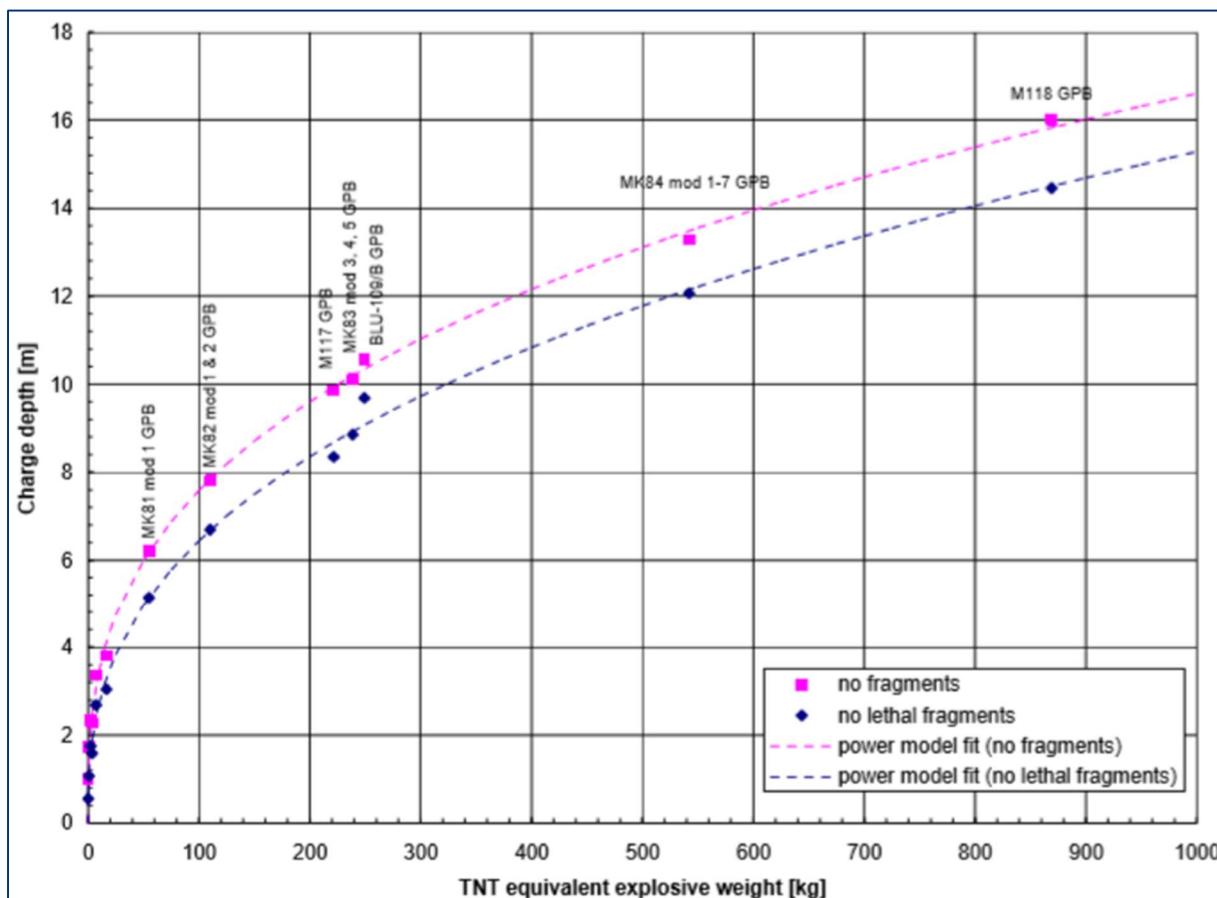
Figure 11: Minimal water depths to suppress fragments for 0-1000 kg. <sup>126</sup>

The displayed values are worst-case values based on spear-shaped fragments and a vertical fragment course (perpendicular to the water line). In case of a non-vertical course of the fragments the distance travelled by the fragments through the water column is larger.

It should also be noted that the bodies of underwater ammunition (the main group of UXO with large explosive content) are not designed for fragmentation. Therefore, fragments of these type of UXO will be larger and irregularly shaped causing them to be sufficiently slowed down by a smaller water column.

Considering the water depths in Bornholm II East OWF (ranging between 30m to 50m) no risks will occur due to fragmentation in case of a detonation at the seafloor. Only in the shallow parts of the export cable corridors, in water depths under 12.5m, fragmentation may pose a HSE risk.

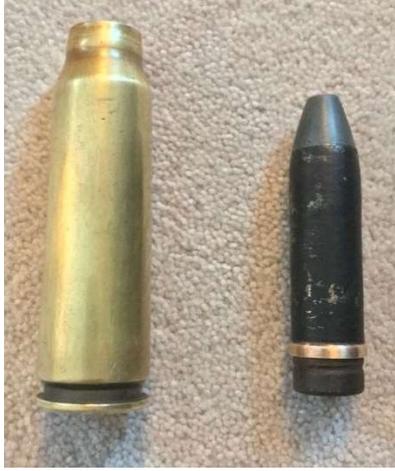
The small calibre UXO projectiles that can potentially be entrapped in the sample are fired from aircraft cannons. They can be of German and British origin. The projectiles are cigar shaped with a diameter of 2 cm/20 mm (German and British) or 3 cm (German) and a length of approximately 8 (2 cm projectile) to 13 cm (3 cm projectile). Below some illustrations of the projectiles are provided for reference as well as some photographs. Since the rounds are fired it is likely that the cartridge case and the projectiles may be encountered separately. The projectiles can be armour piercing, high-explosive or incendiary and may pose a threat to personnel.

20 mm cartridge case (left) and projectile (right)

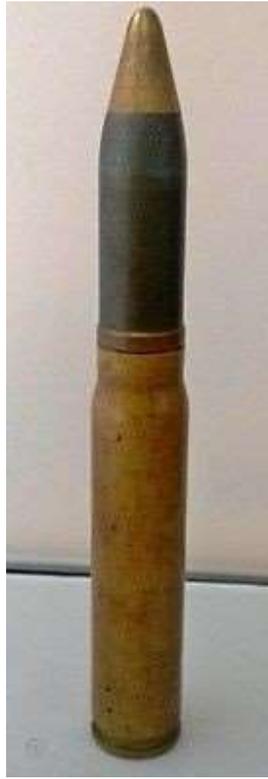
20 mm round

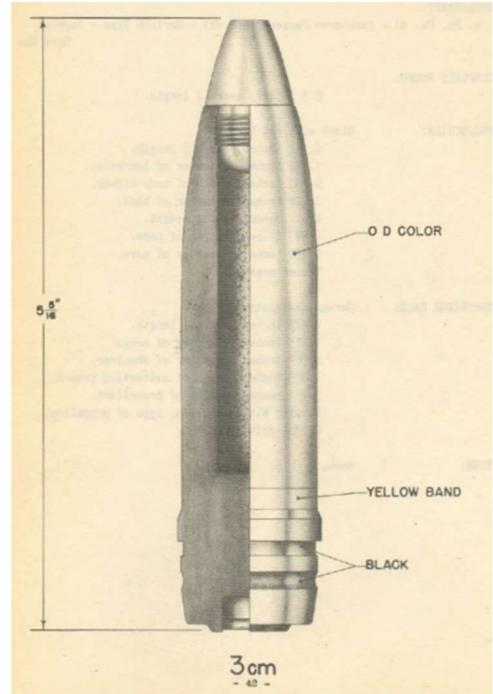
3 cm projectile
